**PERFORMANCE OF LOW VOLUME SEALED ROAD PAVEMENTS: A  
CASE STUDY OF ROADS 2000 STRATEGY IN CENTRAL KENYA**

*A Thesis Submitted in Partial Fulfilment for the Award of the Doctor of Philosophy in Civil  
Engineering, Department of Civil and Construction Engineering, University of Nairobi.*

**July 2024**

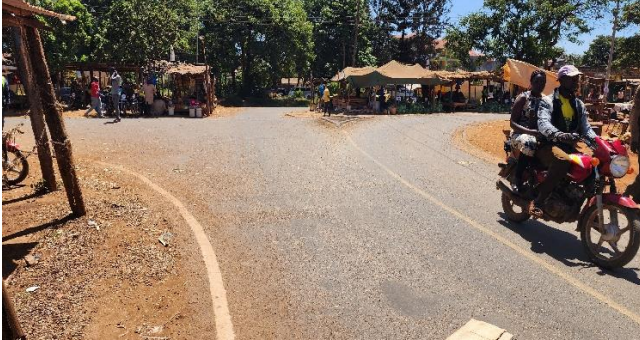
(a) Road start at Maragwa town. Asphalt surface intact, but poor drainage system noted (Author, 2023).

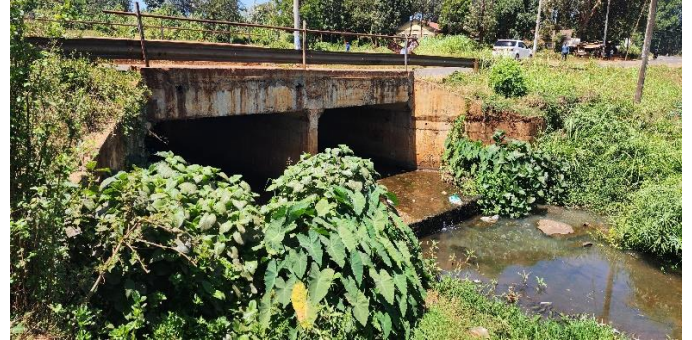
(b) Twin-box culvert in good operating condition, but water pooling was noted at the exit side of the structure. Poor routine maintenance noted. (Author, 2023).

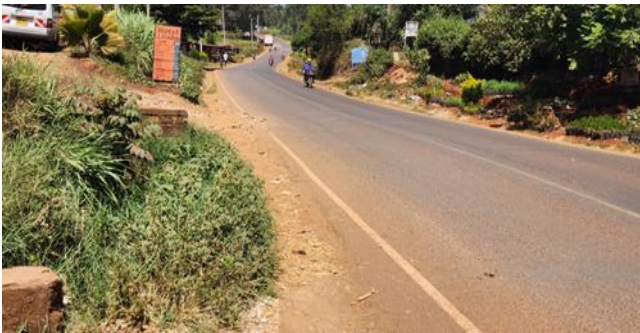
(c) Road transcends an urban setup, still in good serviceability, but in poor maintenance condition (Author, 2023).

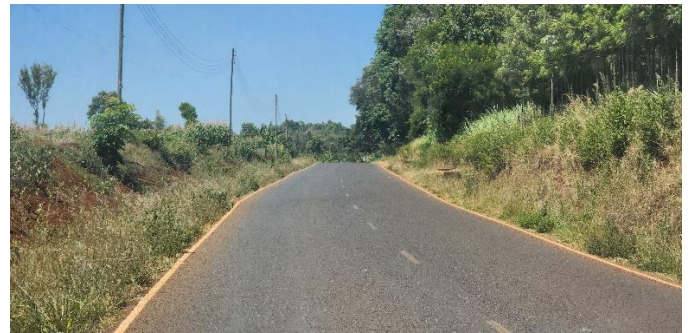
(d) Towards the end stretch of the road, a good ride quality was experienced, and the road was in good service. Poor drainage and lack of timely routine maintenance was noted (Author, 2023).

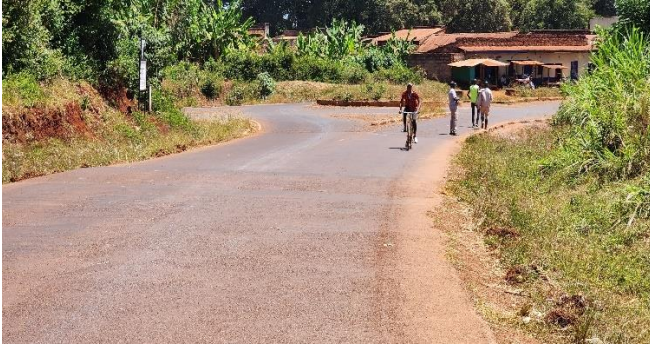
(a) Road start at Gakoigo junction. Asphalt surface intact, but poor drainage system noted (Author, 2023).

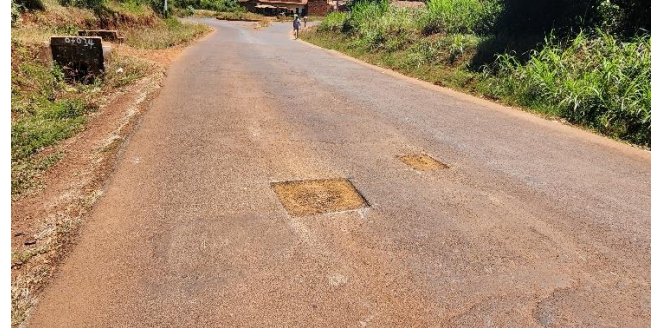
(b) Section showing pothole patching maintenance works in progress. The ride quality was rough on most sections (Author, 2023).

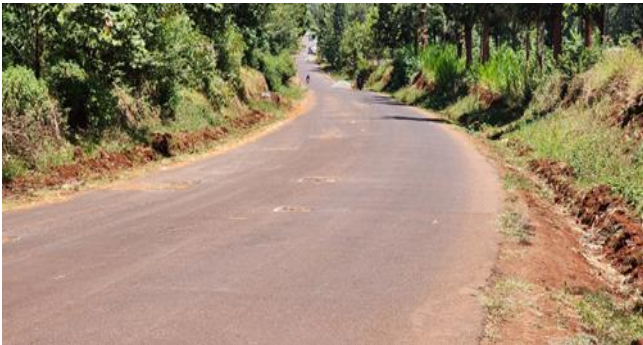
(c) Section showing the road geometry, drainage and surfacing. Asphalt surface intact on most sections, but poor drainage system noted even after routine maintenance. (Author, 2023).

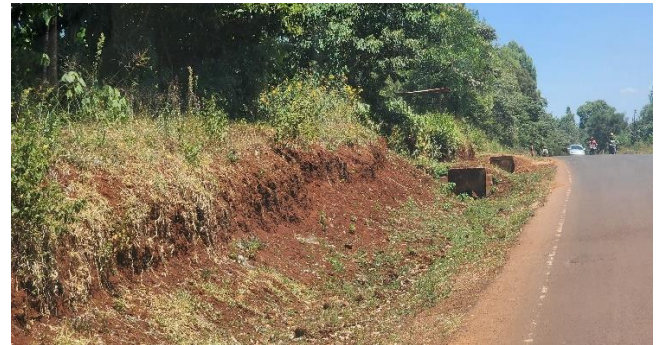
(d) Section showing unprotected slopes prone to erosion, leading to siltation of the drains and culverts (Author, 2023).

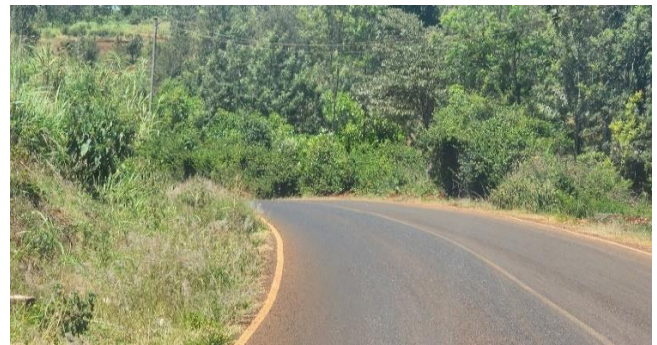
(b) Section showing the road geometry on a curve with poor visibility. Case of inadequate routine maintenance (Author, 2023).

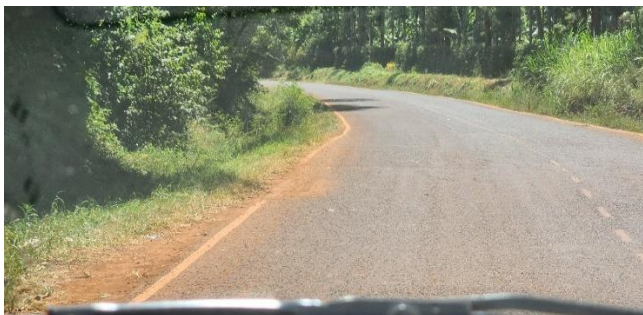
(c) Section showing a section still in good serviceability (Author, 2023).

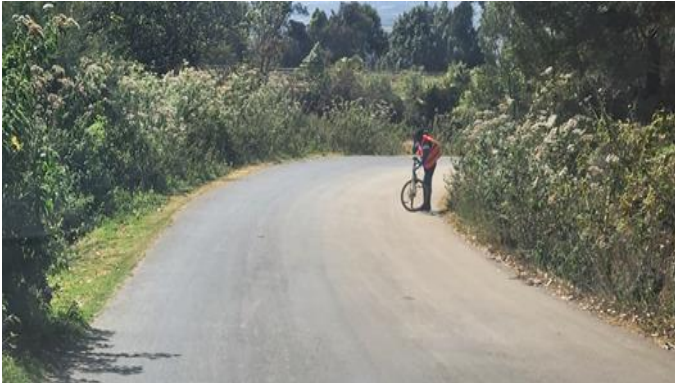
<p>(a) Section showing road geometry on a curve offering inadequate sight distance due to overgrown vegetation (Author, 2023).</p>

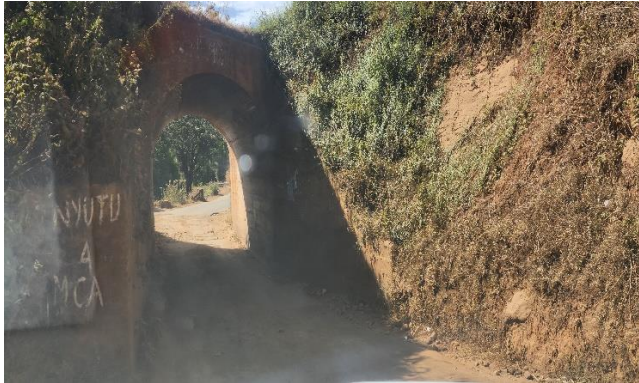
<p>(b) A railway intersection with the road, with the underpass only offering one way movement (Author, 2023).</p>

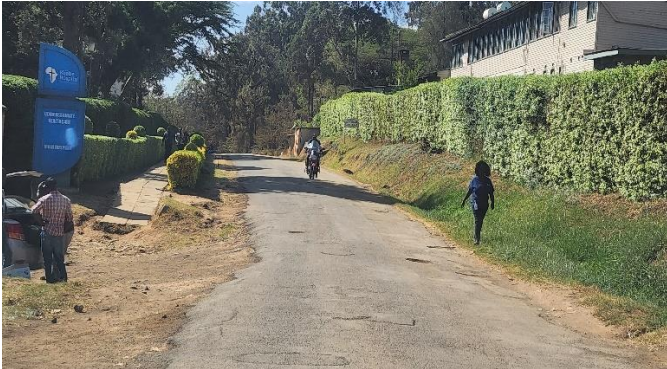
<p>(c) Section showing deterioration of the edges and no clear drainage system (Author, 2023).</p>

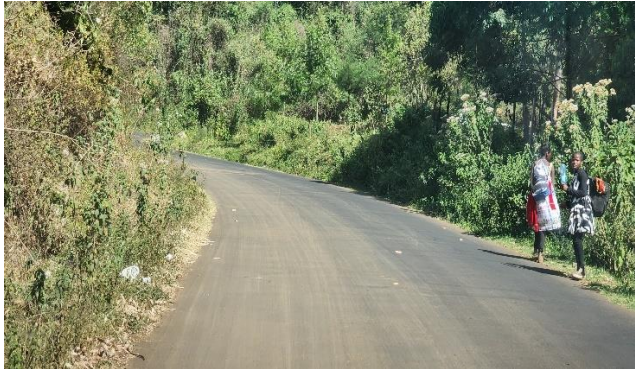
<p>(d) Section exhibiting good serviceability but poor routine maintenance noted (Author, 2023).</p>
<p><b>Plate 4.7:</b> Status of the Gichiengo – Kijabe Hospital Road – E443/2 during the study</p>

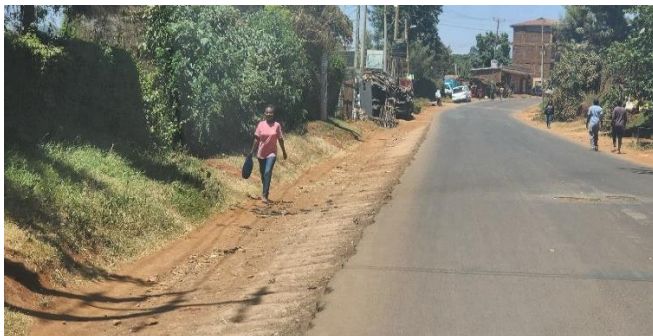
(a) Section of the road exhibiting failure by edge subsidence and potholing (Author, 2023).

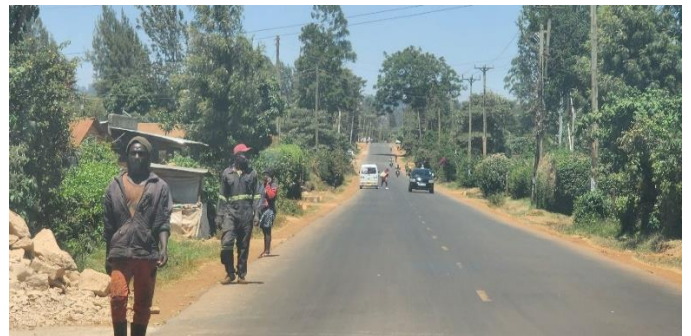
(b) Road section still in good condition and offering a smooth rideability (Author, 2023).

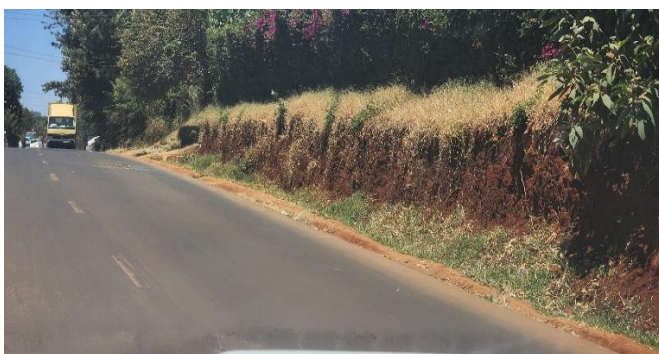
(c) Section showing embankment slopes with a potential for erosion, and drainage system inadequate (Author, 2023).

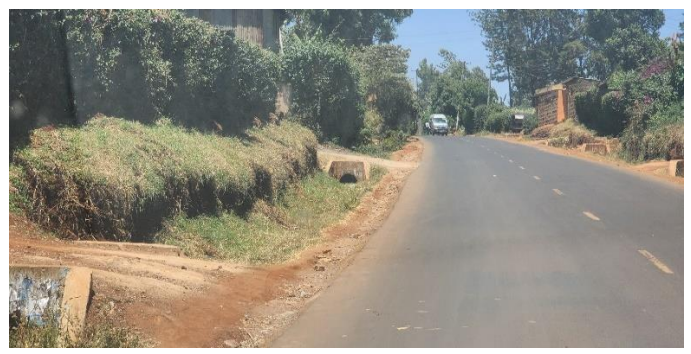
(d) Section offering good serviceability but poor maintenance showing on silted drains and culverts (Author, 2023).

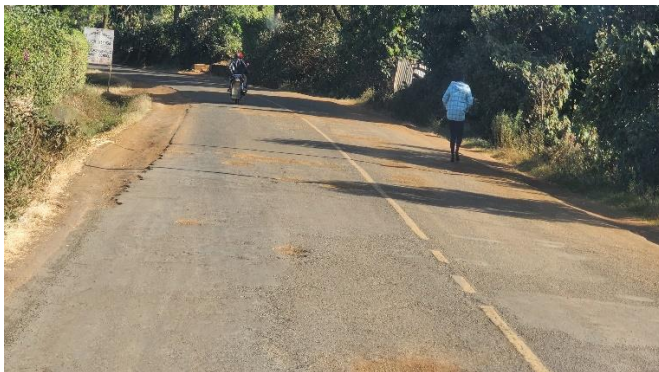
(a) Road start that was quite rough showing the continuing deterioration of the surfacing on that section (Author, 2023).

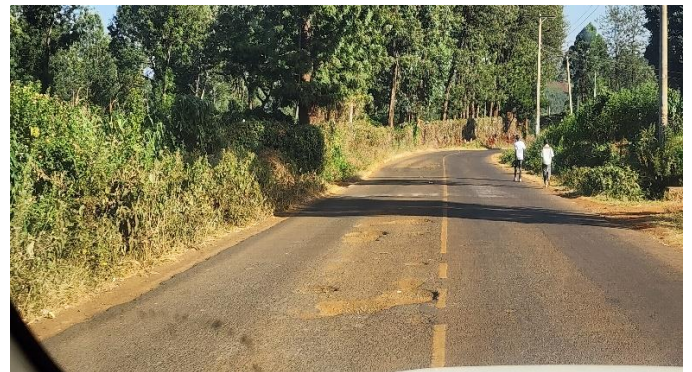
(b) Section showing continuous failure of the pavement by potholing. Inadequate drainage system noted (Author, 2023).

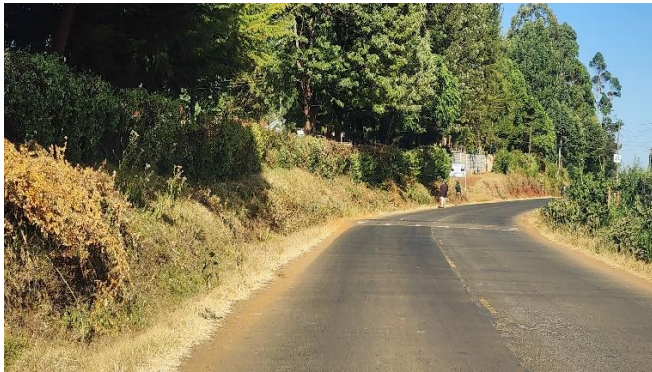
(a) Road start showing road in a good condition (Author, 2023).

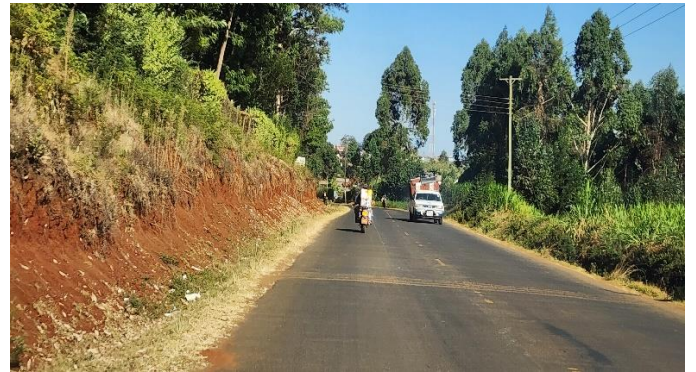
(b) Section showing the embankment slopes on the left with high erosion potential and already silted drainage system (Author, 2023).

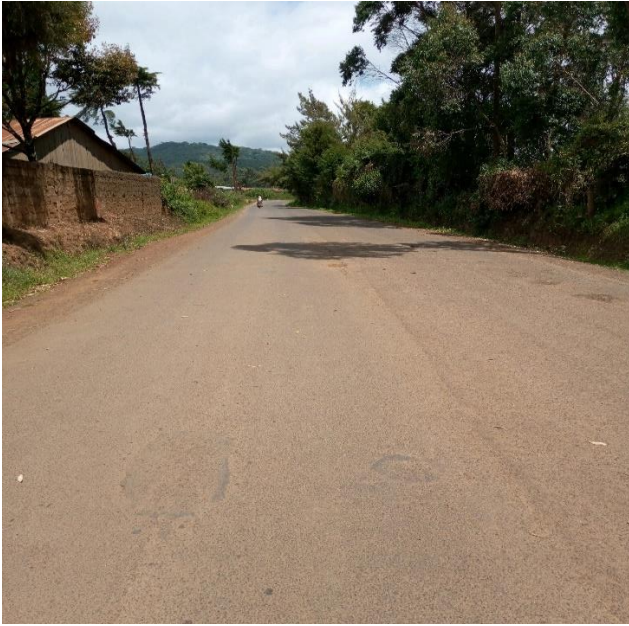
(a) Old pavement, at Km 0+010 where damaged surfacing had been repaired (Author, 2021)

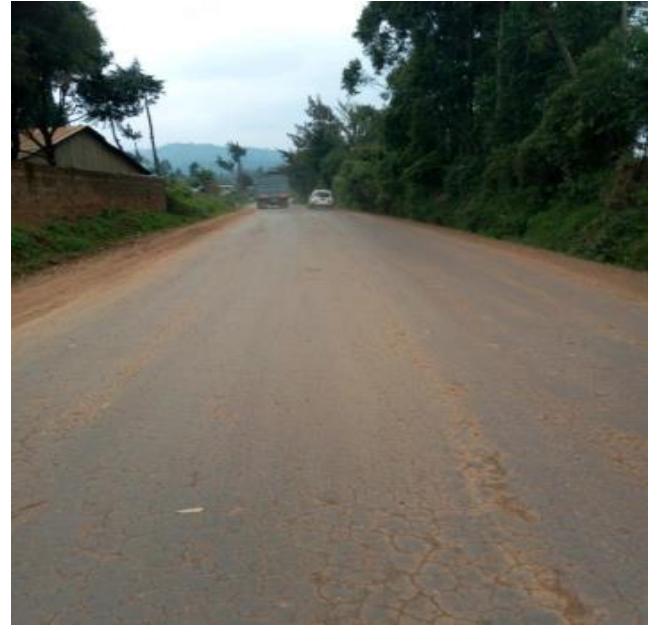
(b) Km 0+010 where asphalt layer has been damaged (Author, 2020).

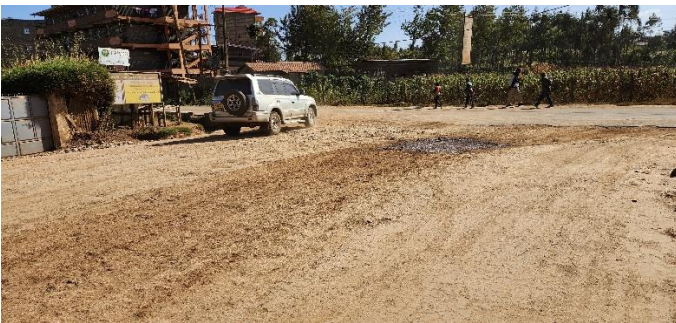
(c) Road start where upgrading works were on-going (Author, 2023)

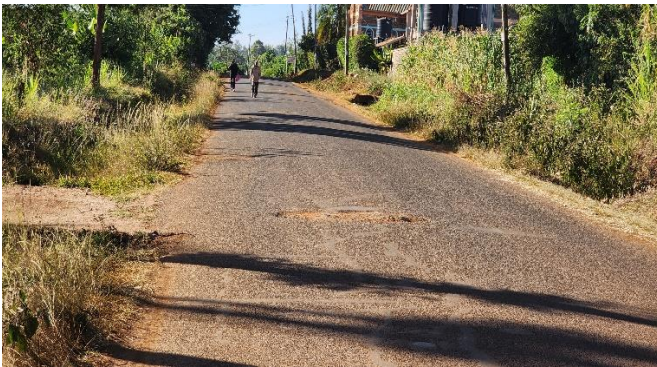
(a) Road start showing signs of failure by potholing. Overgrown vegetation also noted obstructing flow of water on the drainage system (Author, 2023).

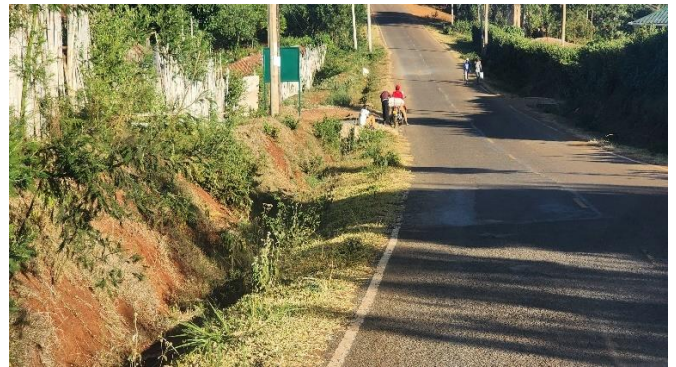
(b) Unlined drains with embankment slopes exhibiting high erodibility potential (Author, 2023).
