TITLE: INVESTIGATION INTO CAUSES OF GULLYING AND
GULLY CONTROL IN KANDARA DIVISION OF
MURANGA DISTRICT.

AUTHOR: JOHN DAMBA, (B. SC. AGRIC., DIP. AGRIC., EDUC.)
(MAKERERE UNIVERSITY)

PROJECT REPORT SUBMITTED TO THE UNIVERSITY OF NAIROBI
IN PARTIAL FULFILLMENT OF THE REQUIREMENT FOR POST-
GRADUATE DIPLOMA IN IRRIGATION AND SOIL CONSERVATION

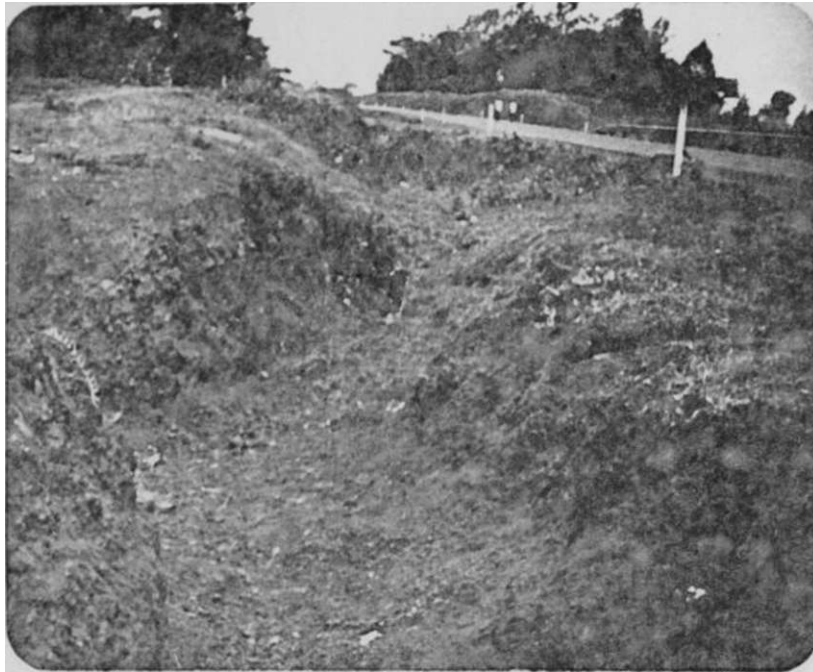
Fig. 5

From the observations made on the site and from the information obtained from Mr. Too and Mr. Kiruri of the Kandara Agricultural division offices, the Kabati gully was caused by water running off the newly constructed road. Concentrated run off from the road drainage coupled with absence of grass cover in the poorly protected natural waterway used as a footpath caused the initiation of gullying.

Figure shows head of Kabati gully. Road in background and road drainage can be seen.

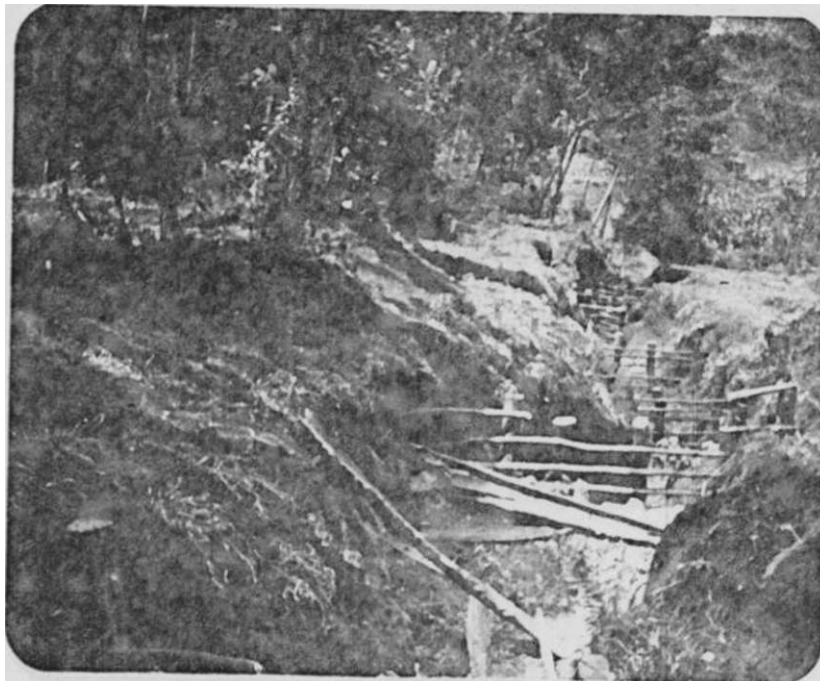
Fig. 6

Check dams have been constructed in the gully to cause siltation. A total of 21 check dams have been constructed along the whole length of the gully and their spacing is between 6-10 metres depending on slope. Check dams are constructed from posts and rafters, hardcore and sacks filled with soil. Posts were lined up across the gully at right angles and were joined together by rafters. Sacks full of soil were deposited behind the posts on the

Kabati gully showing control structures and footpath on the right. Note the grass establishing behind the check dam.

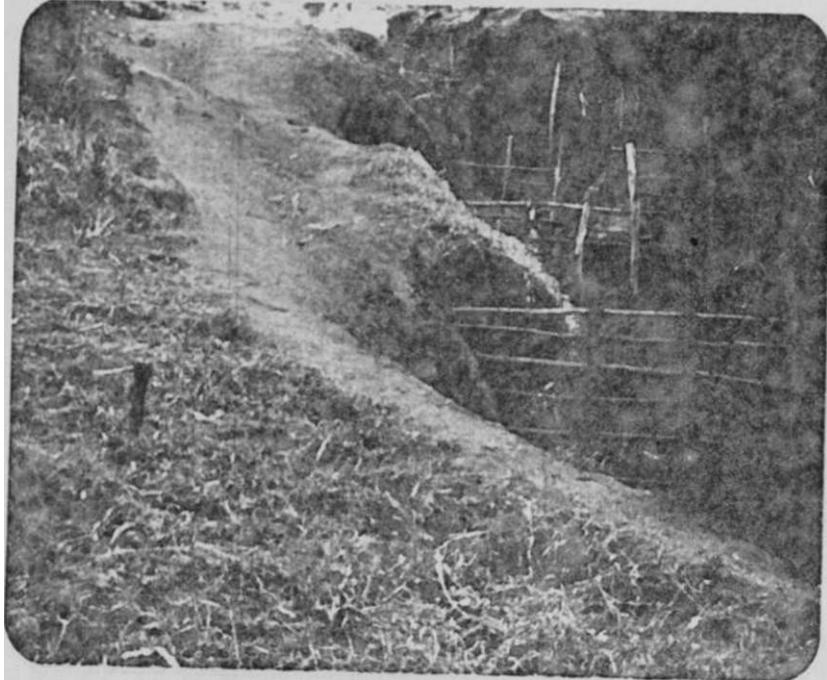
Fig. 7

Kabati gully showing footpath on the left and extent of gully lower down the gully.

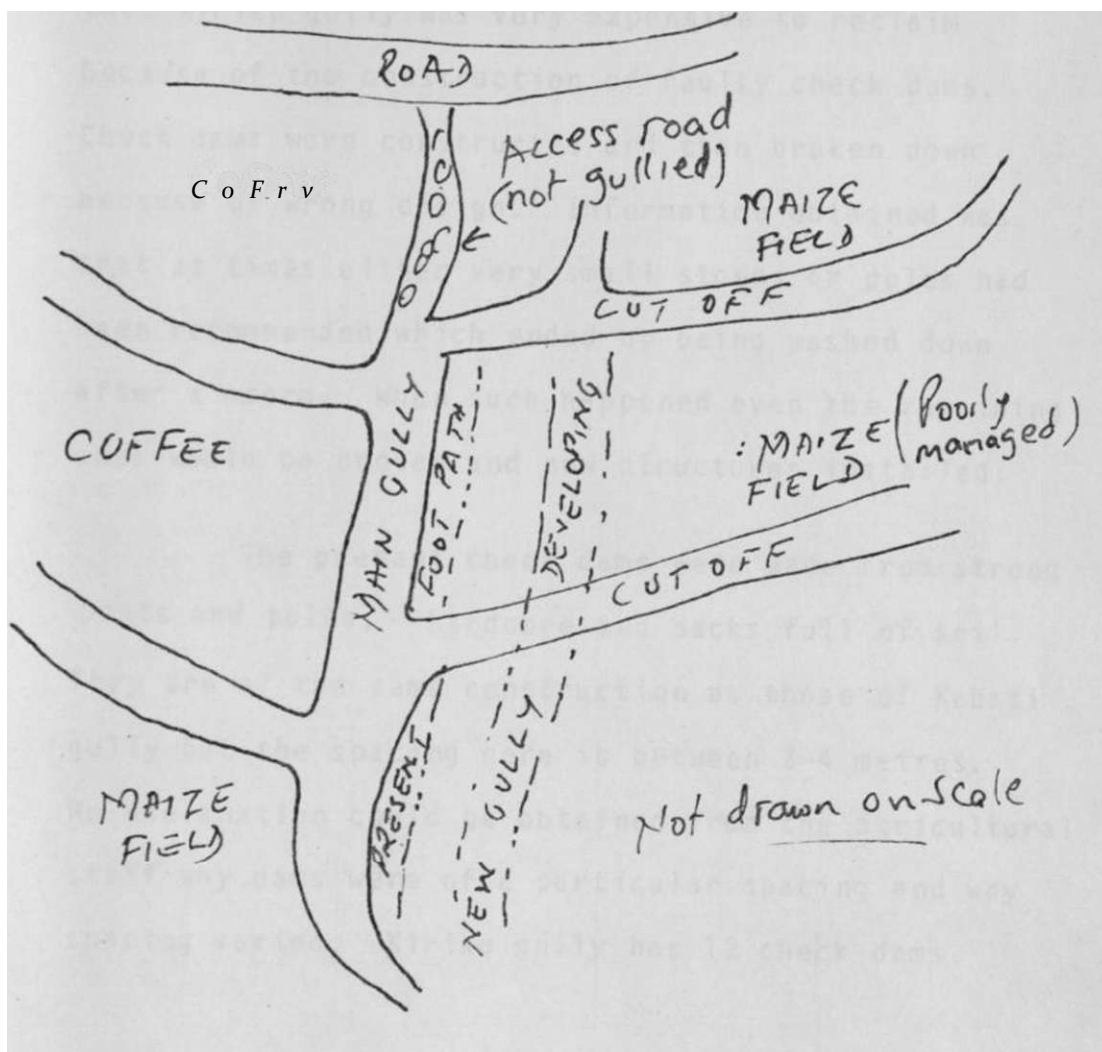
Fig. 11

Kiriko gully was formed by disposing off water into a natural waterway, which was at the same time being used as an access road. The diagram below illustrates the situation at Kiriko gully.

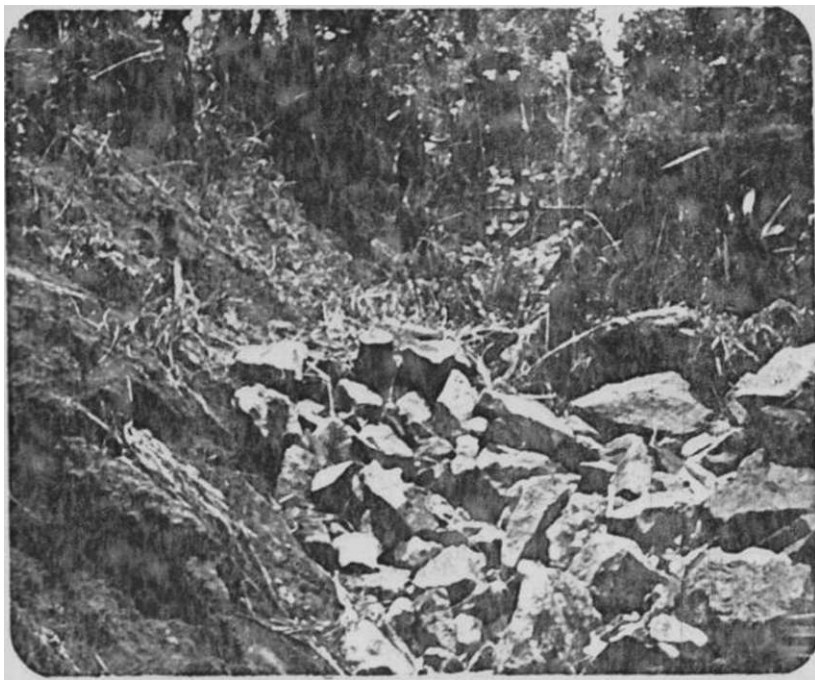
Fig. 12

Check dams were used to control the gully. Information obtained from the Agricultural staff was that Kiriko gully was very expensive to reclaim because of the construction of faulty check dams. Check dams were constructed and then broken down because of wrong design. Information obtained was that at times either very small stones or poles had been recommended which ended up being washed down after a storm. When such happened even the remaining ones would be broken and new structures installed.

Figure shows check dam in Kiriko gully. Note the gentle slopes and the establishment of grass both on the slopes and within the gully.
