GEOMORPHOLOGY AND SEDIMENTOLOGY
OF THE
MOMBASA - DIANI AREA:
IMPLICATIONS TO COASTAL ZONE MANAGEMENT

A thesis submitted in partial fulfilment for the
degree of Master of Science in the
University of Nairobi.

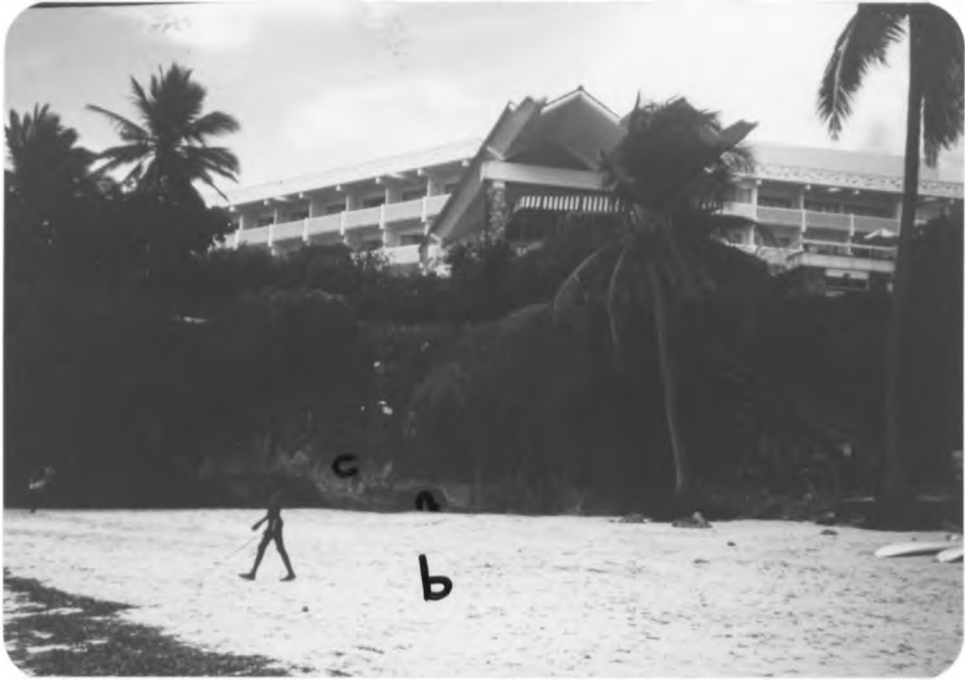
Plate 1 shows a cliffed coast (c) with undercut notches (n) and a beach (b) adjacent to the cliffs at Nyali (September, 1990; Photo by P. Abuodha).

The coastlines north and south of Mombasa are characterized by coral rocks and sandy beaches protected from the open Indian Ocean by the fringing reefs. Except for the interruption of the reefs at the creeks by the outflow of fresh water from rivers, the reefs run parallel to the entire shoreline at a distance of approximately 2 km in the study area. North of Mombasa, the shore platform extends 1-2 km offshore leaving a well protected lagoon inside. Small sand dunes and offshore bars are also characteristic features of the northern part of Mombasa. South of Mombasa the reefs are found mostly close to the shore and the shore platform is characterized by small stacks and cavities because the waves generally break on it and thus it is most of the time under strong wave action. The upper level of the shore platform is either an area consisting of weathered undercut cliffs with frequent notches and caves (plate 1) or

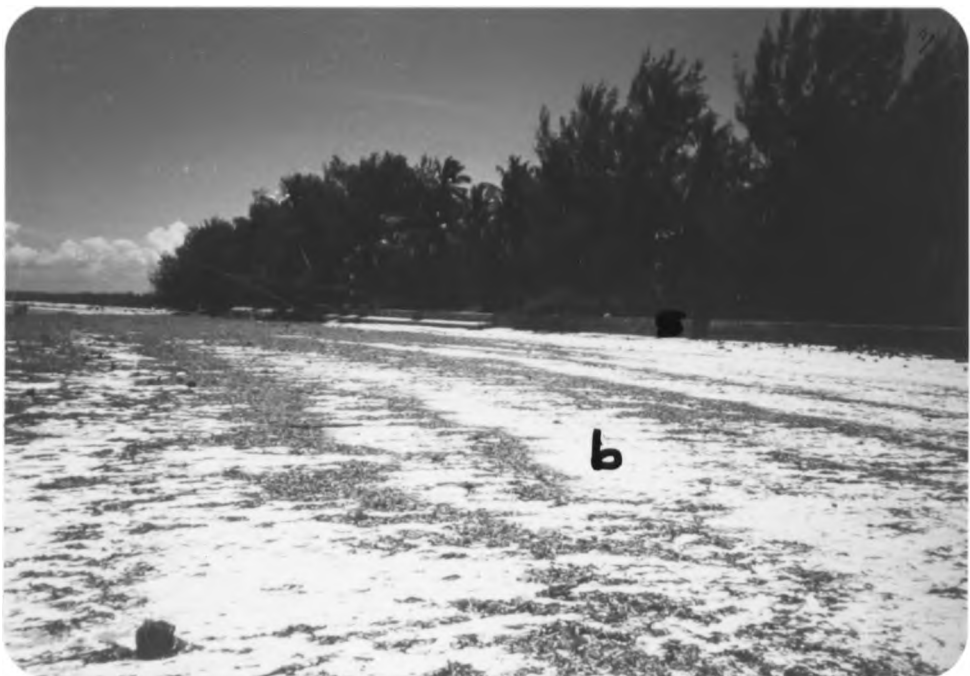
Plate 2 shows a beach (b) marked on the landward side by a seawall (s) along Bamburi beach (September, 1990; Photo by P. Abuodha).

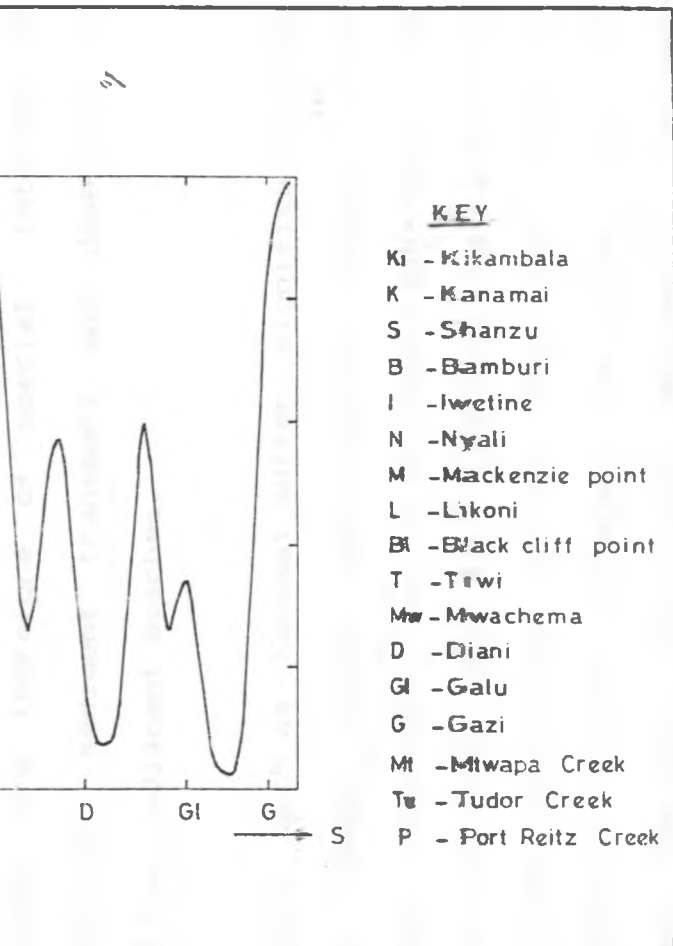
Fig. 15 shows non-carbonate (quartz) sands along Mombasa-Diani area to be associated with terrigenous material brought down by rivers into the creeks.

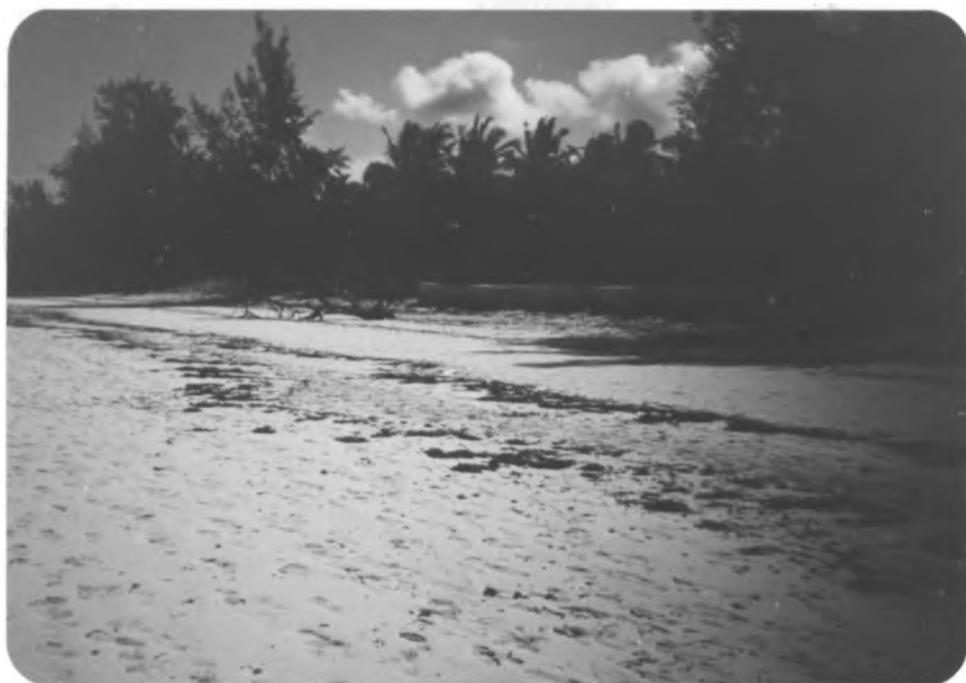
Plate 3 shows debris marking the highest swash mark along Bamburi beach (September, 1990; Photo by P. Abuodha).

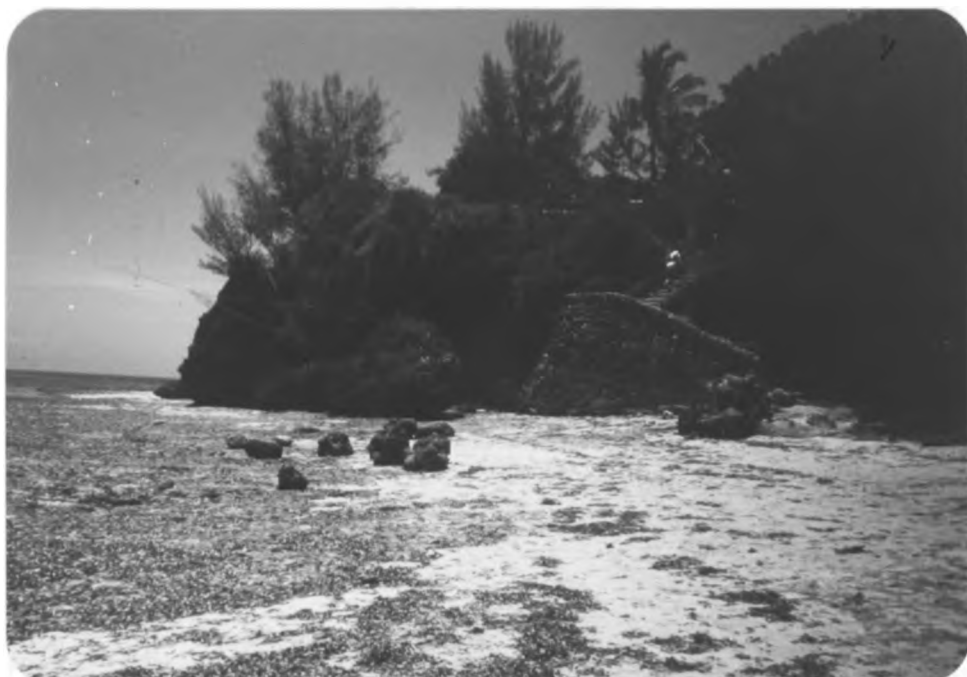
Plate 4 shows high tide mark marked by a weathered cliffed coast and a seawall (September, 1990; Photo by P. Abuodha).

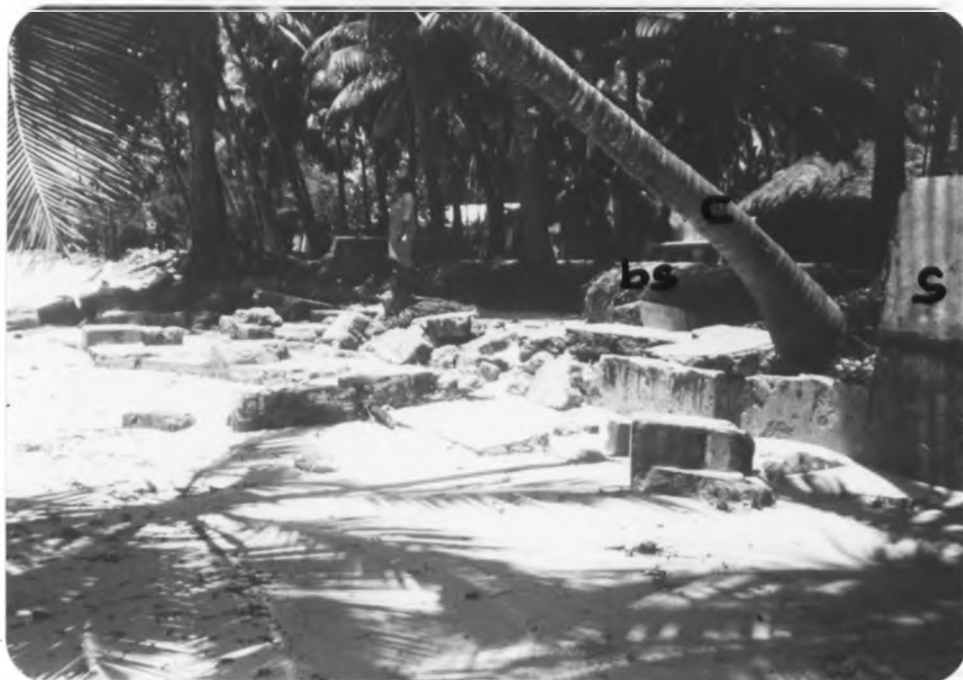
Plate 5 shows a 1 m beach scarp (bs), slanting coconut tree (c) and remnants of a seawall (s) at Kanamai as the results of wave action during a flood tide (September, 1990; Photo by J. Abuodha).

A near-vertical beach scarp of about 0.5-1.0 m has developed at Kanamai (Plate 5). It is caused by unusually large waves. Beach scarps are, not only found at Kanamai, but are a common feature along the investigated area. Narrow beaches show steep but smooth profiles for instance at Bamburi (Fig. 16). Beaches with wide widths exhibit an undulating profile as at Diani as shown in figure 18.

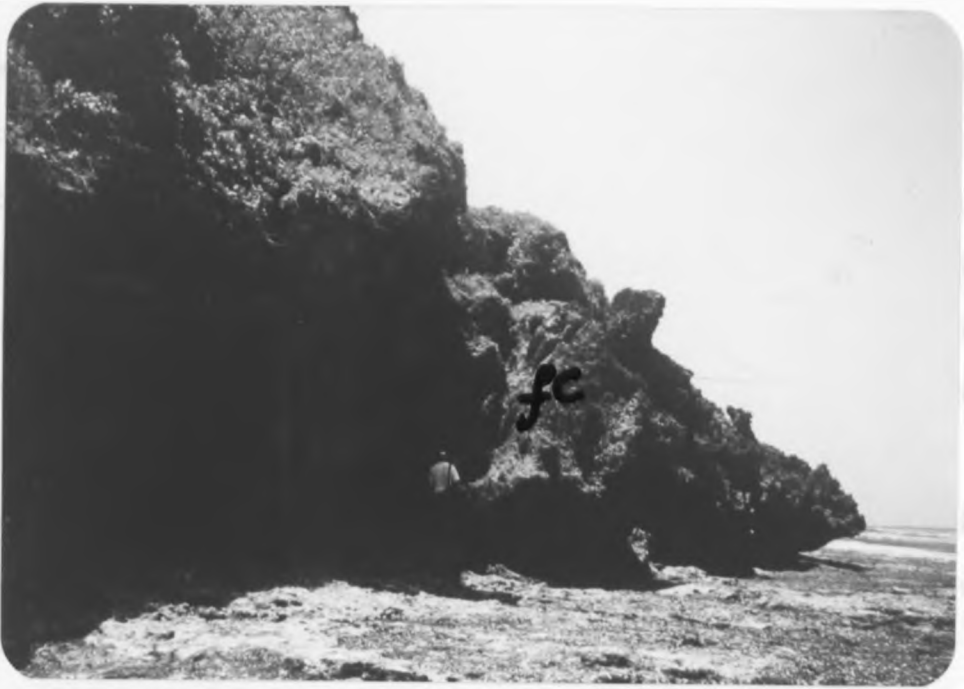
Plate 6 shows fallen cliff (fc) due to wave erosion at Mtwapa (September, 1990; Photo by P. Abuodha).

Limestone cliffs were observed at Kanamai, Shanzu, Iwetine, Nyali, Likoni (Fig. 25) and at Black Cliff Point as well as Tiwi (Fig. 26). The height of these cliffs (Plate 6) was estimated to be 10-15 m above sea level. The cliffs are near vertical with pronounced wave-cut notches (Plate 6) at 4 m above sea level (Ase, 1978). The notch is deepest where dynamic pressures are highest (Carter, 1988). The notch is evidently not only an abrasion notch but is

essentially the outcome of solution process. The base of the notch is mostly smoothed and polished by the movement of sand caused by waves. Notch-development will continue until the overburden fails (Plate 6). A tendency for the cliff to bulge seaward or even fail is created by negative pressures which occur between wave crests. When a wave impacts a cliff, the pressure distribution varies across the cliff face, some areas being far more affected than others.

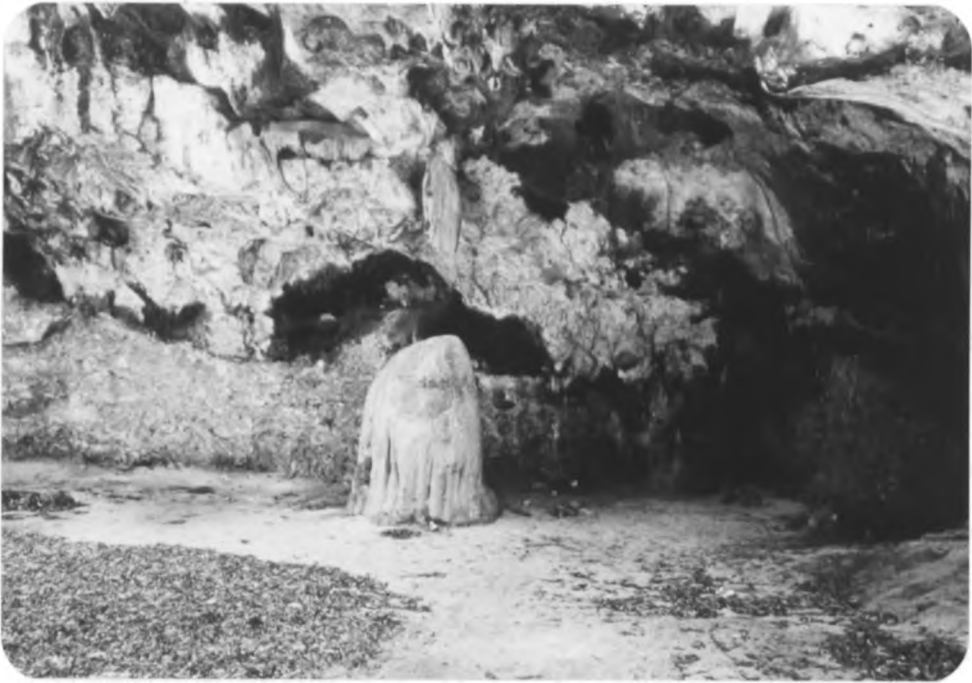
Plate 8 shows a cave at Shanzu (September, 1990; Photo by P. Abuodha).

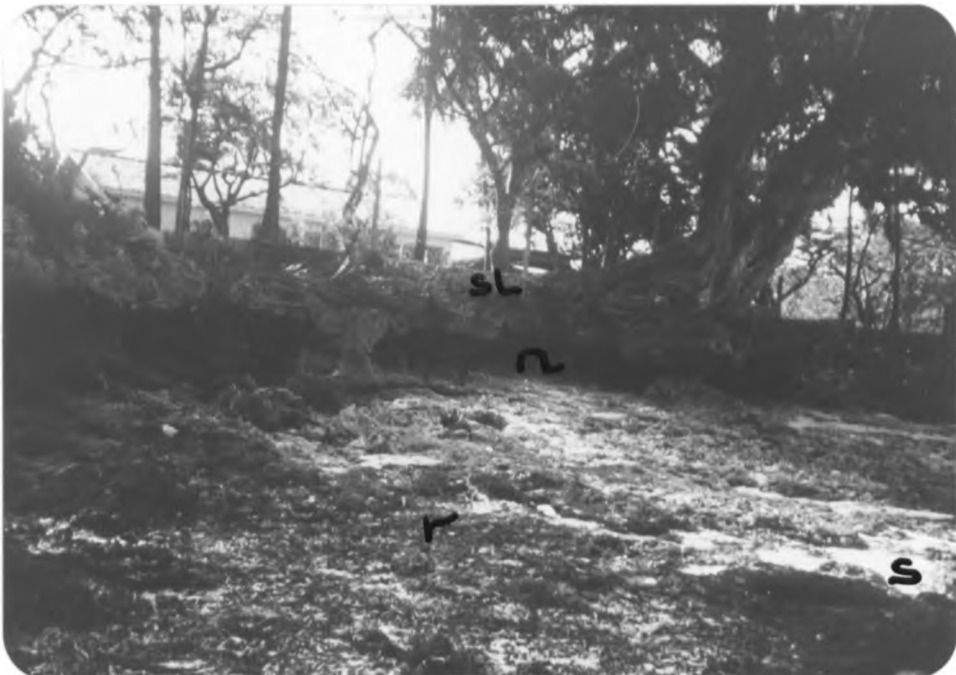
Plate 9 shows notches (n) beneath a sea wall (sl) at Kenyatta. Also note the exposed rocky shore (r) with little sand (s) (September, 1990; Photo by P. Abuodha).

have formed immediately below a seawall that has been constructed to protect the property behind.

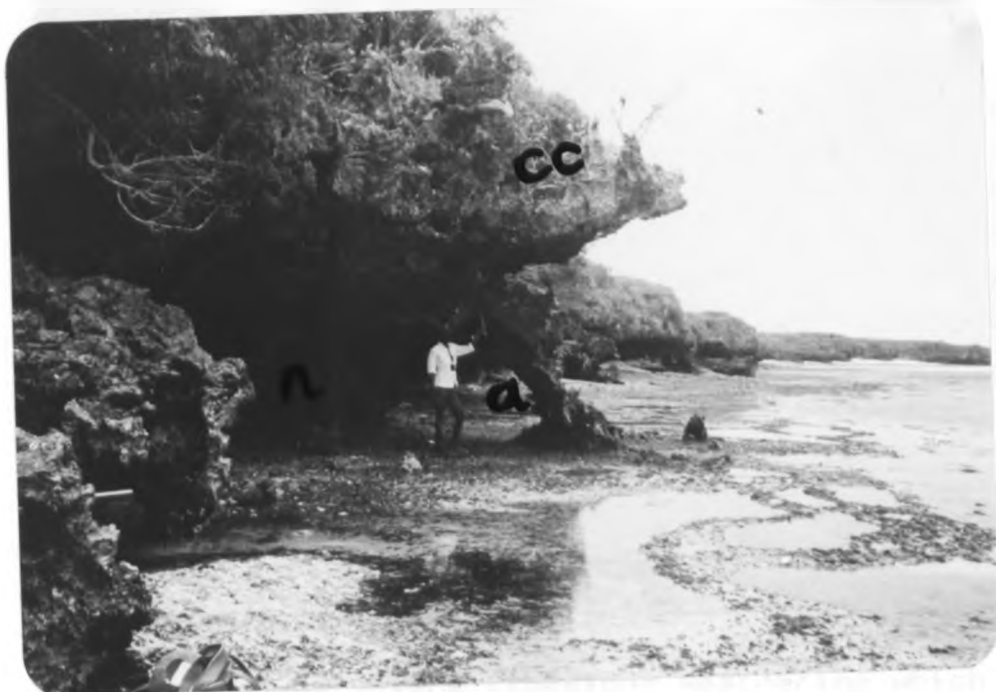
Plate 10 shows general view of a cliffed coast (cc) at Black Cliff Point with notches (n), sea arch (a), and a rugged shoreline (September, 1990; Photo by F. Abuodha).

From these observations, it can be seen that wave action on cliffs has two effects. First, there is the direct undercutting and erosion of the face and secondly, the removal of detritus products from the toe. Accumulation of eroded products at the cliff toe halts cliff recession. It has also been observed that wave action eroding the softer portions of the coral limestones may develop caves into openings running through the headland, sea arches as exemplified at Black Cliff Point (Plates 10). Continued erosion and crumbling of arches produces stacks.

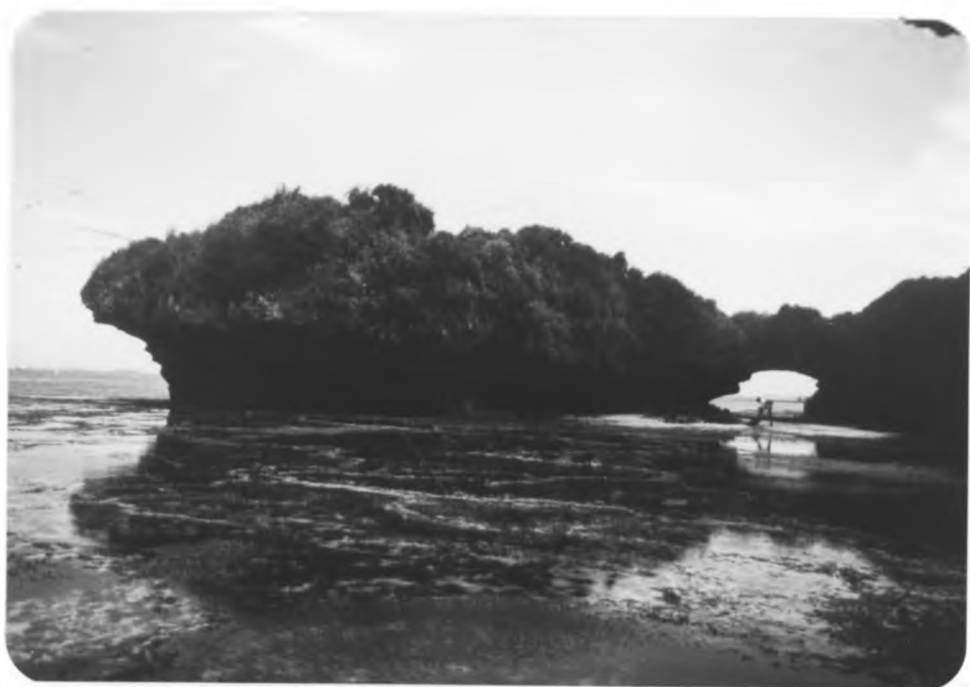
Plate 11 shows a sea arch at Black Cliff Point (September, 1990; Photo by F. Abuodha).

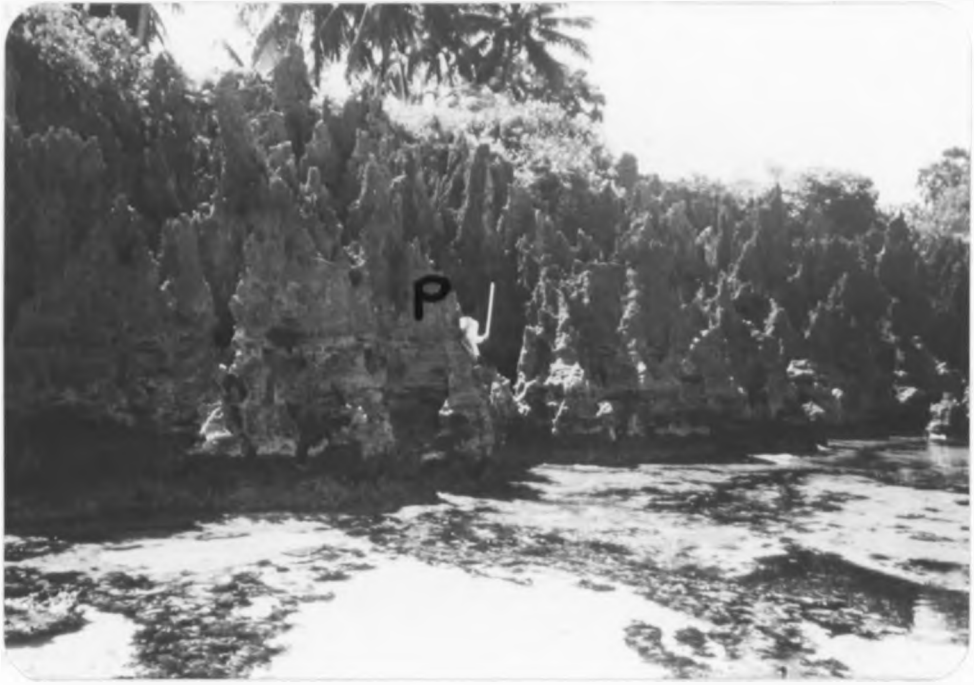
Plate 12 shows severe limestone weathering which has resulted in pinnacle structures (p) at Tiwi (September, 1990; Photo by P. Abuodha).

Tiwi a karst topography forming a rugged shoreline due to its weathering style has formed a pinnacle structure (Plate 12). This structure occurs in severely dissected areas. A cross section of pinnacle structures is shown in figure 27. Besides this mechanical corrosion, biological weathering is very active. The subtidal zone is characterized by biological erosion from boring organisms.

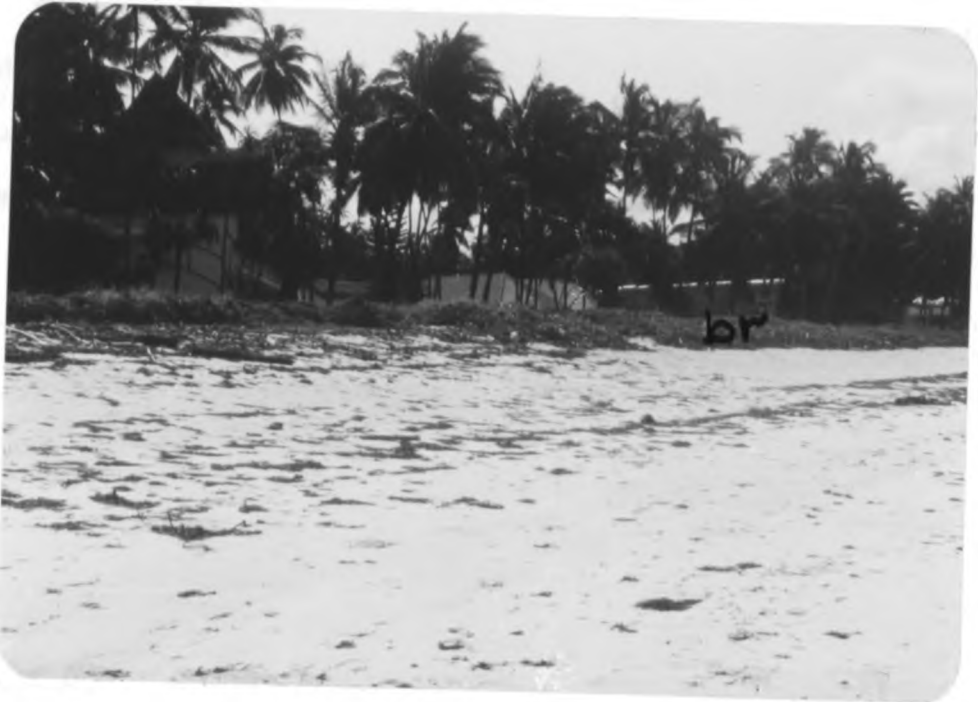
Plate 13 shows high tide mark indicated by low beach ridges (br) at Kikambala (June, 1991; Photo by S. Langat).

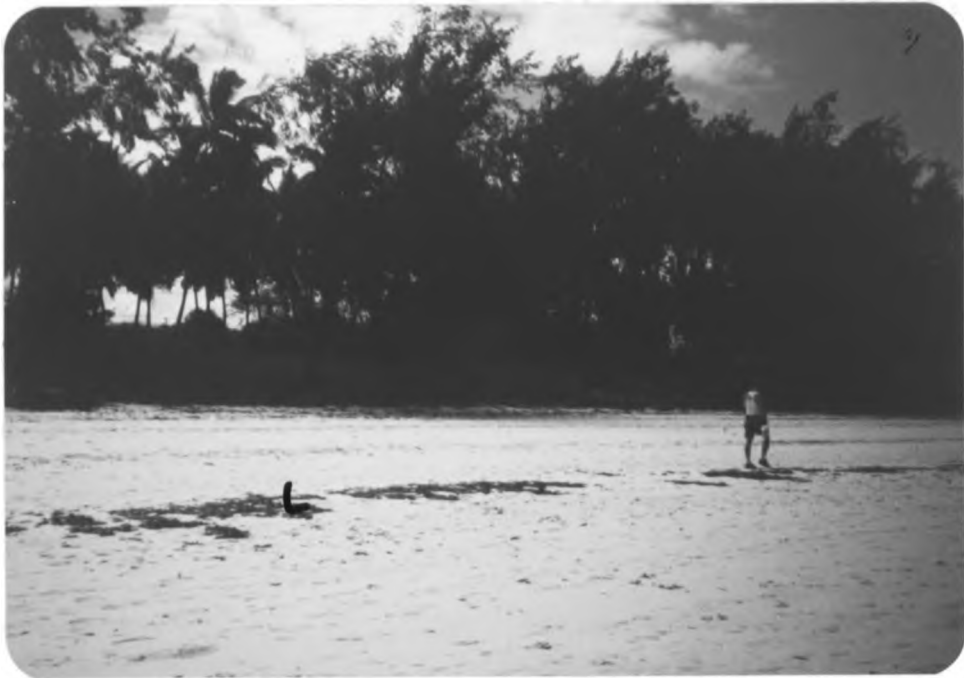
Plate 14 shows high tide mark indicated by swash mark level (1) at Diani (September, 1990; Photo by P. Abuodha).

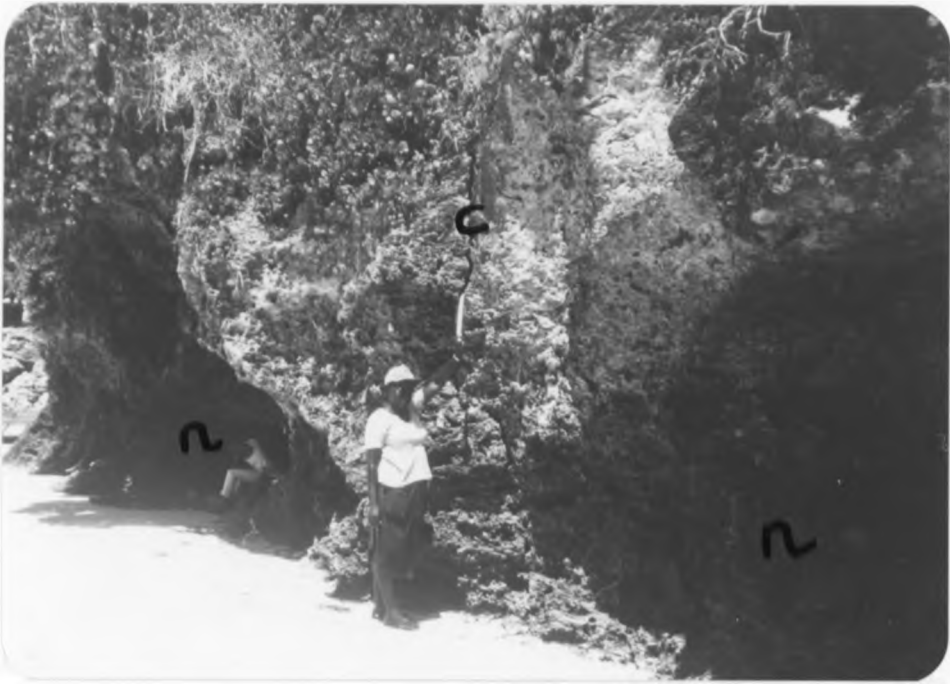
Plate 15 shows notches (n) and a crack (c) on a cliffed coast, a precursor to a major slab failure along Nyali (September, 1990; Photo by J. Abuodha).

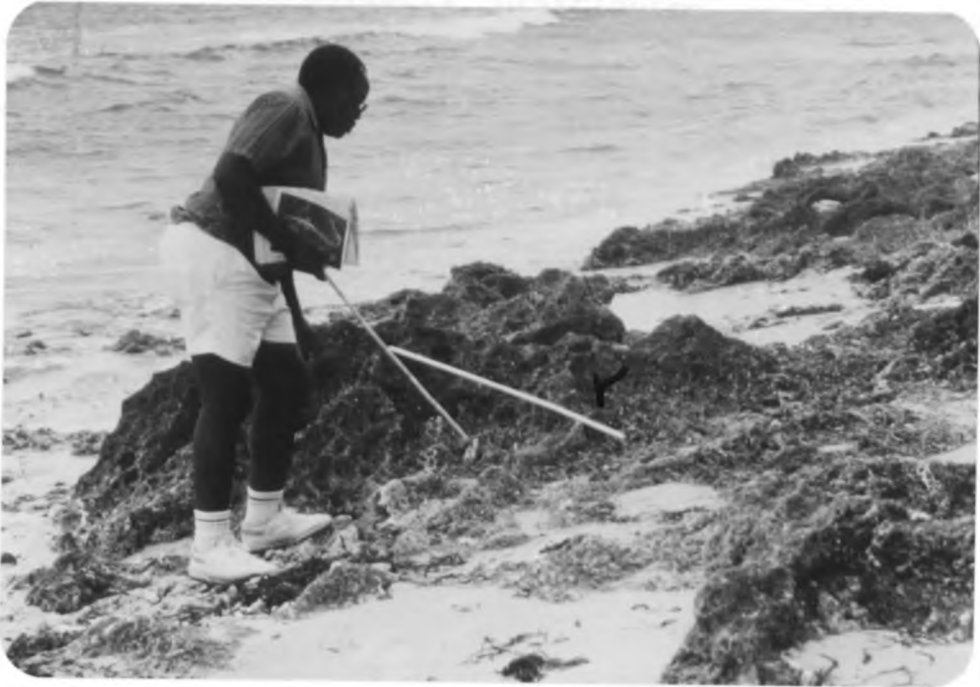
Plate 17 shows a rocky shore platform (r) marking the lower edge of the beach at Shanzu (June, 1991; Photo by S. Langat).

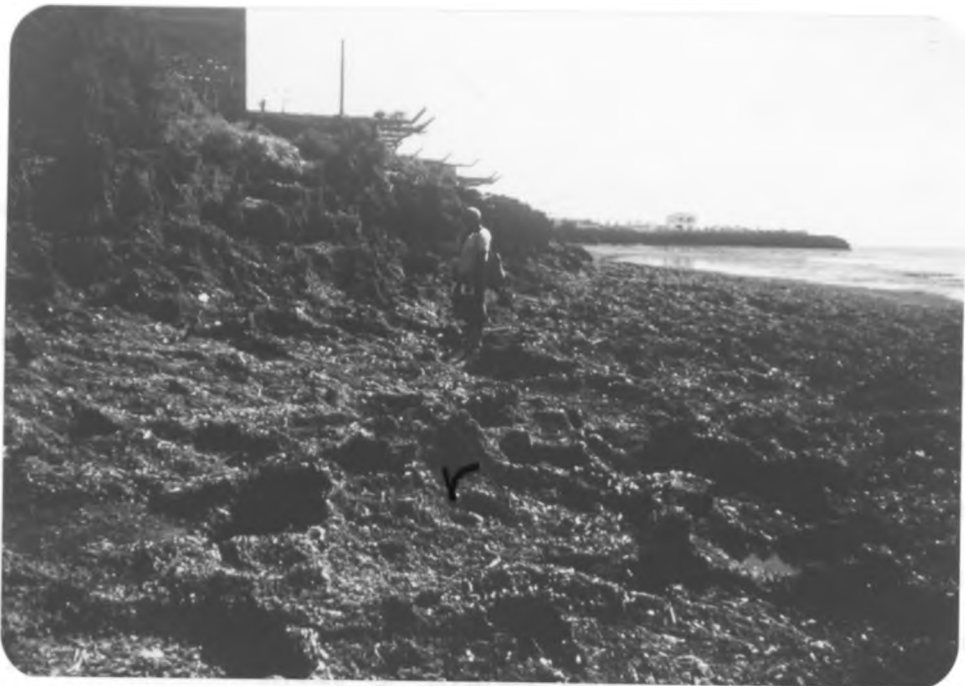
Plate 18 shows jagged surface of the rocky shore (r) at Iwetine (September 1990; Photo by J. Abuodha).

sediments sporadically distributed on the shore platform of Iwetine headland, the rocky shore is well characterized by extremely jagged surface and numerous pits and pans indicating the weathering style of the limestones (Plate 18). These rocky shores are also characterized by a spur and groove structure developed perpendicular to the cliffs (Plate 19). The grooves act as channels for water and sediments and are thus vital to the dissipation of the wave energy incident on the cliffs. It is possible to envisage that a cliff notch (Plate 7) may turn into a rocky shore (Carter, 1988). The relatively level abraded surface is initiated at the base of the cliff by plunging waves, and then widened by spilling waves, probably armed with abrasive clasts.

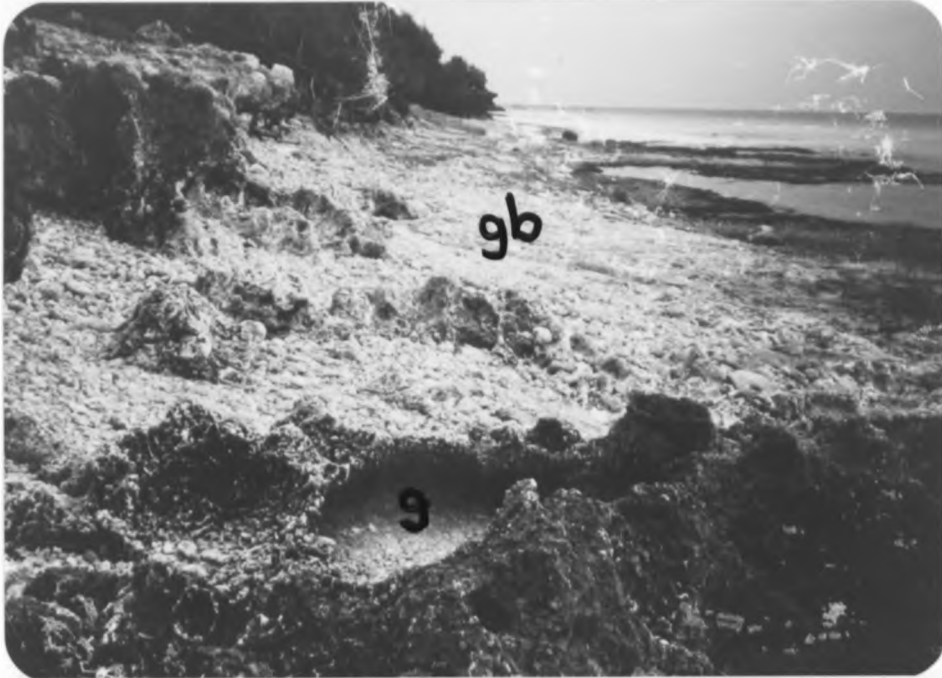
Plate 19 shows a groove structure (g) developed perpendicular to the cliffs and a gravel beach (gb) at Galu (September, 1990; Photo by P. Abuodha).

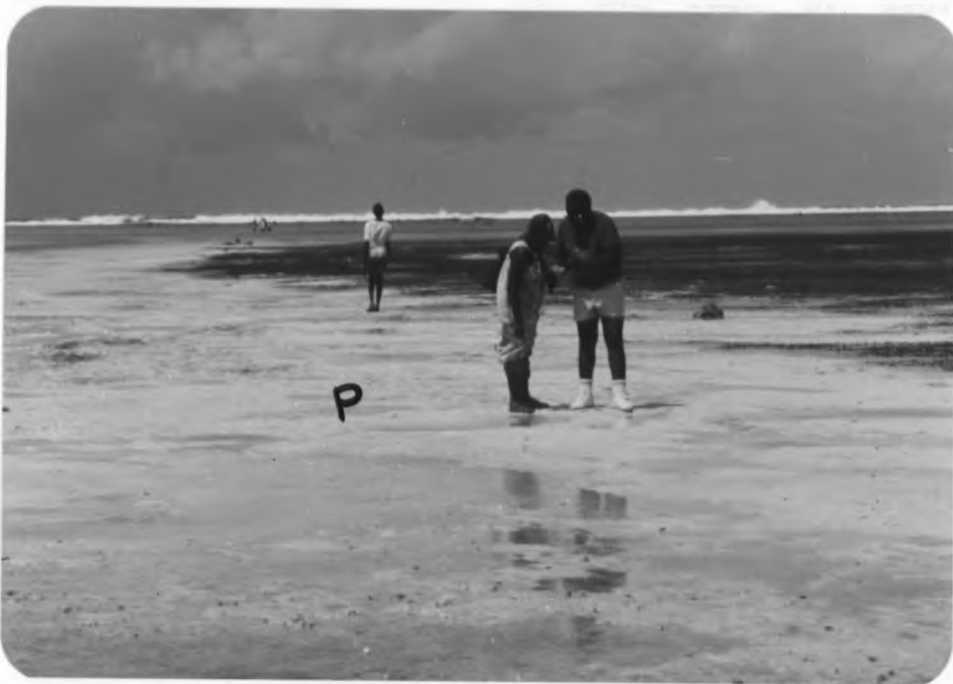
Plate 20 shows sand distributed on the shore platform (p) exposed during low tide at Kikambala (June, 1991; Photo by S. Langat).

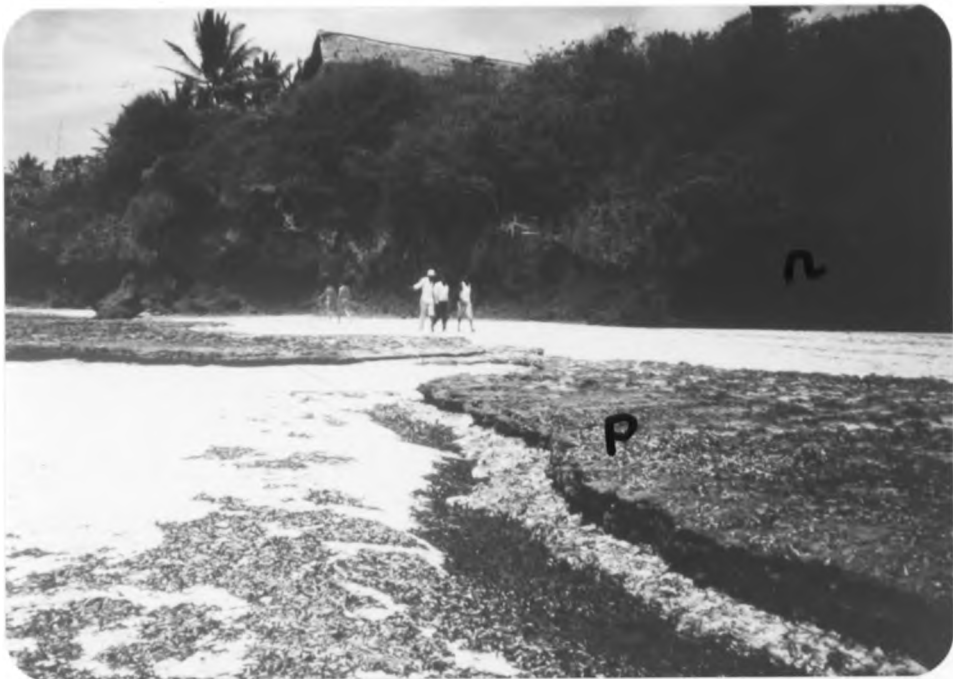
Plate 21 shows a raised shore platform (p) at Nyali. Note notch (n) formation immediately opposite the perforated shore (September, 1990; Photo by P. Abuodha).

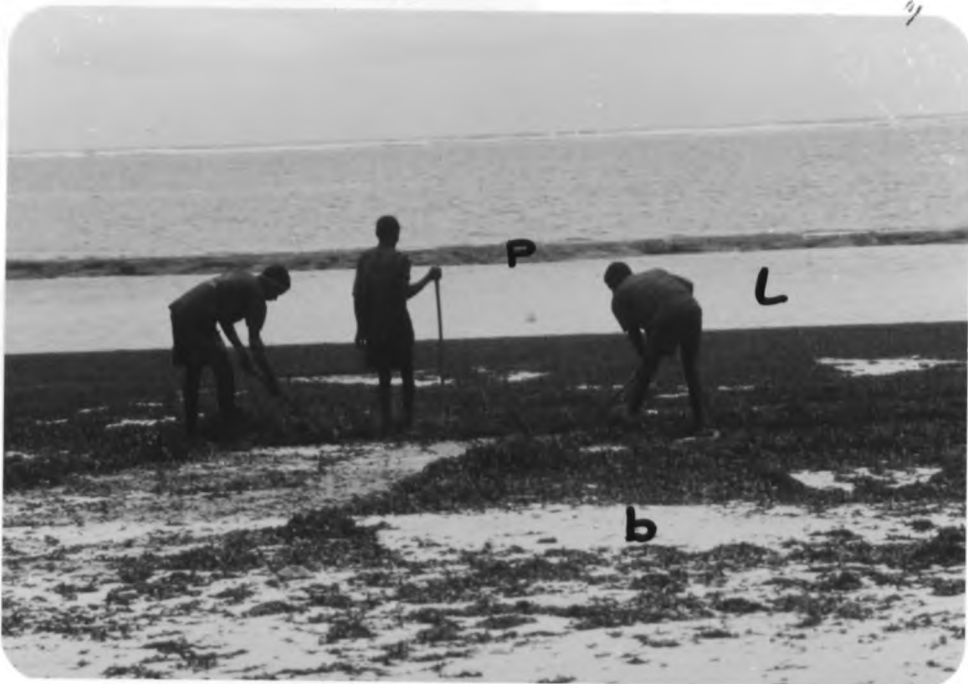
Plate 23 shows coastal lagoon (l) at Diani located between the beach (b) and the raised shore platform (p) (June, 1991; Photo by S. Langat).

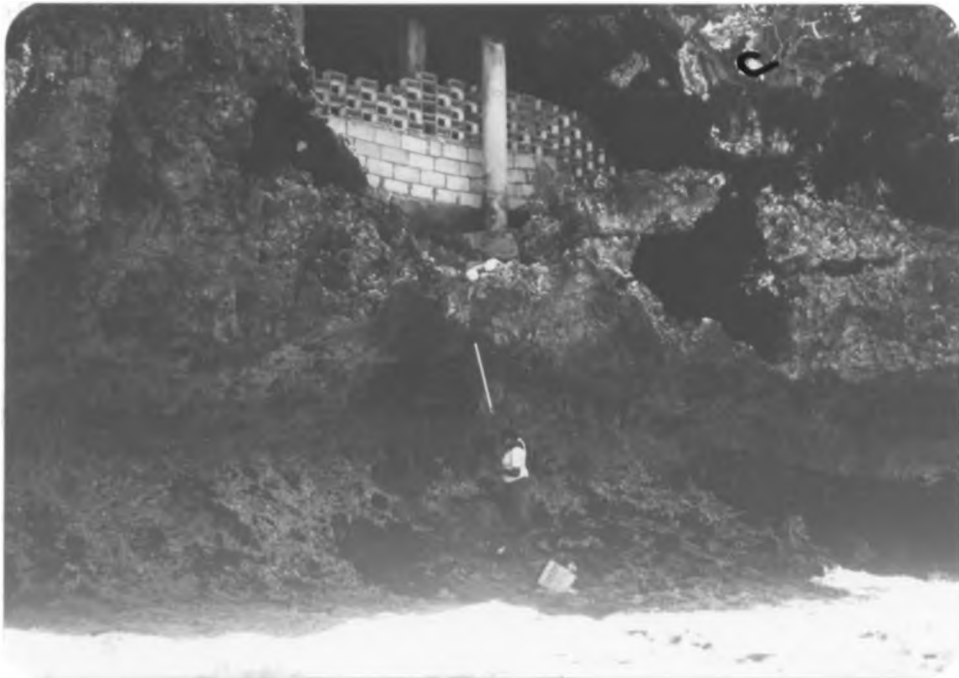
Plate 24 shows reinforcement of a hanging cliff (c) at Nyali. (September, 1990; Photo by J. Abuodha).

Erosion is a prevalent phenomenon along the Mombasa-Diani coast. In many places, the rate of coastline retreat and the resulting environmental degradation and economic loss is on such a scale as to be alarming (Plate 24). Most of the beaches are being eroded due to lack of major rivers which would

A private house built along the shoreline on a retreating cliff at Nyali is being reinforced using pillars as erosion has caused undercutting below it (Plate 24). However, it was surprising to note that this house is still inhabited. This was evident from the garbage at the foot of the pillar and a dry carton that must have been dropped onto the beach after water receded during low tide. A few metres southward of this location, a private house stands at the edge of a retreating cliff. A 1 m scarp has formed as a result of landward adjustment of shoreline (Plate 32). At Leven manifestation of intense cliff erosion has resulted in a slab failure which has formed a crack on the wall above. It can be clearly seen that when finally this slab falls due to hydrostatic pressure of waves, it will move with part of the house (Plate 33). At the entrance to Tudor Creek, a resort for show members has been build with an extension into the creek and supported with pillars (Plate 34). Although the resort is

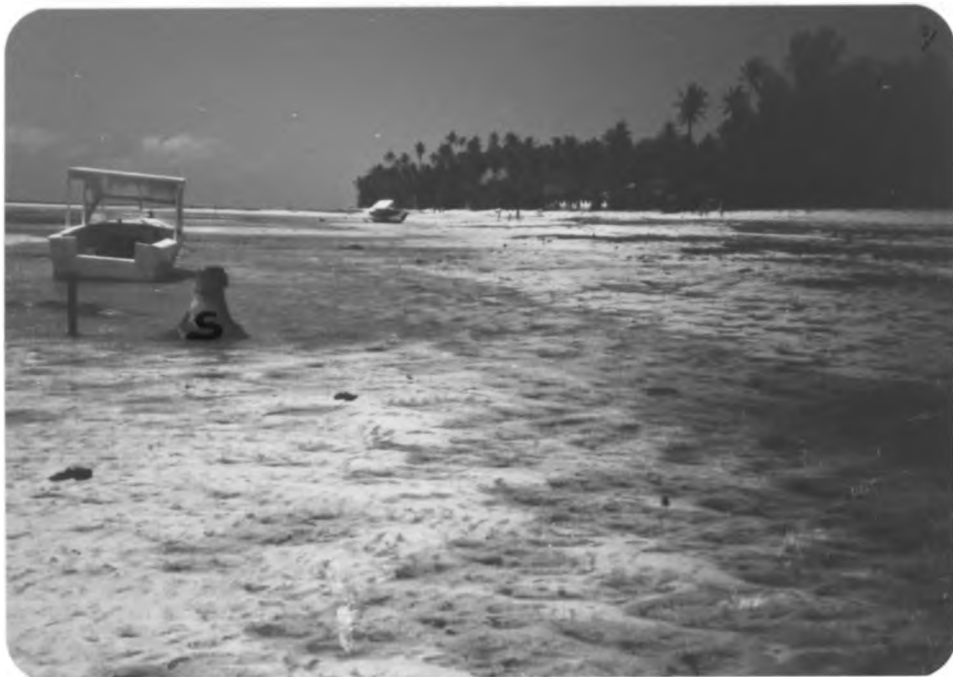
Plate 25 shows coastline retreat in front of Kanamai beach leaving a coconut stump (s) 50 m from the present coastline (September, 1990; Photo by P. Abuodha).

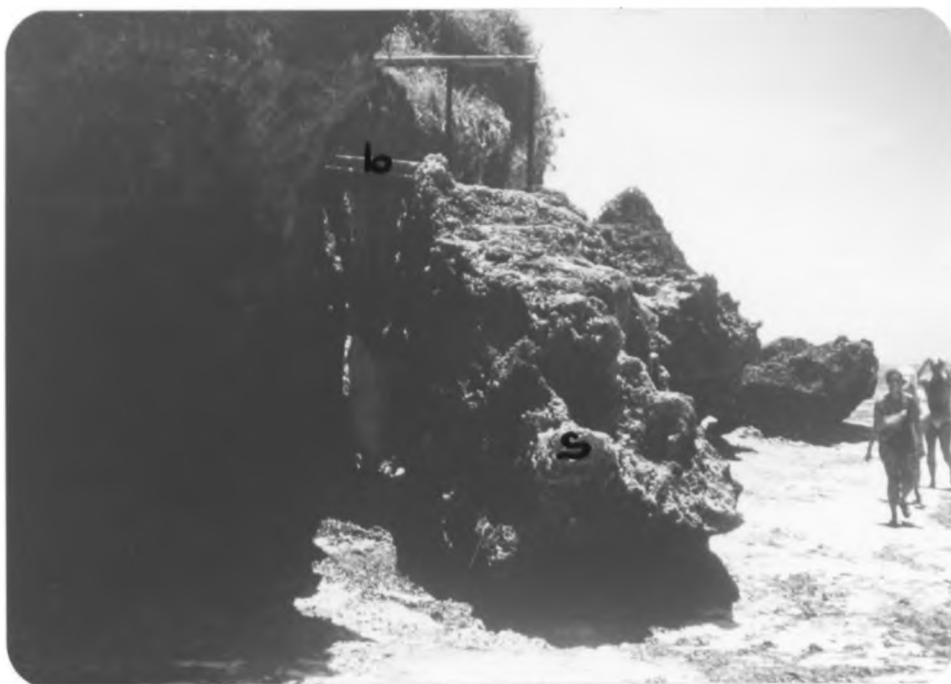
Plate 26 shows slab (s) failure has cut off the only bridge (b) access to the sea at Shanzu (September, 1990; Photo by P. Abuodha).

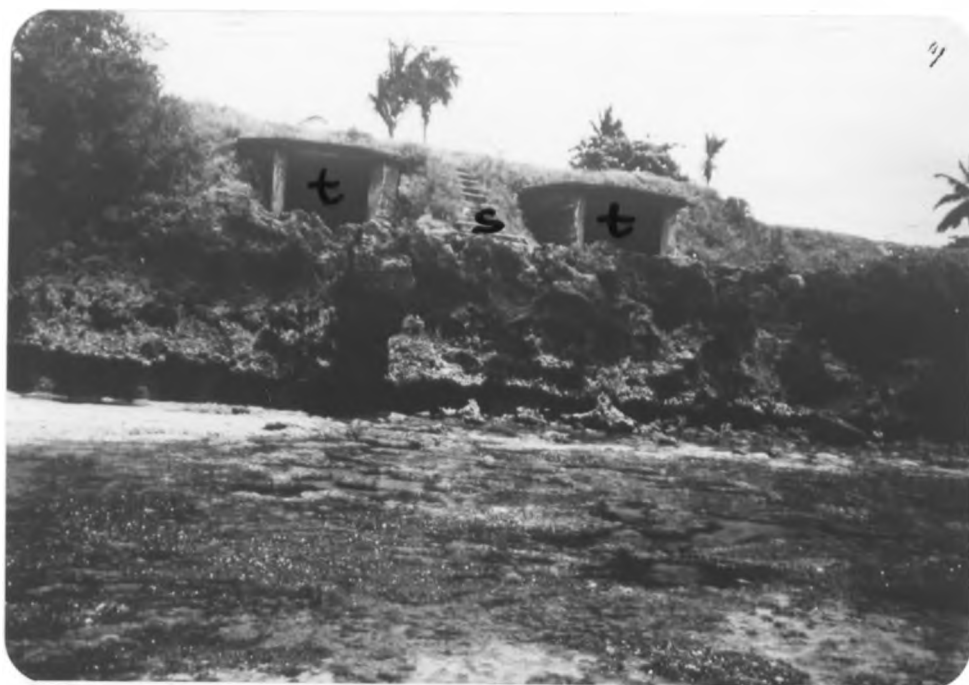
Plate 27 shows hanging staircase (s) and tunnels (t) on a cliff at Mombasa Island (September, 1990; Photo by P. Abuodha).

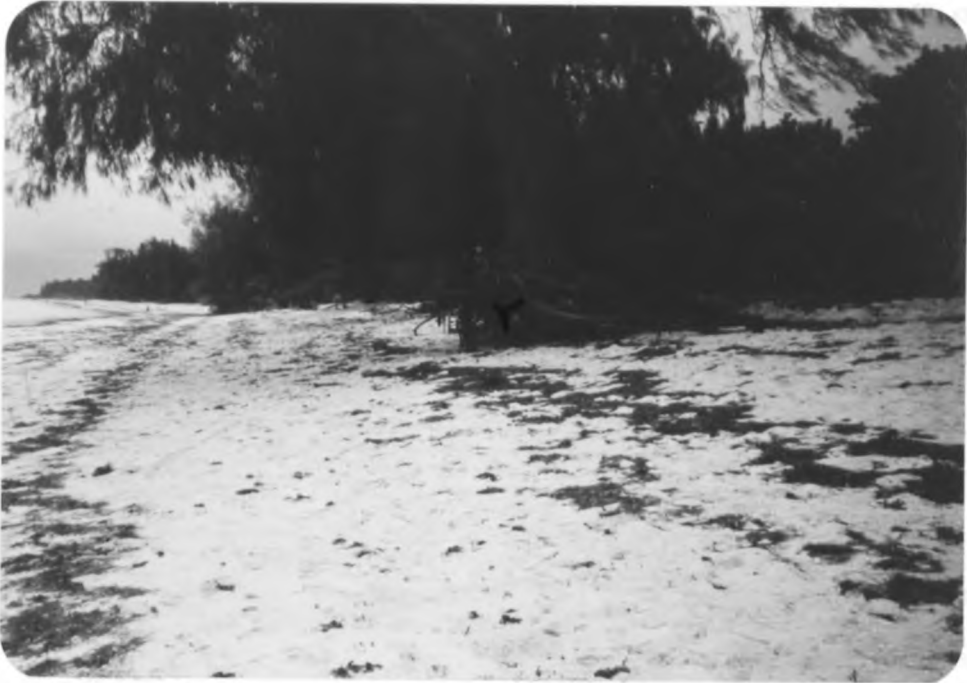
Plate 28 shows exposed tree roots (r) at Galu due to erosion (September, 1990; Photo by P. Abuodha).

27), while at Galu, on a undeveloped coast, exposure of tree roots by 1.5 m is an indication of intense erosion along this coast (Plate 28).

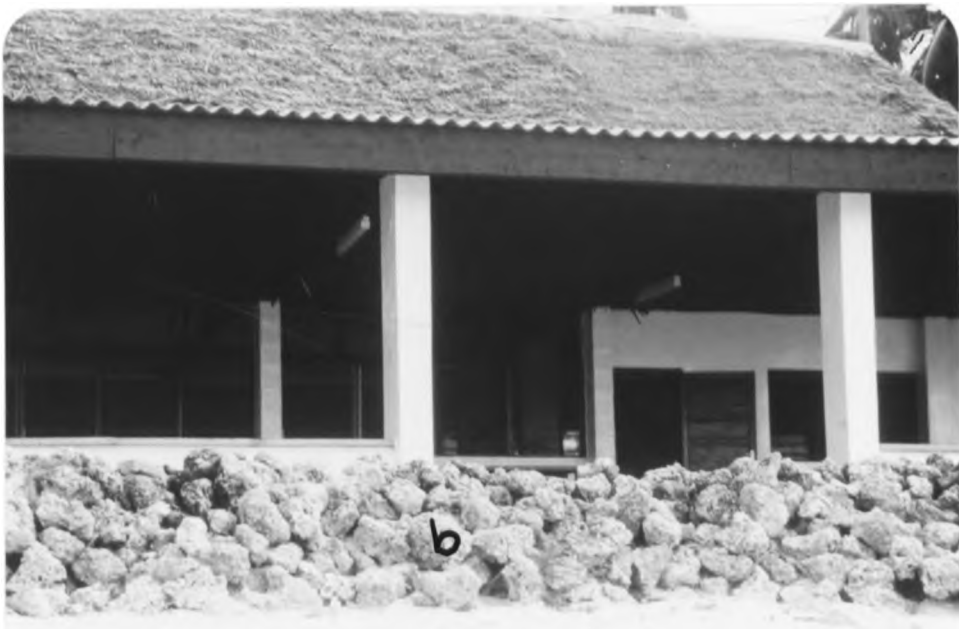
Plate 29 shows limestone boulders (b) placed against a house to protect it from flooding during flood tide at Kanamai (June, 1991; Photo by S. Langat).

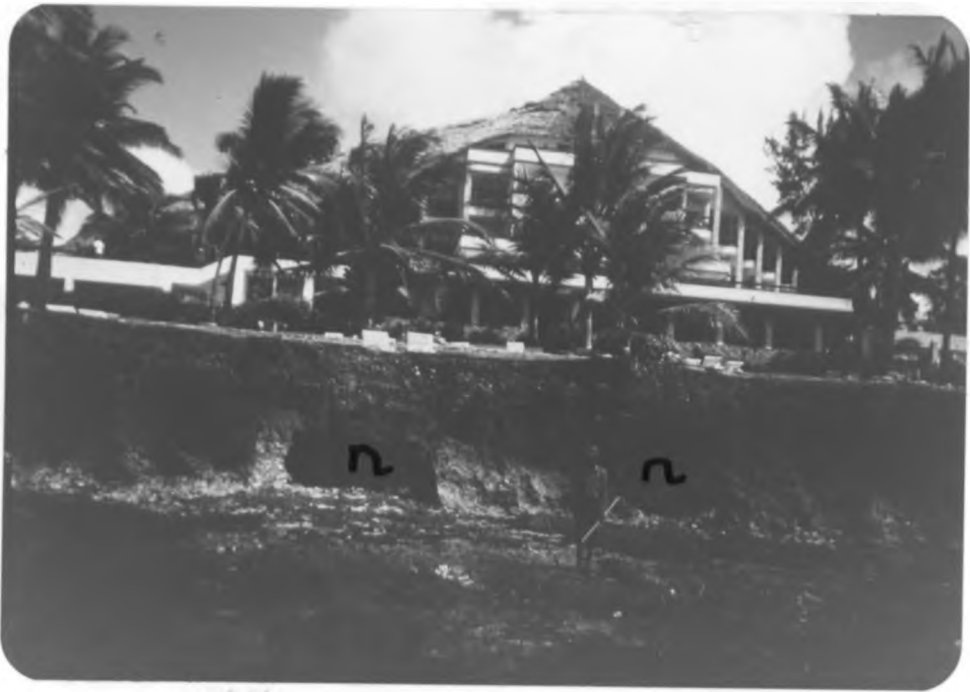
Plate 30 shows notches (n) developed beneath a beach hotel at Shanzu (September, 1990; Photo by P. Abuodha).

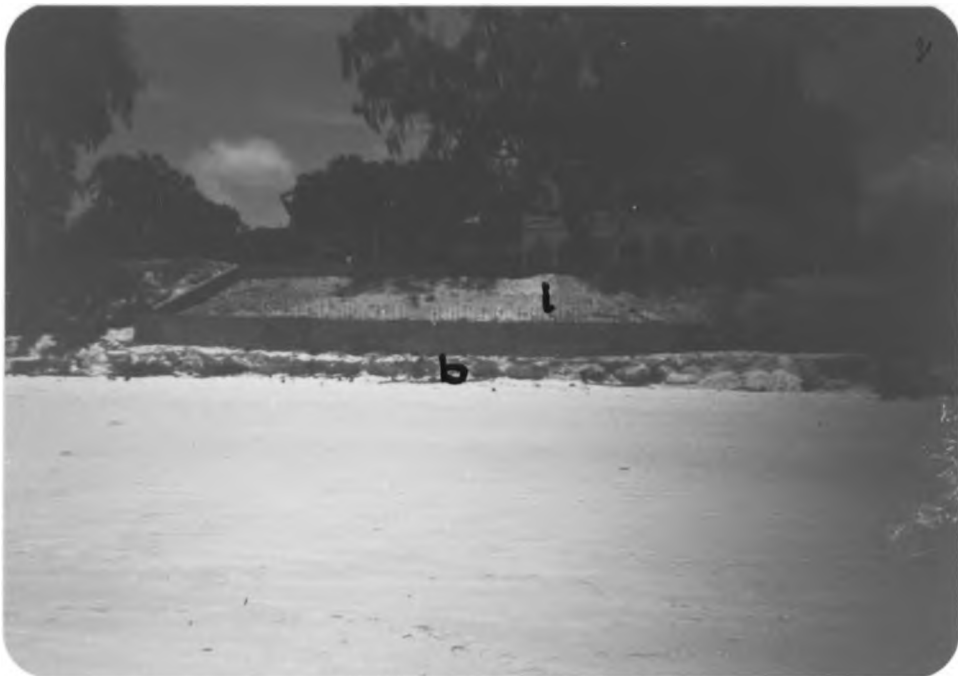
Plate 31 shows sand infilling (i) from the lower beach (b) at Nyali to build a protection structure (September, 1990; Photo by P. Abuodha).

In some areas along Nyali beach, development has been extended beyond the shoreline by sand infilling into a structure built on the beach (Plate 31). The

sand is obtained from the adjacent beach or the dunes along the shore. After sand-infilling, the structure is stabilized by a pavement on seaward side. The outcome of this project is the acceleration of beach erosion due to no exchange of sand between dunes and the beach.

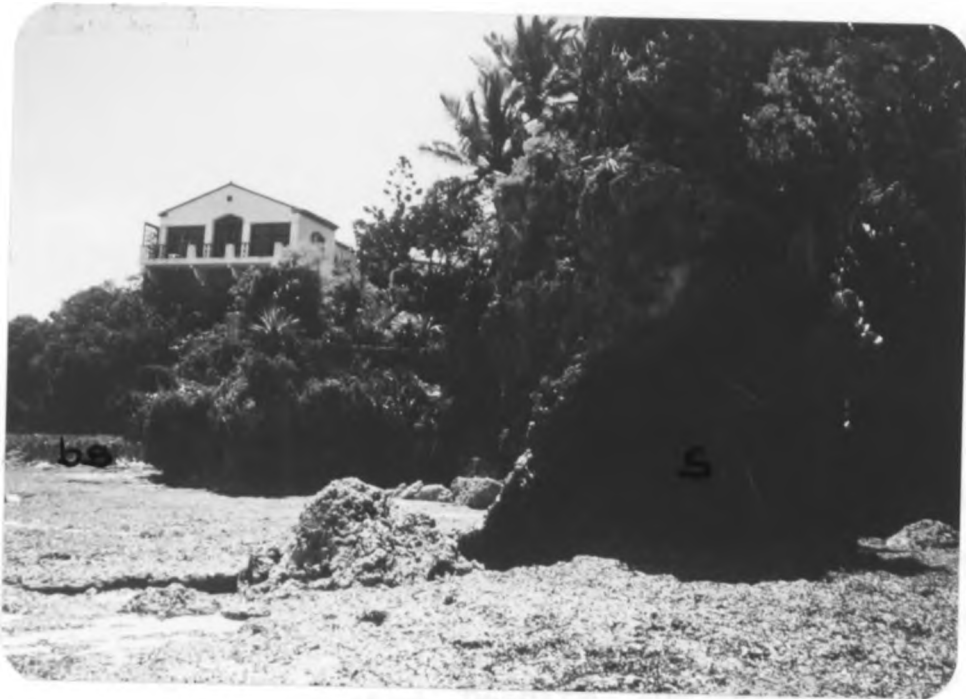
Plate 32 shows property on a cliff. Note stack (s) on the right and a beach scarp (bs) on the left of the plate at Nyali (September, 1990; Photo by P. Abuodha).

formed a beach scarp of about 30 cm at Nyali (Plate 32).
