GEOMORPHOLOGY AND SEDIMENTOLOGY
OF THE
MOMBASA - DIANI AREA:
IMPLICATIONS TO COASTAL ZONE MANAGEMENT

A thesis submitted in partial fulfilment for the
degree of Master of Science in the
University of Nairobi.

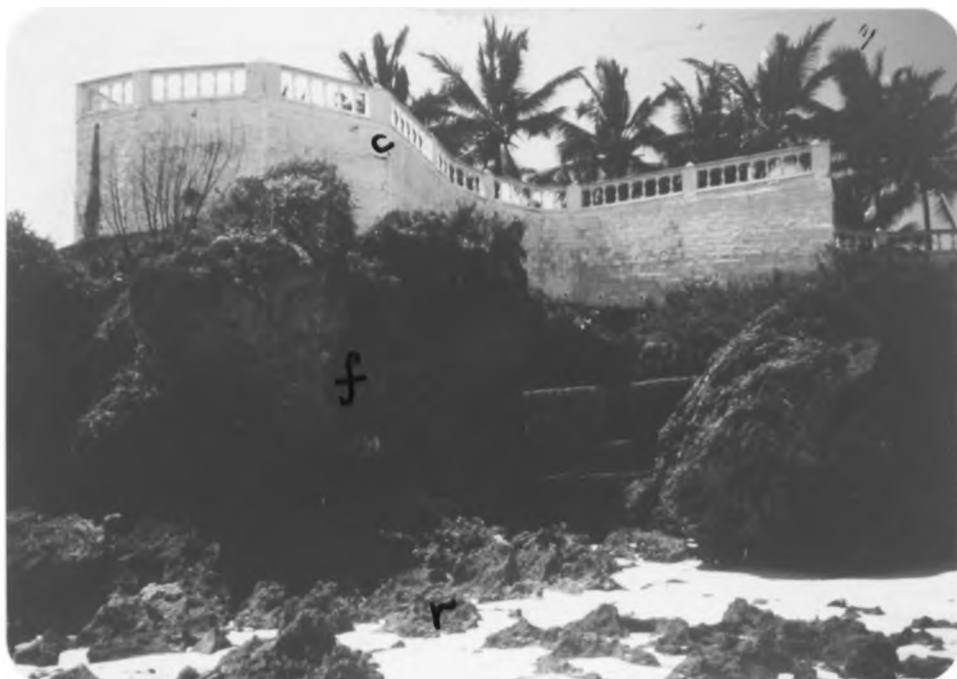
Plate 33 shows slab failure (f) leading to crack (c) on house wall at Leven. Note the exposed rocks (r) beneath (September, 1990; Photo by J. Abuodha).

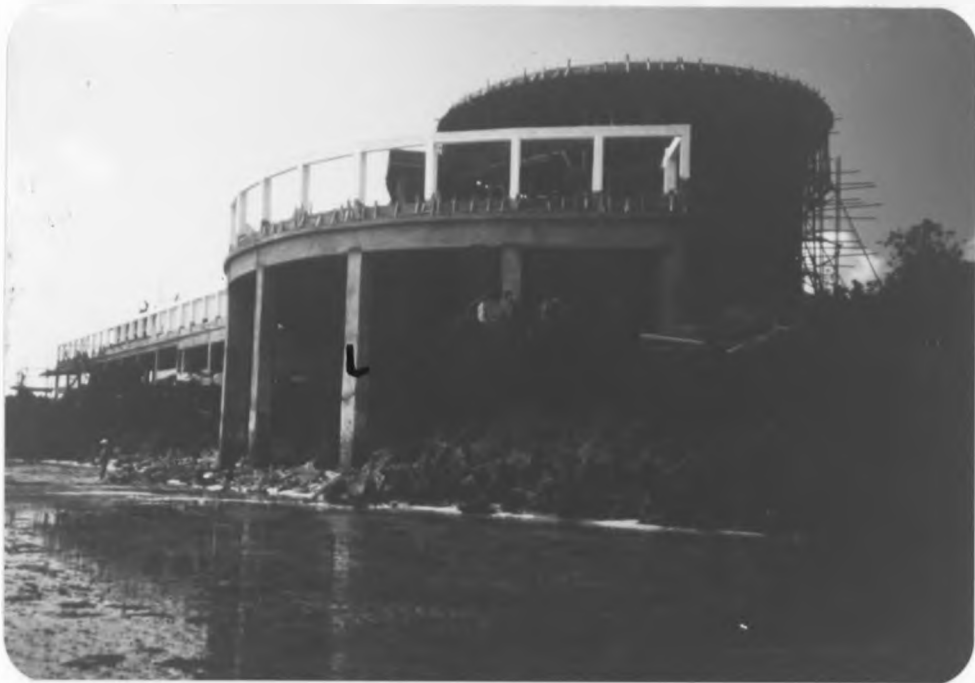
Plate 34 shows construction of property at the entrance to Tudor Creek. Note level (1) of high tide mark on the pillars (September, 1990; Photo by P. Abuodha.)

A private house built along the shoreline on a retreating cliff at Nyali is being reinforced using pillars as erosion has caused undercutting below it (Plate 24). However, it was surprising to note that this house is still inhabited. This was evident from the garbage at the foot of the pillar and a dry carton that must have been dropped onto the beach after water receded during low tide. A few metres southward of this location, a private house stands at the edge of a retreating cliff. A 1 m scarp has formed as a result of landward adjustment of shoreline (Plate 32). At Leven manifestation of intense cliff erosion has resulted in a slab failure which has formed a crack on the wall above. It can be clearly seen that when finally this slab falls due to hydrostatic pressure of waves, it will move with part of the house (Plate 33). At the entrance to Tudor Creek, a resort for show members has been build with an extension into the creek and supported with pillars (Plate 34). Although the resort is

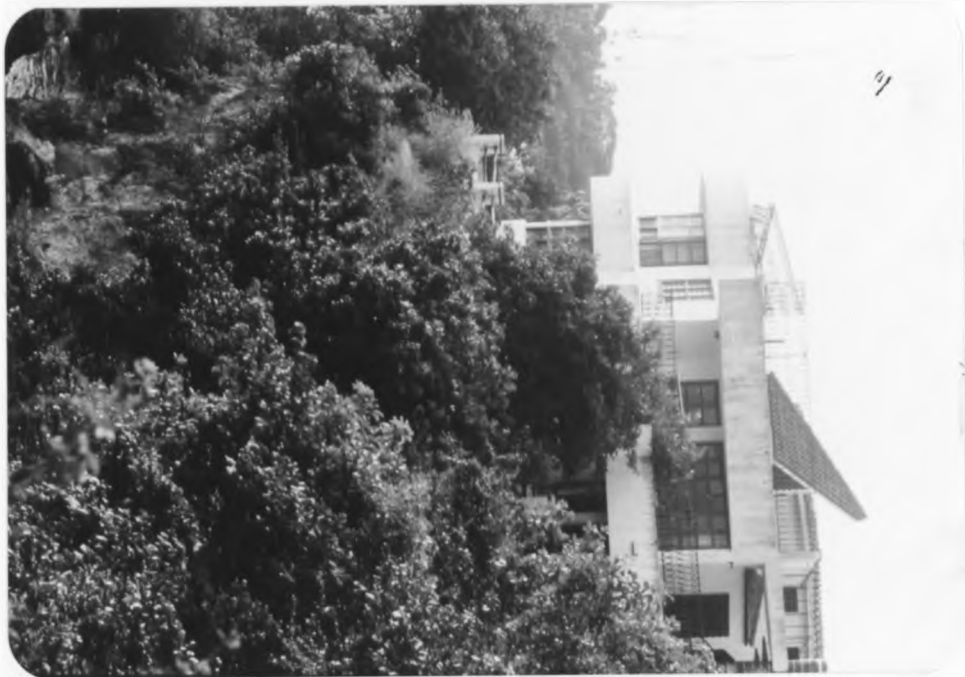
Plate 35 shows property constructed at the entrance to Tudor Creek standing risks of erosion in the near future (June, 1991; Photo by S. Langat).

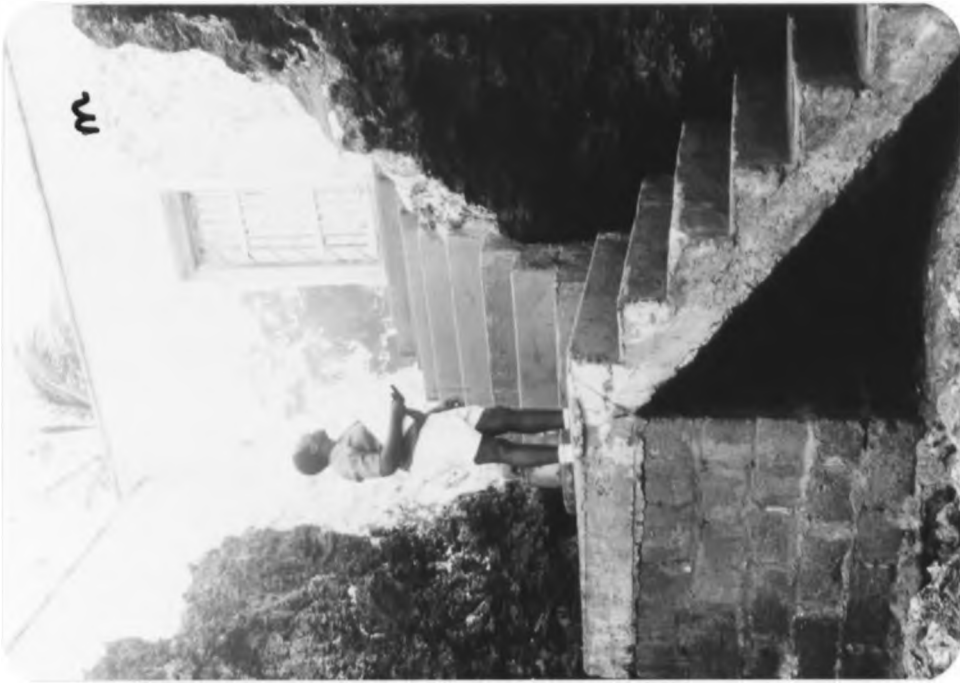
Plate 36 shows splash water marks (m) above house door at Tiwi (June, 1991; Photo by S. Langat).

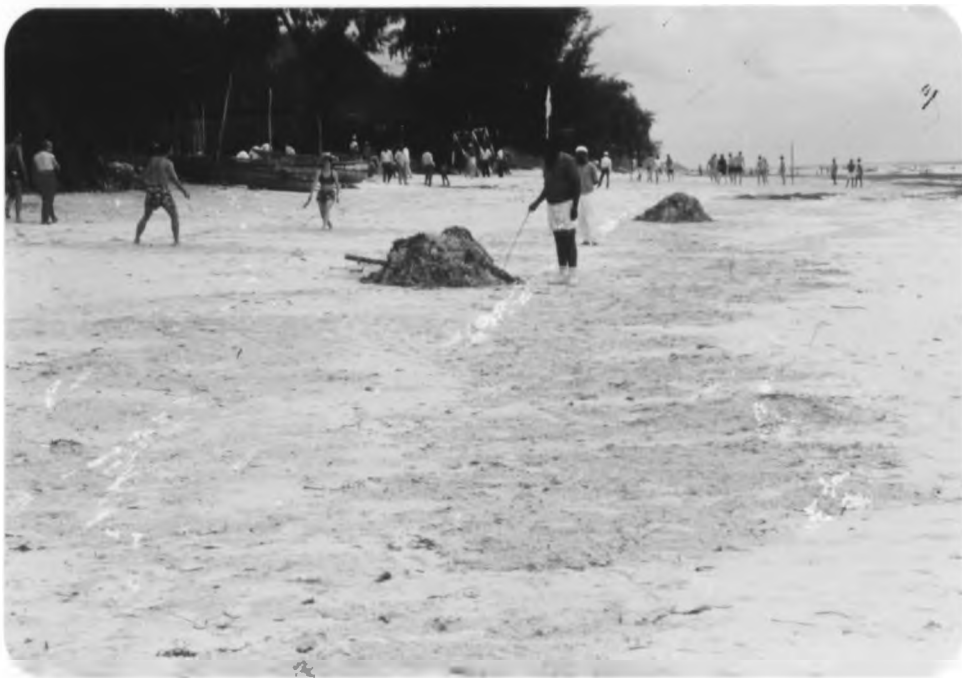
Plate 37 shows collected seaweeds at Diani. This disturbs the sediments thus enhancing erosion. Note games in the background (June, 1991; Photo by S. Langat).

and bury seaweeds brought onto the beach during high tides (Plate 37). Sweeping of the seaweeds off the beaches has two serious effects on the beach;

1. By sweeping off the seaweeds from the beach with a rake, sand is not only exposed but also loosened. During high tide, therefore, more sediments are likely to be eroded and
2. by loosening the sand, the waves easily erode the loosened sand from the beach into the lagoons or onto the shore platforms.

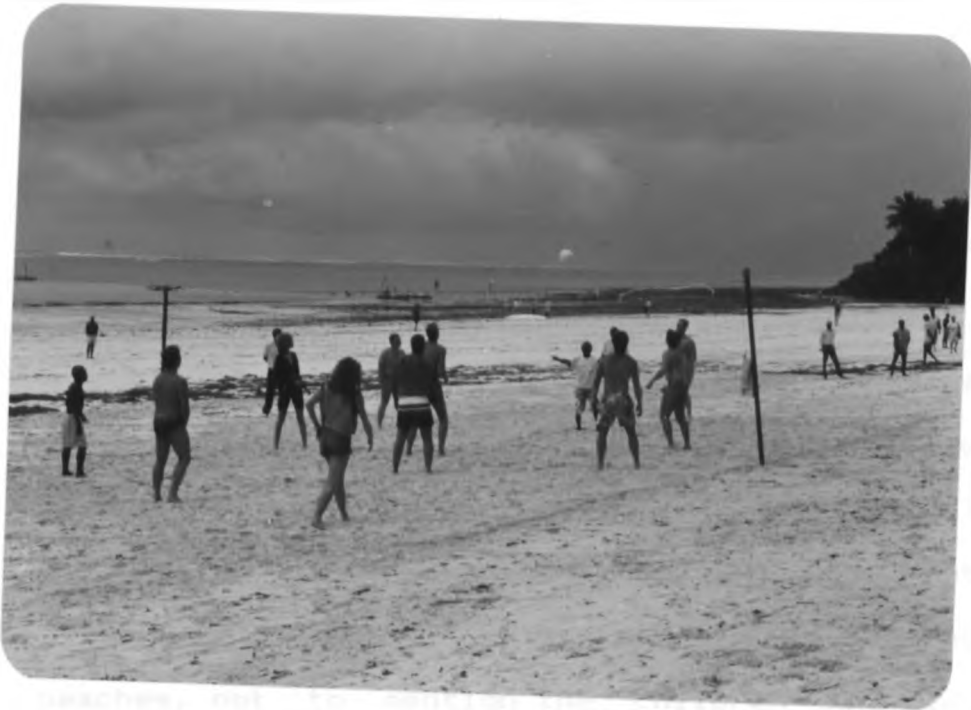
Plate 38 shows games on the beach at Diani. This disturbs sediments and enhances sand depletion from the beach during flood tide (June, 1991; Photo by S. Langat).

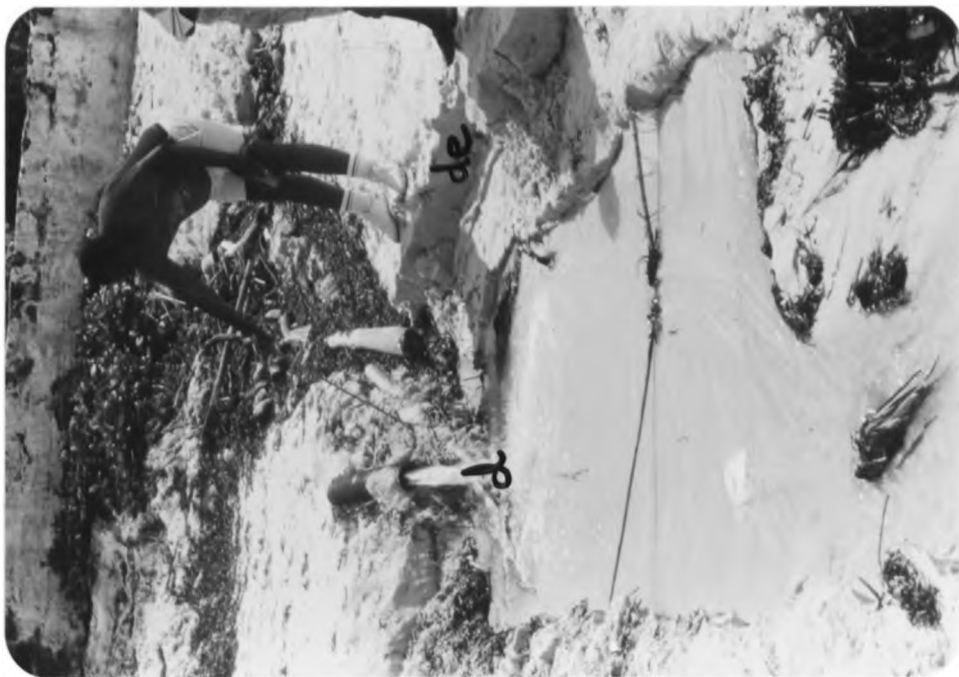
Plate 39 shows liquid waste disposal (d) on the beach at Kikambala. It has formed a depression (de) of about 50 cm into the sands (June, 1991; Photo by S. Langat).

beach hotels within the study area dispose of their wastes, especially from the swimming pools directly into the sea (Plate 39). This results in volumes of sand being eroded from the beach which has formed 50-100 cm depressions into the beaches. The eroded sediments finally reach the coral reefs which they smother and thus the growth of the coral reefs is hindered, which in turn enhances beach erosion as the waves will now be breaking on the shore. These liquid wastes not only affect the marine life but is also dangerous to the health of swimmers along the beaches, not to mention the children who play in them.

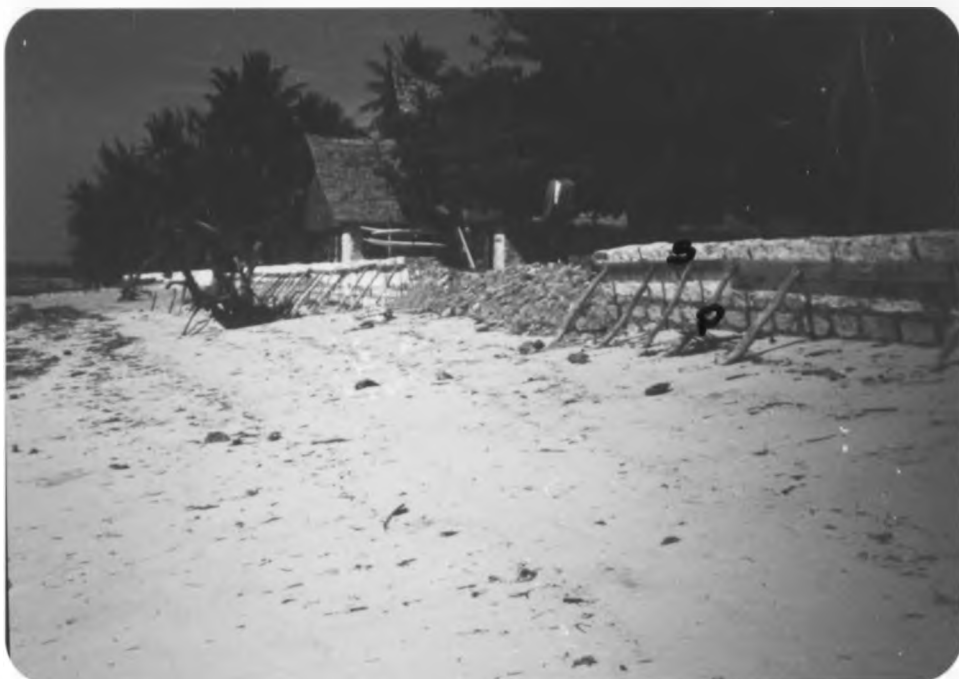
Plate 40 shows a seawall (s) at Kikambala. Wall is held in position by mangrove poles (p). This wall has however now fallen (September, 1990; Photo by P. Abuodha).

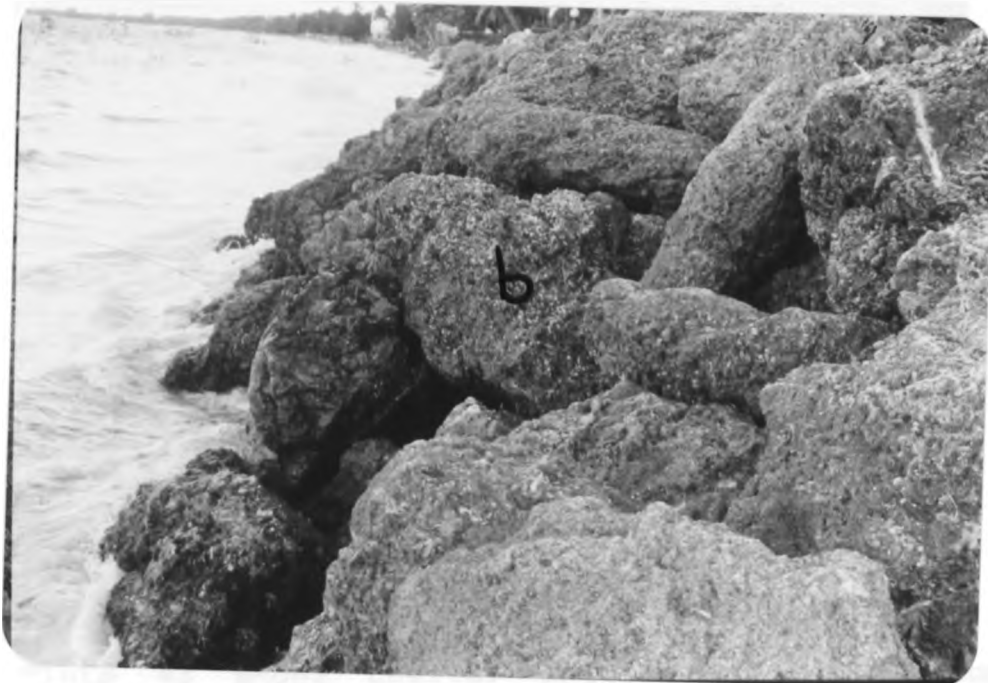
Plate 41 shows coastal protection using limestone boulders (b) along Bamburi (June, 1991; Photo by S. Langat).

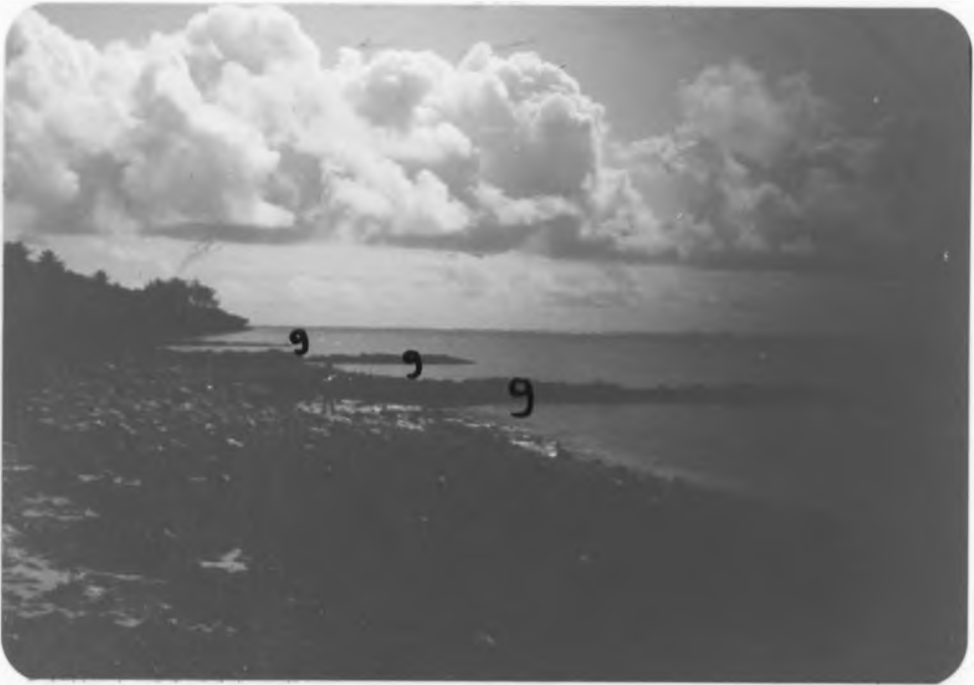
Plate 42 shows coastal protection using groynes (g) along Shanzu (September, 1990; Photo by P. Abuodha).

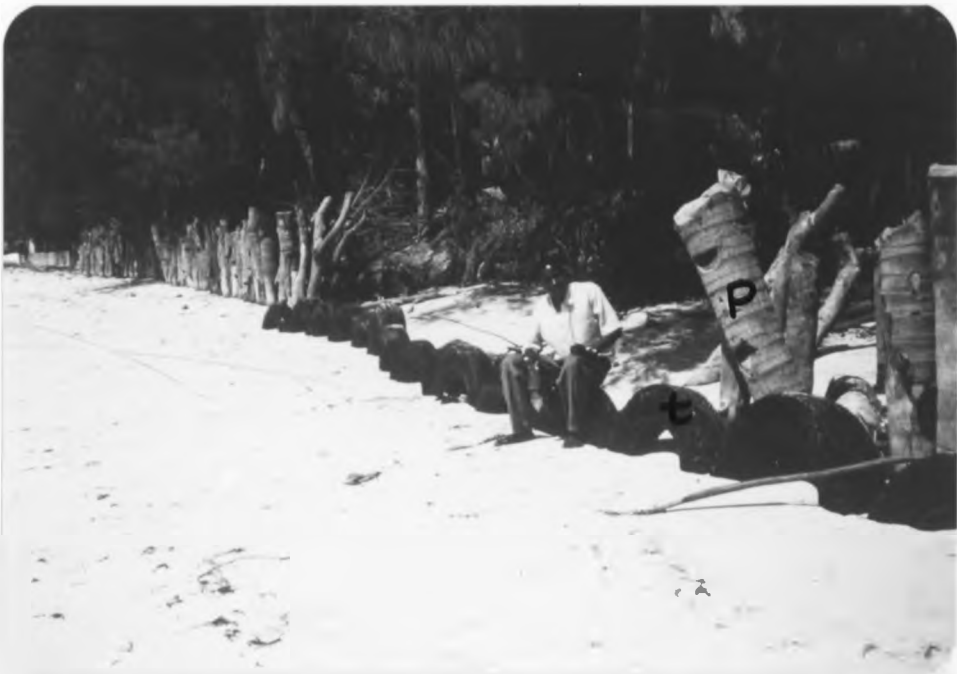
Plate 43 shows coastal protection using coconut poles (p) and used tyres (t) at Kikambala (September, 1990; Photo by P. Abuodha).

no scour in front of the tyres as the wave-front can easily penetrate between the tyres to the backshore area.

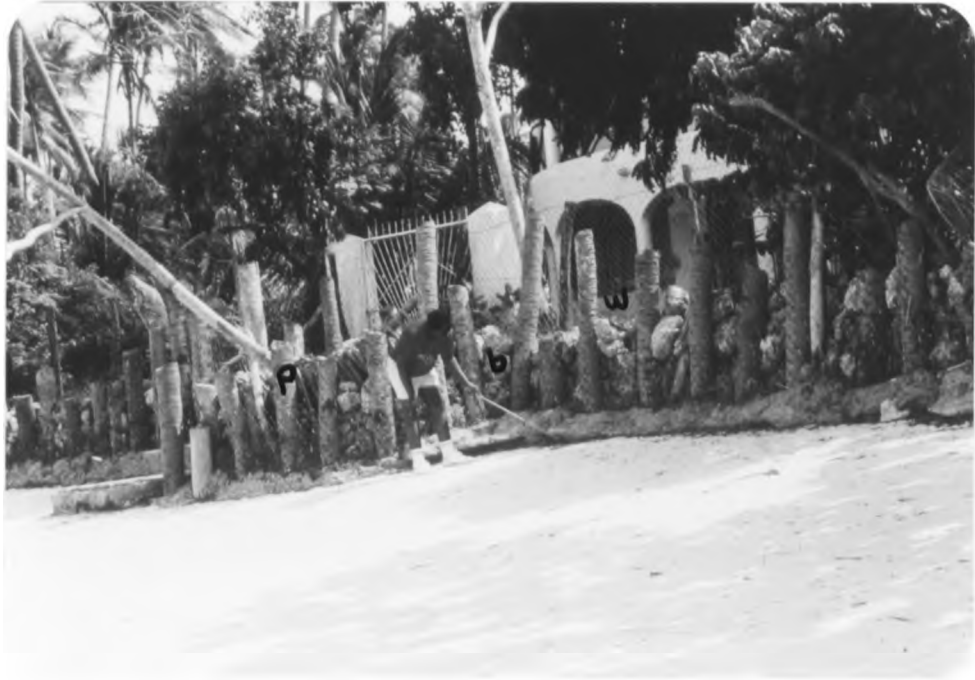
Plate 44 shows poles (p), limestone boulders (b) and wiremesh (w) at Kikambala being used for coastal protection (June, 1991; Photo by S. Langat).

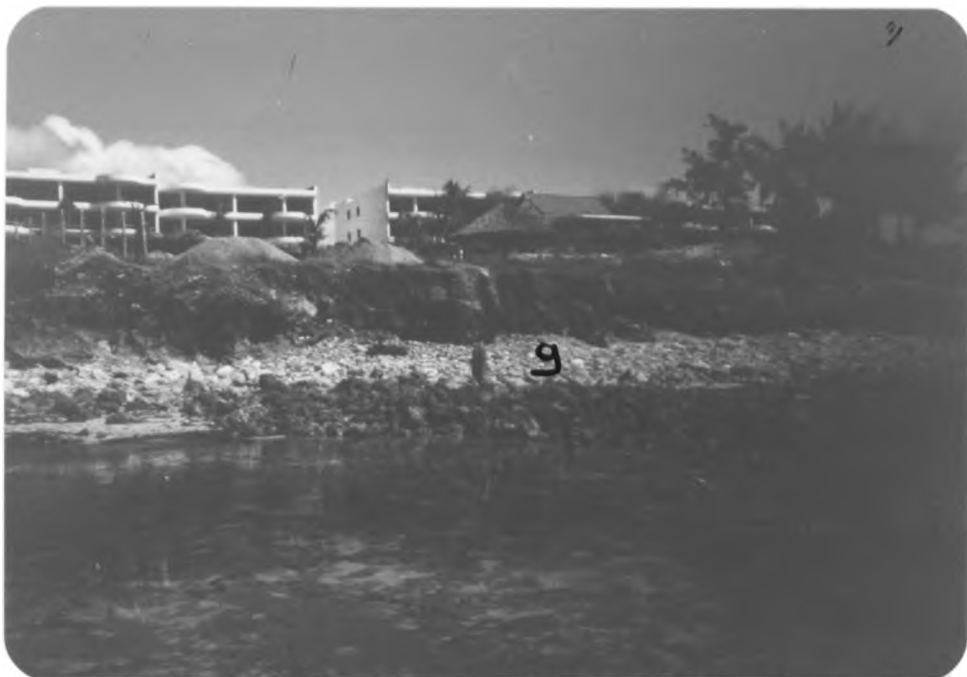
Plate 45 shows gravels (g) along Shanzu as an attempt to nourish the beach (September, 1990; Photo by J. Abuodha).

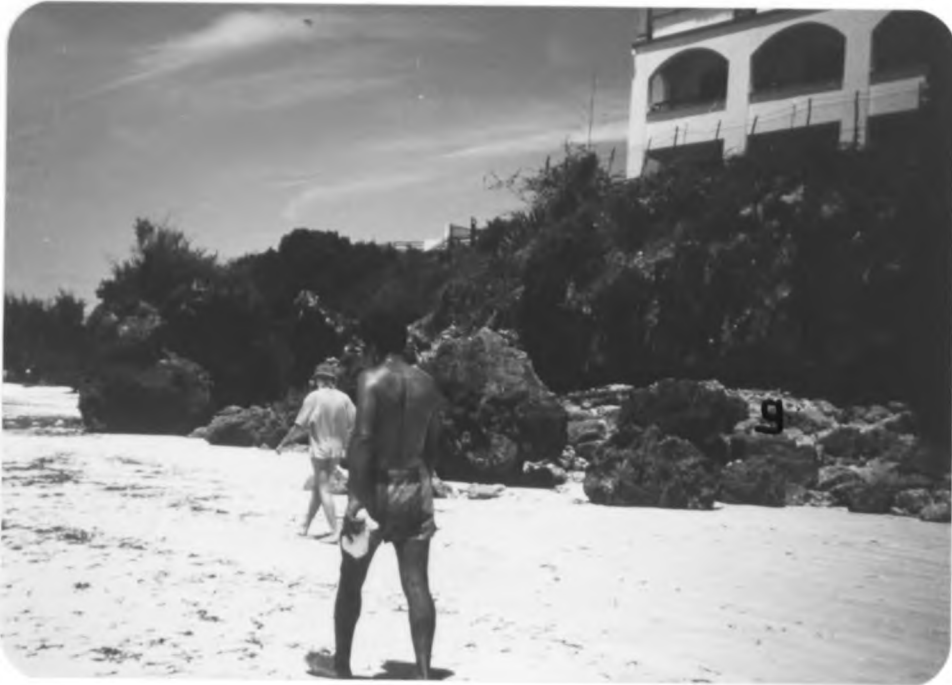
Plate 46 shows gravels (g) placed along Nyali as a beach nourishment scheme (September, 1990; Photo by P. Abuodha).

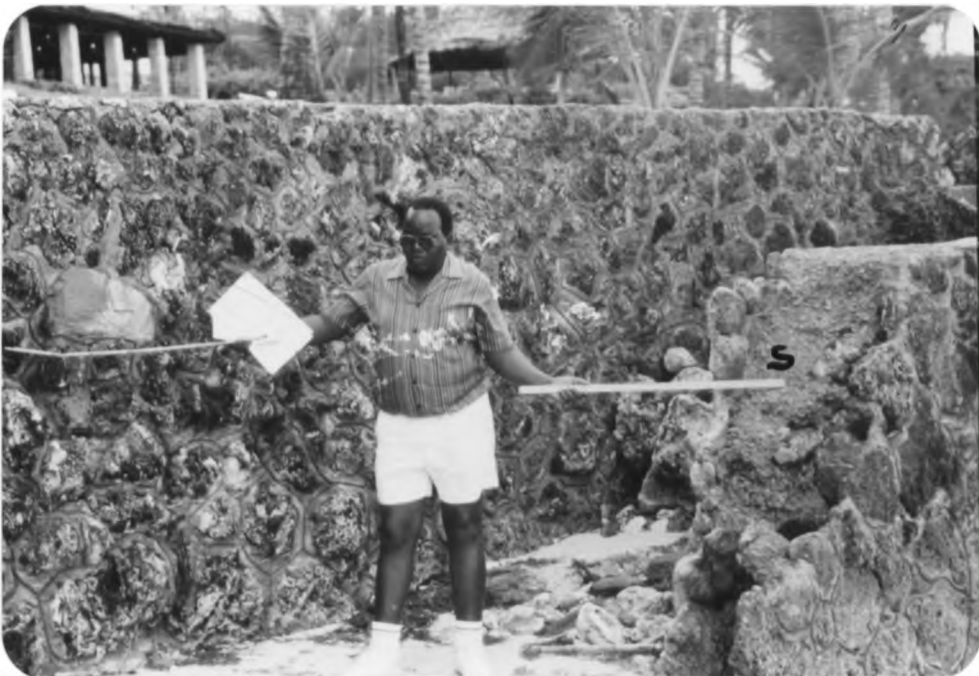
Plate 47 shows a thick vertical seawall (s) at Shanzu. A new seawall is inland of the failed seawall (s) (June, 1991; Photo by S. Langat).

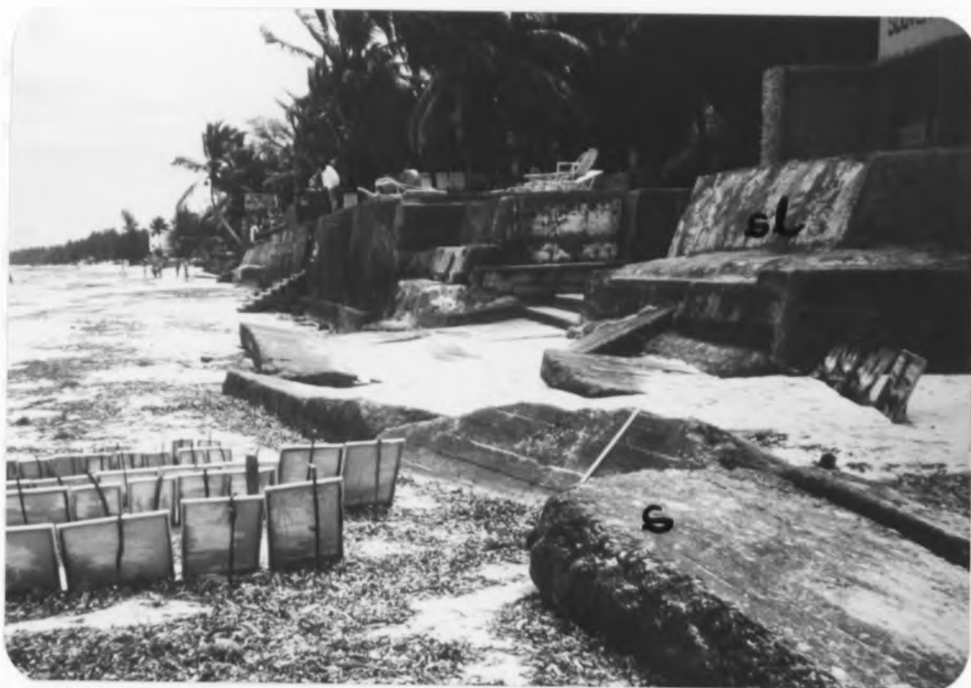
Plate 48 shows a thick seawall (s) at Bamburi. Note another seawall (sl) behind the failed wall (s) (September, 1990; Photo by P. Abuodha).

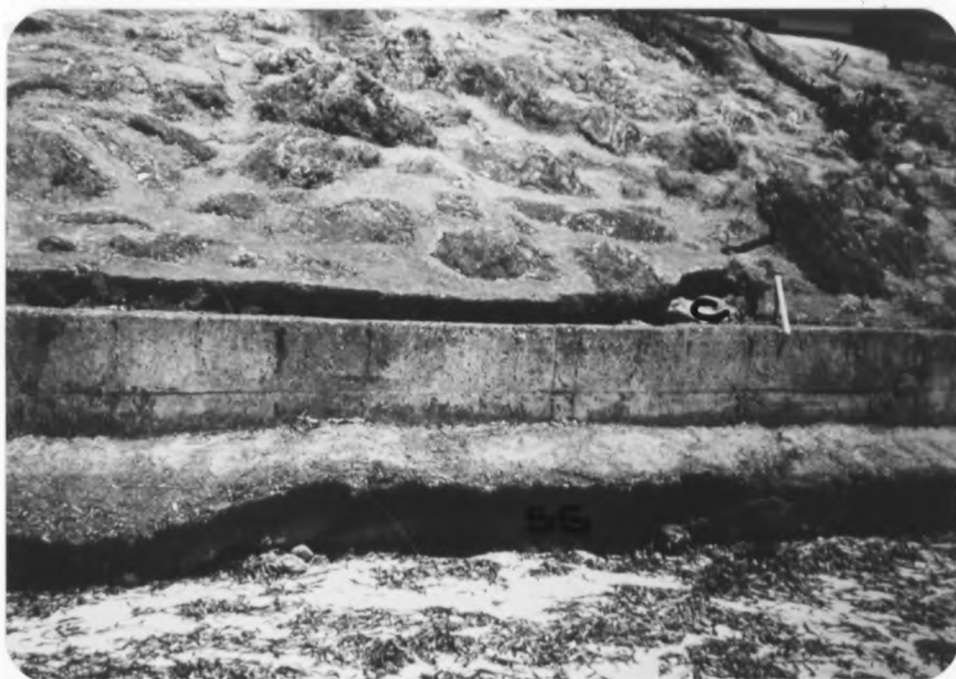
Plate 49 shows seawall along Nyali beach. Note crack (c) on the wall and the result of sediment scour (ss) beneath the wall (September, 1990; Photo by P. Abuodha).

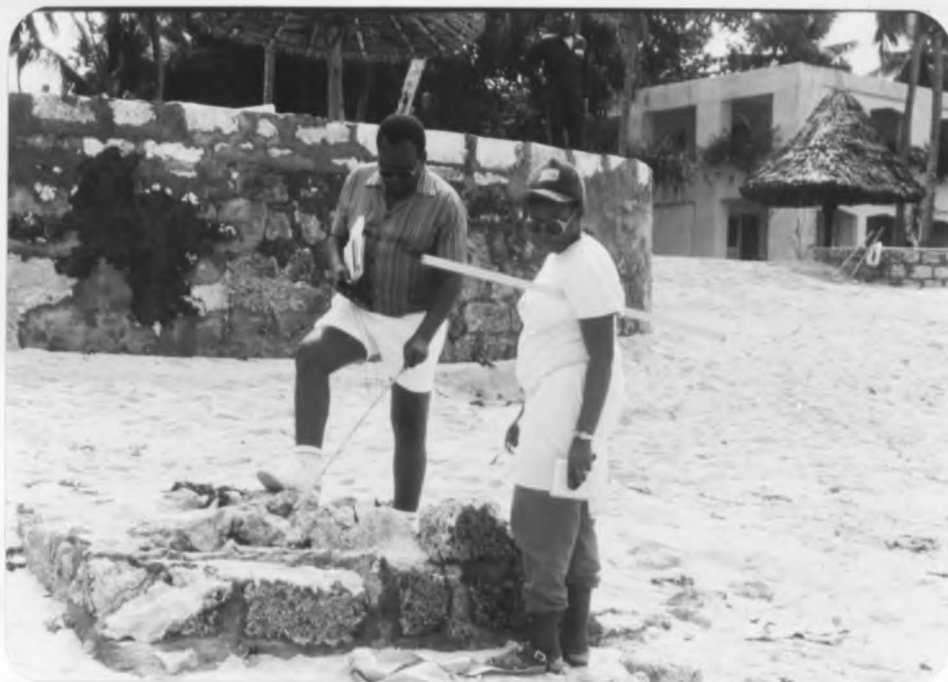
Plate 50 shows remnants of former seawall left 22 m seawards of the present wall at Likoni (June, 1991; Photo by S. Langat).

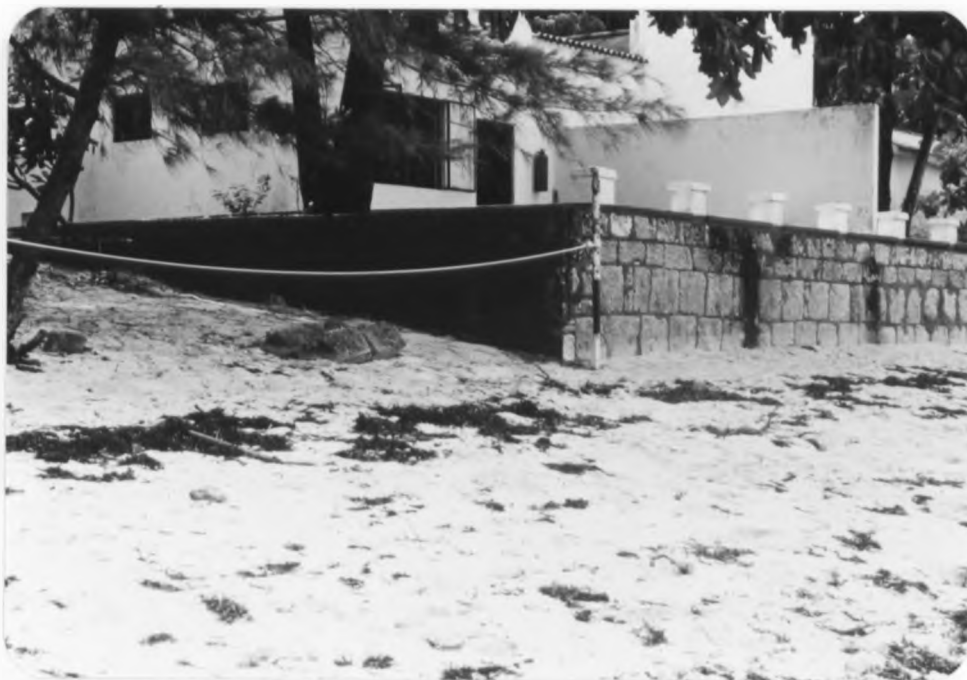
Plate 51 shows a recent seawall and a wall-in-the-making at Likoni. Note increased erosion at the end of the wall (June, 1991; Photo by S. Langat).
