**LAND DEGRADATION AND ITS CONTROL IN THE
KIBWEZI AREA, KENYA**

**This Thesis was submitted in partial fulfilment of the requirements
for the degree of Master of Science in Land and Water Management
in the University of Nairobi.**

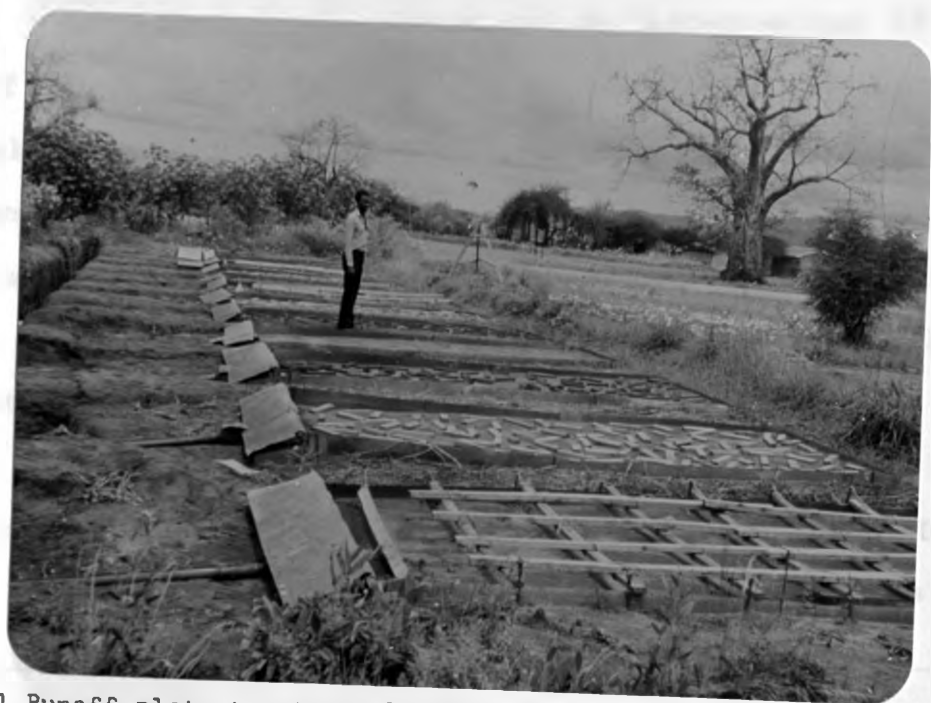
Plate 1 Runoff plots treatment layout. Treatments have been randomised in blocks. The surface seal had first to be broken (photo taken in February 1989).

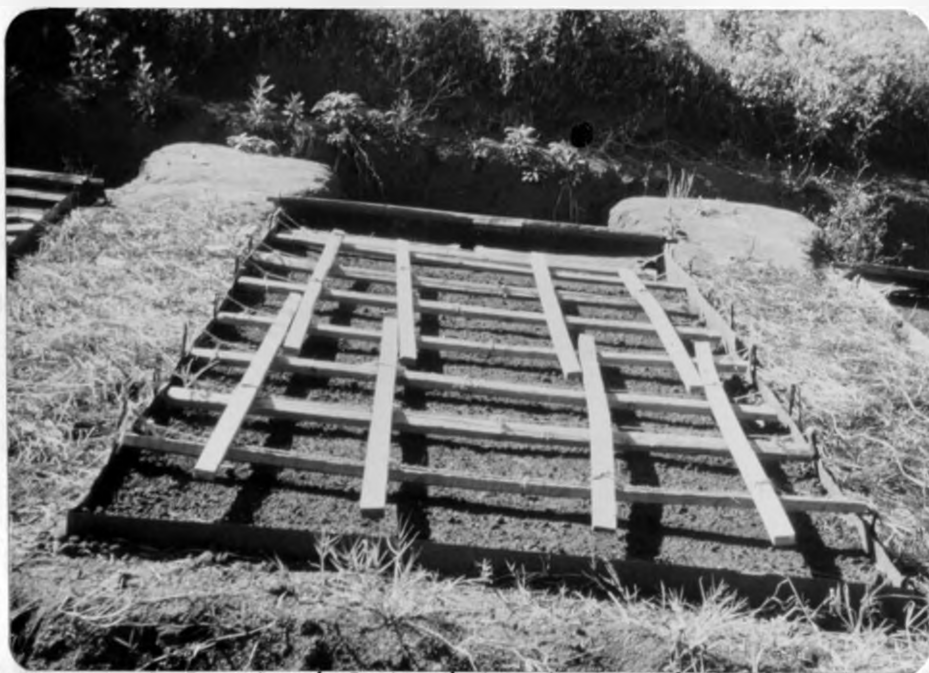
Plate 2. Suspended material to intercept rainfall only.
Note the hooked iron pegs used to suspend the
cover material (photo taken before the long rains 1989).

In "A", cover materials were suspended using a piece of string at about 7 cm from the ground to intercept raindrop impact. Hooked iron rods were pegged outside the plots at an interval of 0.5 m both sides of 4 m length of the plots (See plate 2).

One piece of timber of 2m x 0.053m was added to cater for areas where they crossed each other thereby reducing the cover. The material, as stated elsewhere was cut into small pieces of 15 cm long for treatment "B" and "C" otherwise it was suspended whole in "A". (See plate 2).

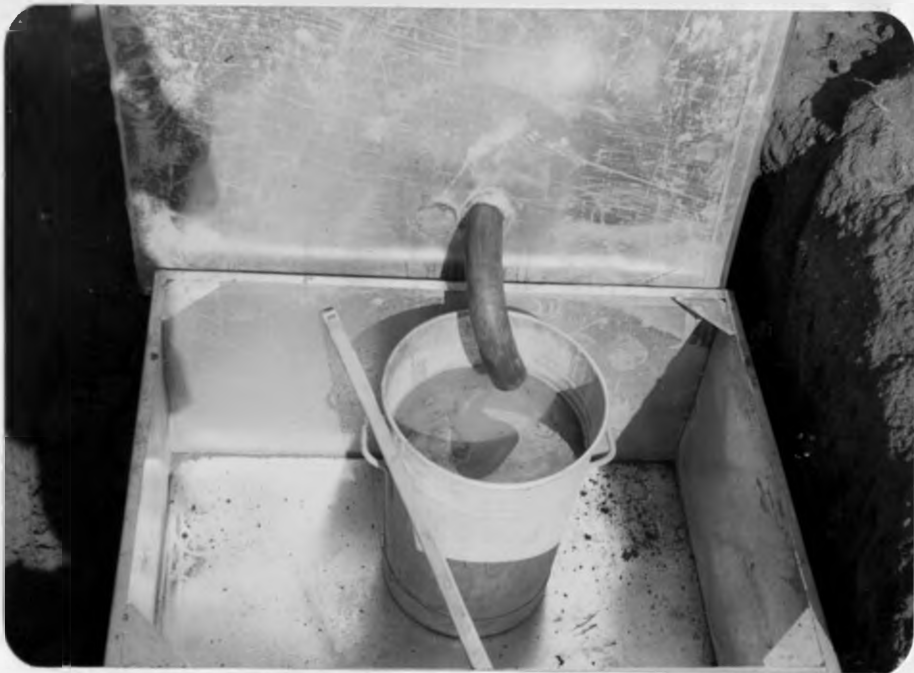
Plate 3. Storage tank and the drum inside with small storm awaiting sampling (Photo taken on 8/4/89).

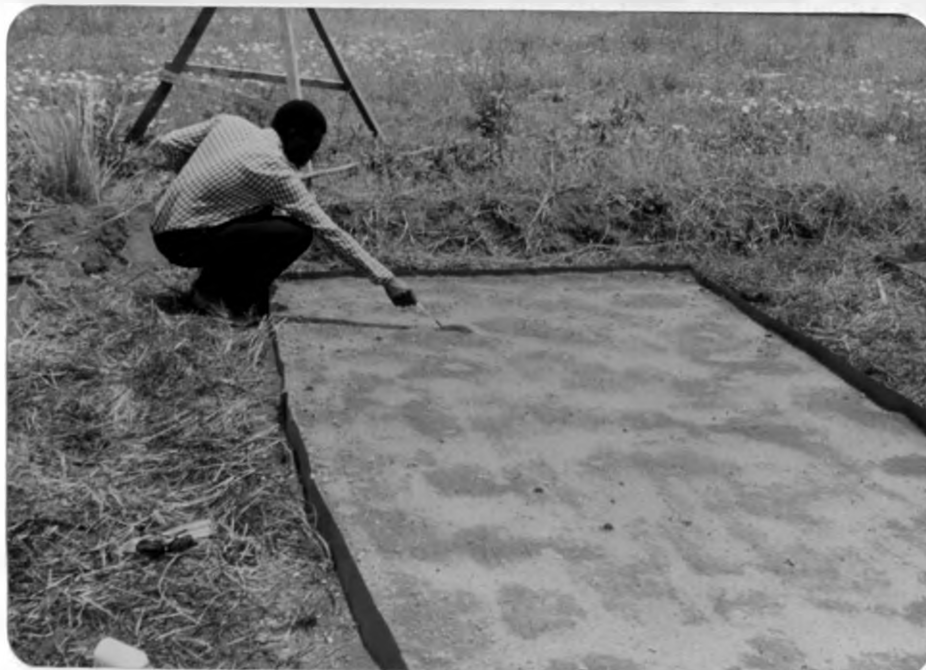
Plate 4. Control after the rains. Note the surface seal and activity of termites after the rains (Photo taken in April 1989).

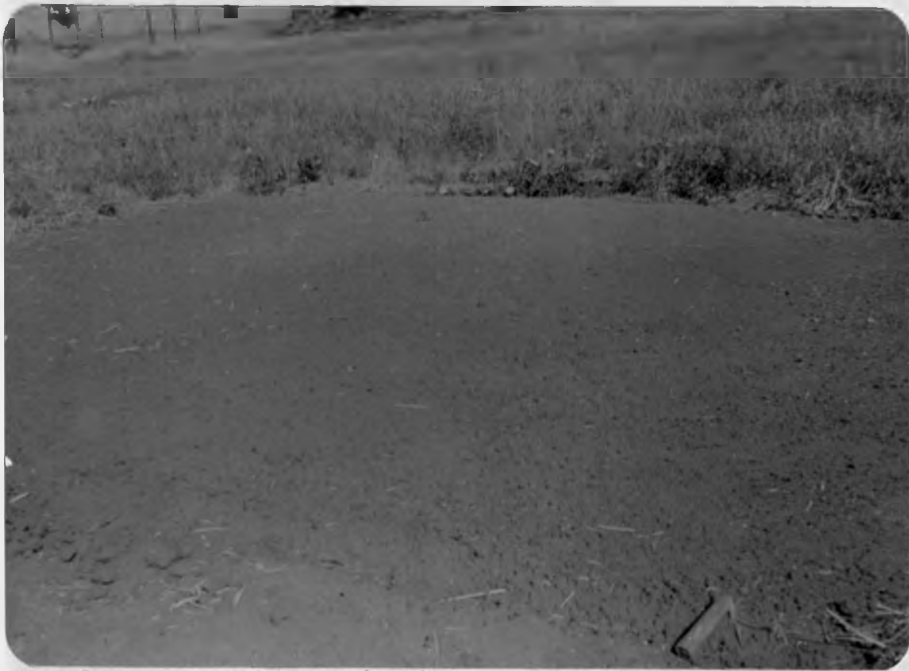
Plate 5. Land prepared for infiltration tests. Seal is broken and land levelled (Photo taken in April 1989).

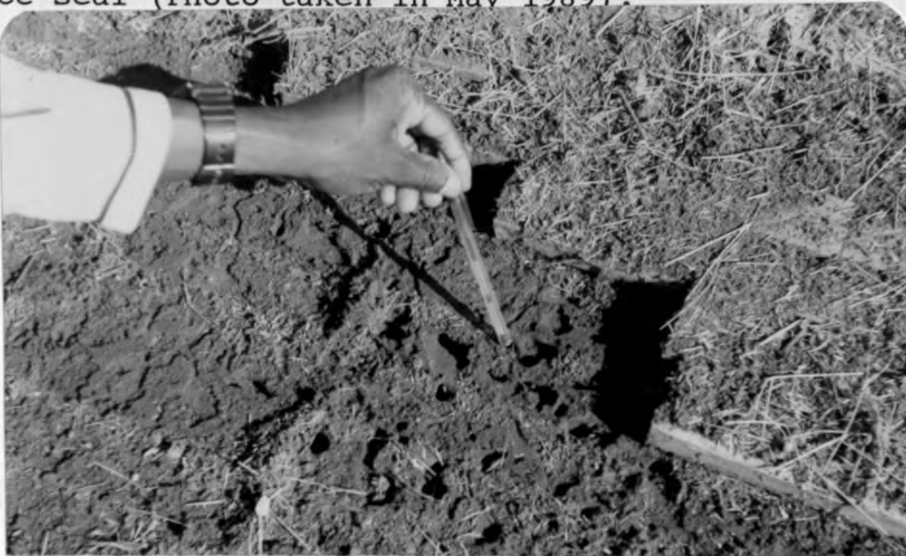
Plate 7. Tunnels created by termites after the cover material is removed (Photo taken in May 1989).

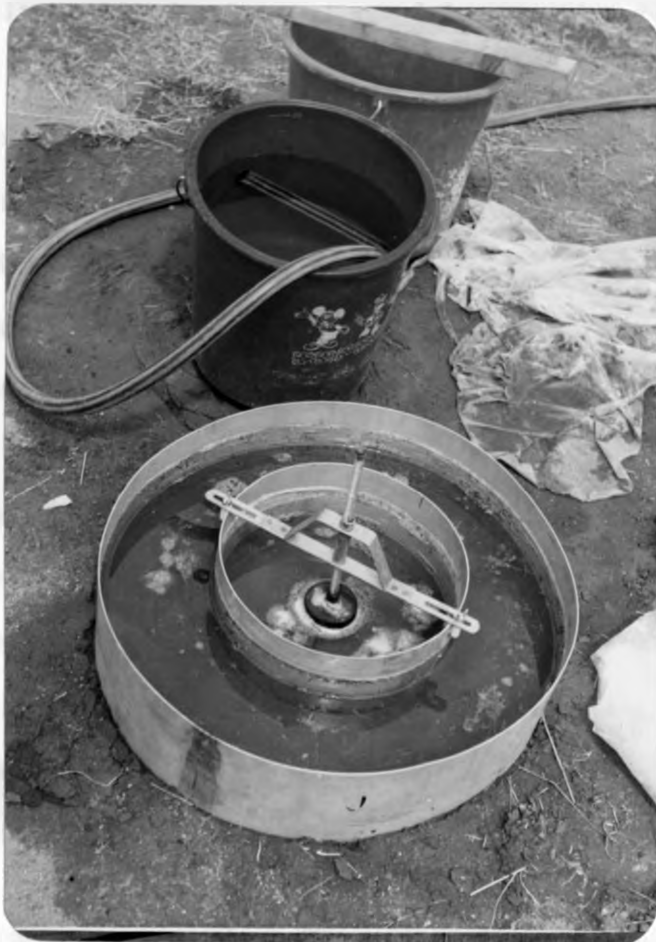
Plate 8. Experimental set-up for determining infiltration characteristics of sealed soils under different treatments (Photo taken in June 1989).

Ring infiltrometer tests were carried out in duplicates in the three treatments on the same plots. See plate 8 for the apparatus. The double ring infiltrometer method was chosen to avoid uncontrolled lateral movement of water from the rings. Earlier studies conducted using single rings gave data of high degree of variability (Michael et al. 1972).

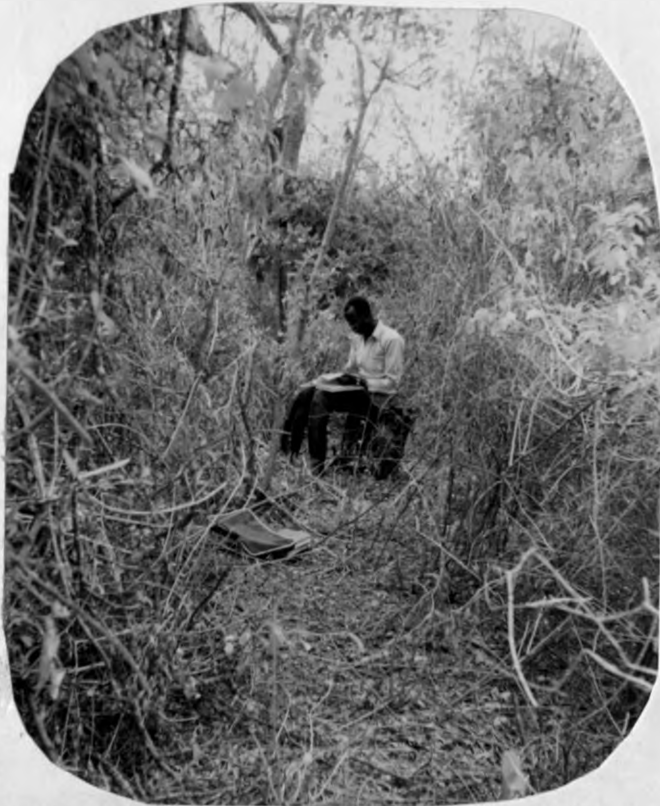
Plate 9 Transect cut into the woodland (Photo taken in March 1989).

The first inventory was carried out to find botanical composition of the understory in the woodland to be used later to supplement composition of the whole vegetation. A transect was set out in the area indicated on the topo-map (see fig. 2) using the cutline grid reference 968405 to 967416 in quarter degree sheet 175/3 of 1973 (see map extract 2, Survey of Kenya, 1974). This was taken as the base transect from which subtransects were set out at a right angle and at regular intervals of 100 meters. This was in an effort to remove bias in sampling. A line of 50 meters running across the zone to be sampled was set facing eastward using range rods and a compass to make sure that samples are taken at regular intervals. See plate 9.

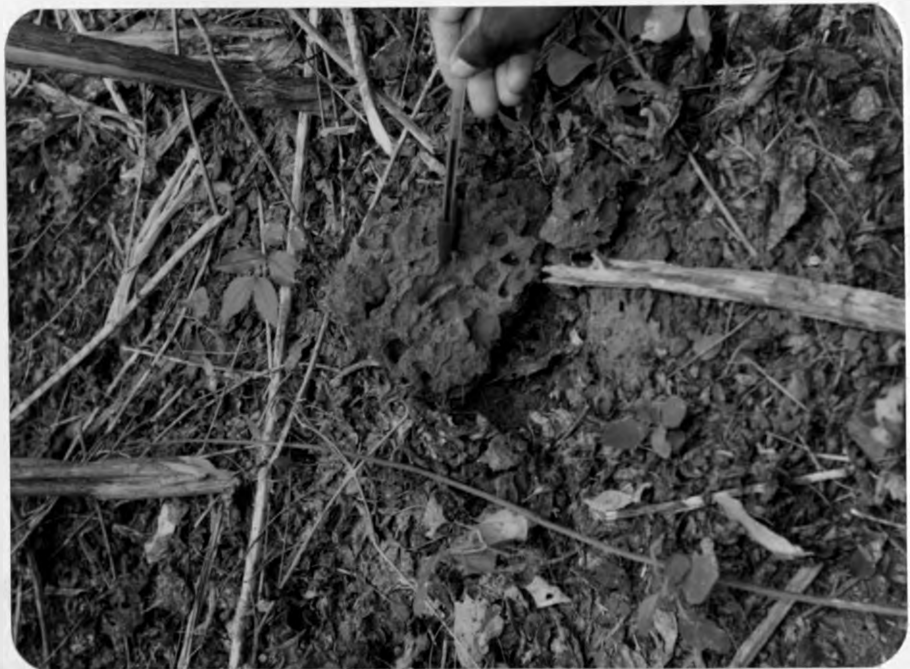
Plate 10. Presence of termite mound in the undisturbed
Woodland. Note the tunnels in the mound (Photo taken in March 1989).

Sampling sites of 2x2 meters quadrat were determined by assigning letters "A", "B", "C" and "D" to 20m, 30m, 40m and 50m respectively and then picking two at random. "A" and "D" were picked and a 2mx2m quadrat was set out by pegging down the sampling area. Sampling was done by identifying each species in the quadrat and recording its frequency on a designed form. Other observations made were on the presence of termites (see plate 10), percent litter cover and bare ground in the undisturbed woodland and soil sealing.

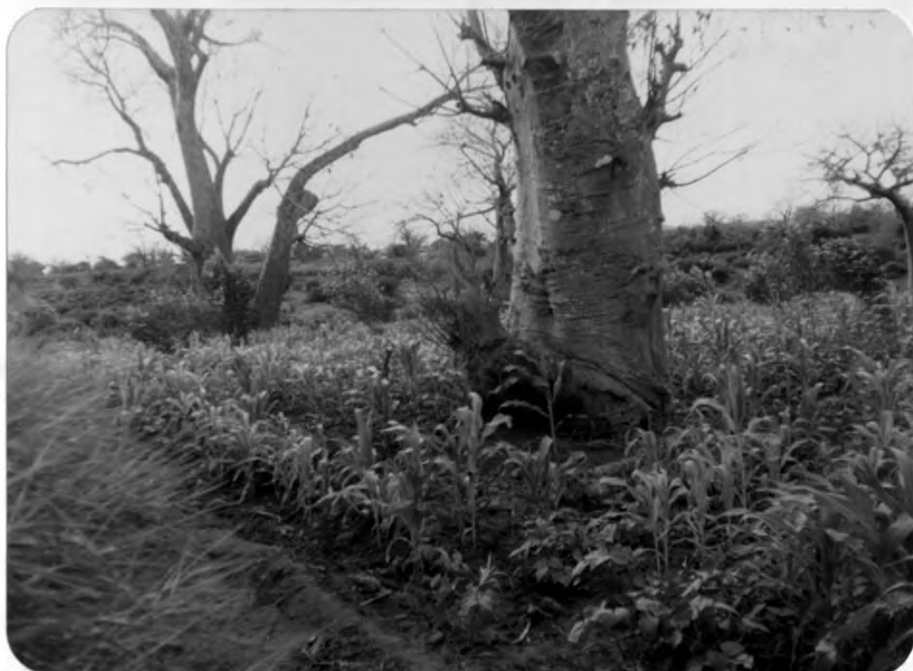
Plate 11. Baobab tree on cultivated land. Note good crop under the tree and the grassed fanya juu terrace (Photo taken in May 1989).

Efforts were made to document socio-economic reasons as to why some species of vegetation are preserved on the cropped lands. In this case, occurrence of Adansonia digitata (Baobab) was surveyed both on cultivated land and in the same wooded vegetation but using a different approach. Socio- economic reasons for retention of the tree were gathered from the inhabitants of the area (see plate 11 and 12).

Adansonia digitata (Baobab) was sampled using a different approach. This was as a result of its infrequent occurrence both in cropland and land not subjected to cultivation (See Plate 11). The method of Strikler et al. (1963) for determining density of randomly distributed populations was followed; i.e. The closest individual method and the nearest neighbour method;

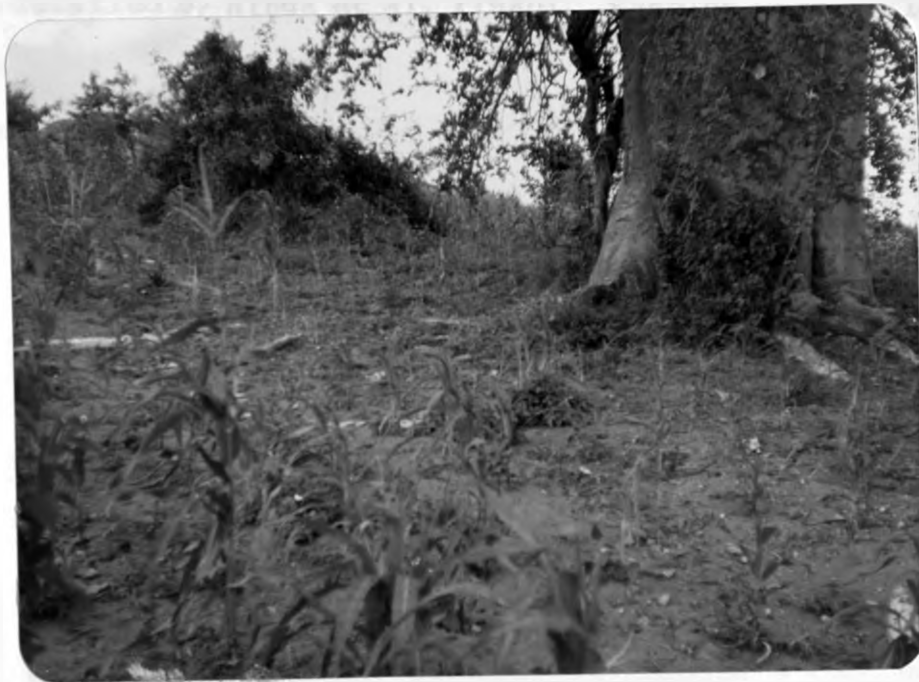
Plate 12. Baobab tree on land with no soil conservation measures (Photo taken in May 1989).

An observation of the above tables and plates 9, 12, 18 and 19 taken from different places in the study area can be derived that the vegetation of the area was a dense woodland and wooded bushland of Enteropogon macrostachyus and Chloris roxburghiana (> 30% of all grasses) with Acacia brevispica, Combretum exalatum, Commiphora, Premna holstii, Ocimum basilicum and Grewia species and other woody species. Adansonia digitata (Baobab) is a common vegetation component in the area. Makin and Pratt (1984) showed that the vegetation is a characteristic of the drier sectors of eco-climatic zone V. Grazing was poor in the undisturbed land but browse was in general of rather good quality and quantity due to Grewia, Premna, Ocimum and Acacia species.

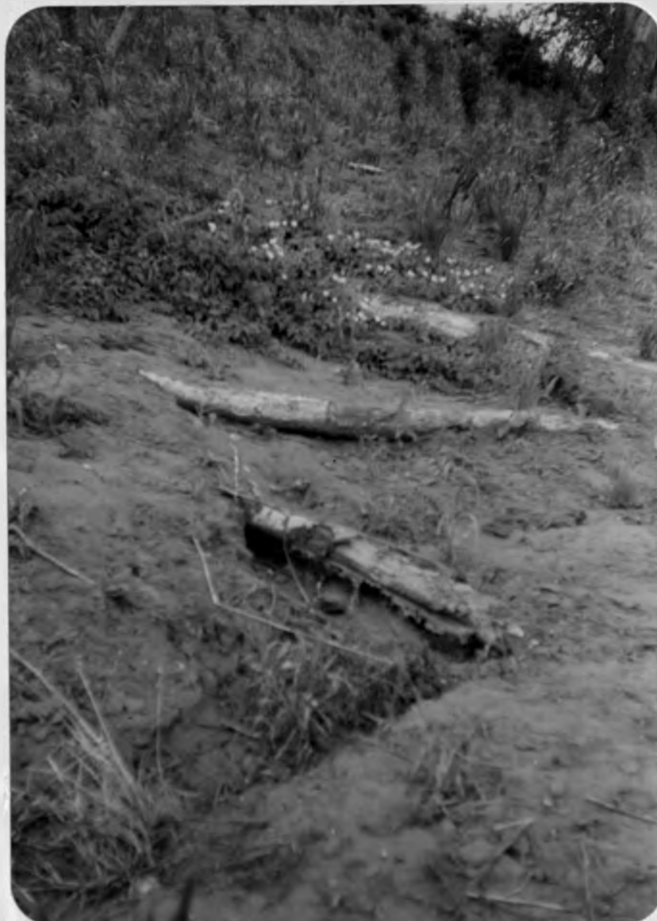
Plate 13. Exposed roots on farmers' land as an evidence of erosion process in action (Photo taken in May 1989).

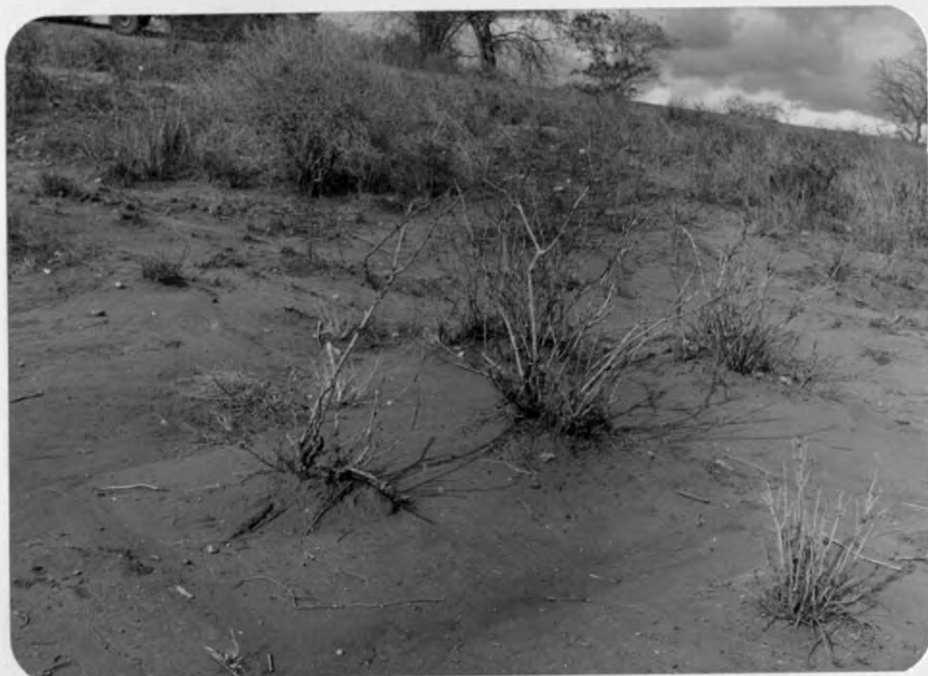
Plate 14. An erosion mound protected by vegetation while the surrounding grazing land surface is reduced by erosion. (photo taken in October 1988).

Much grazing land is normally bare and degradation is taking place quite rapidly, and little is being done in many places. This was observed as shown in plate 14 taken in October 1989 and from information given in tables 26 and 27. Even after the rains revegetation was noted to be slow in some areas. This is evident from plate 23.

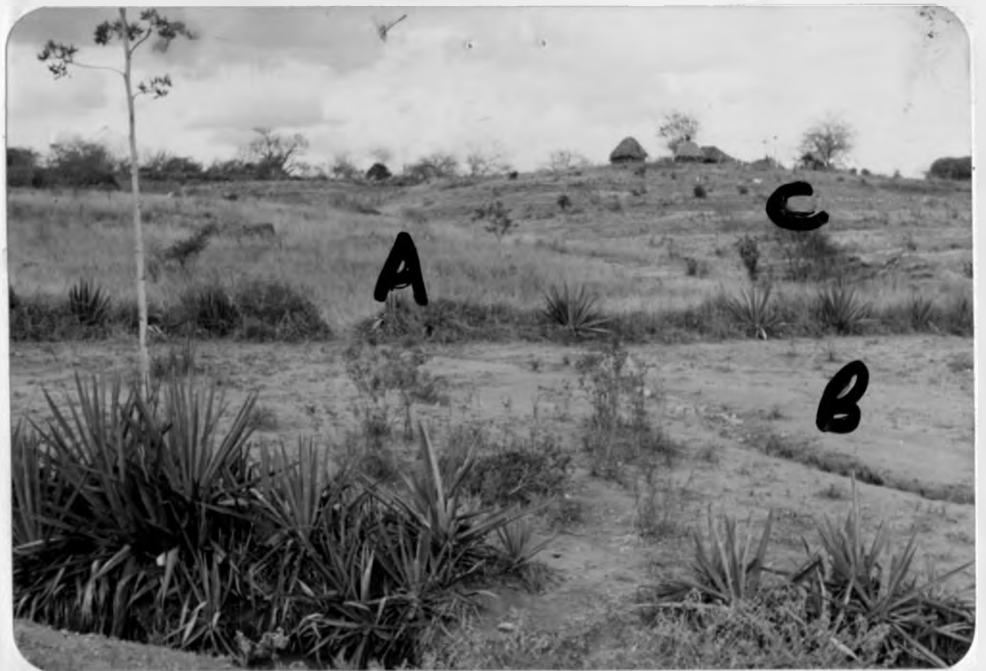
Plate 16. Soil conservation measures on grazing land: At the foreground marked B. overgrazed land, no soil conservation measures used except rest period to allow cover to establish in A , "C" Bench terracing on grazing land. Note also the sisal planted to prevent further gully development (Photo taken in September 1988).

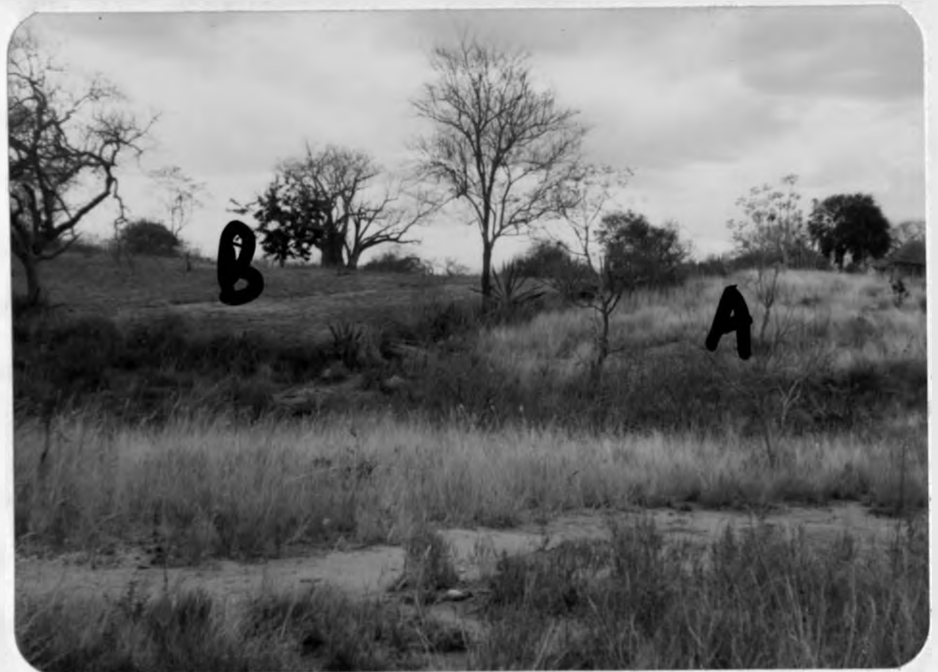
Plate 17. Comparison of landscape under conservation measures "A" and with no conservation measures "B". Note the presence of Adansonia digitata in the background which has been preserved (Photo taken in September 1988).

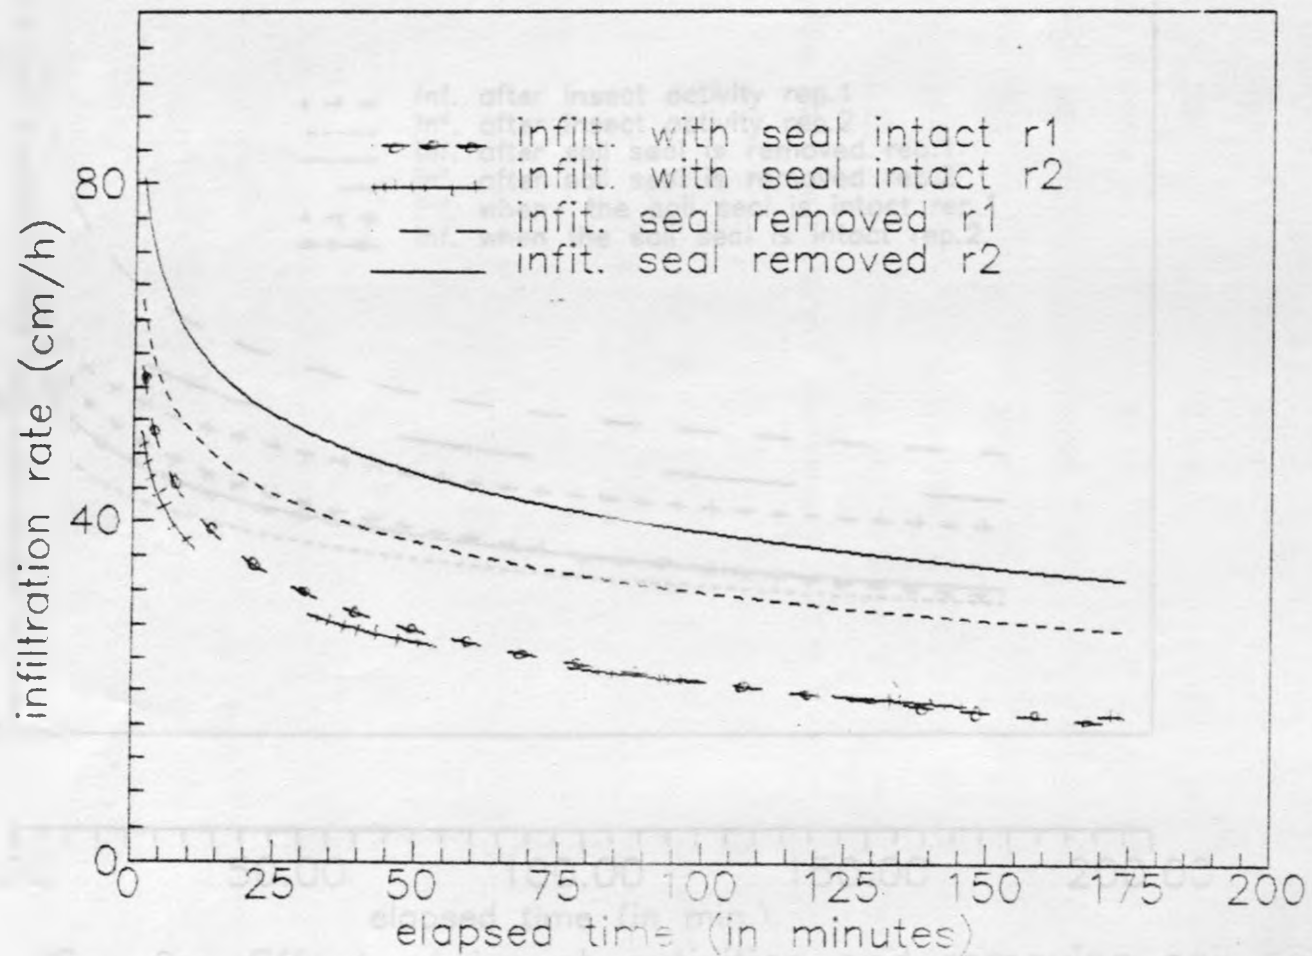
Fig. 5 . Effect of removing soil seal on infiltration rates of sealing soils.

Raindrop impact on the soil surface to cause sealing will cease to be effective after a lot of runoff is generated. Data obtained is as shown in appendix 3a to 3f. The effects of insect activities, removing soil sealing and the combined effect of both treatments on infiltration rates of sealing soils has been plotted together with rates when the soil seal is not removed (figures 4, 5 and 6).

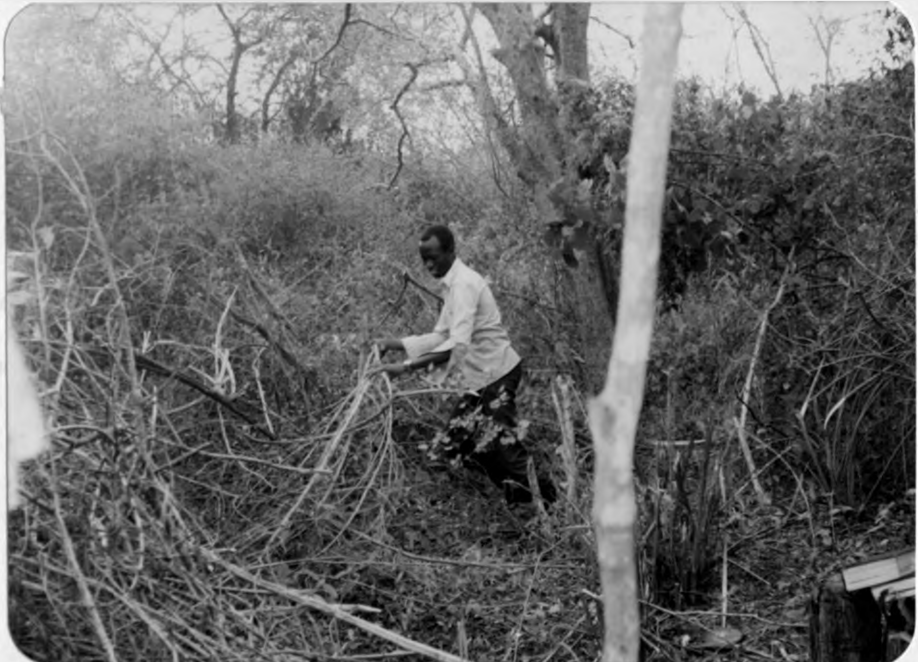
Plate 18: Wooded bushland. Note Premna holstii and associated shrubs in the foreground and Commiphora species trees in the background (Photo taken in March 1989).

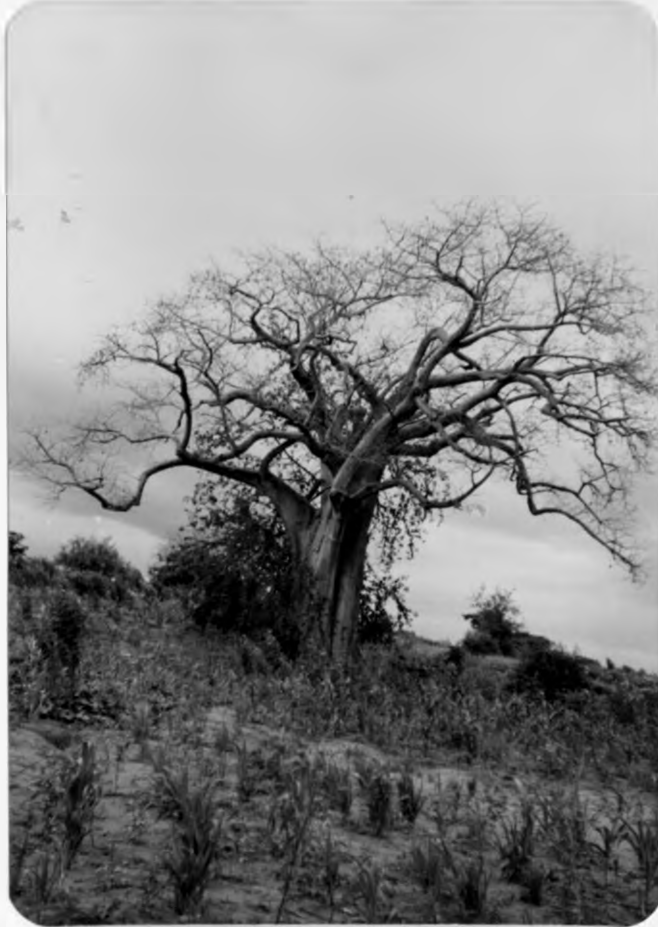
Plate 19: Baobab (Adansonia digitata) retained on farmers land for its social-economic uses (Photo taken in April 1989).

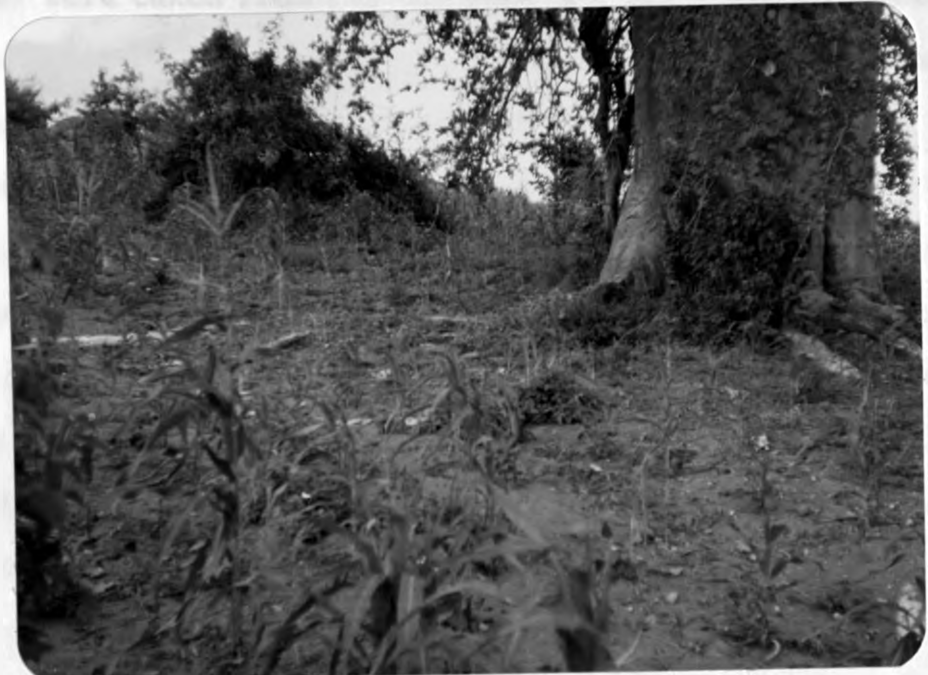
Plate 20: Baobab roots can act as an indicator of land deterioration. Note the poor state of crops next to the tree and a good crop few meters from it, also indicated in plate 12, possibly due to competition for nutrients or shade effects (Photo taken in May 1989).

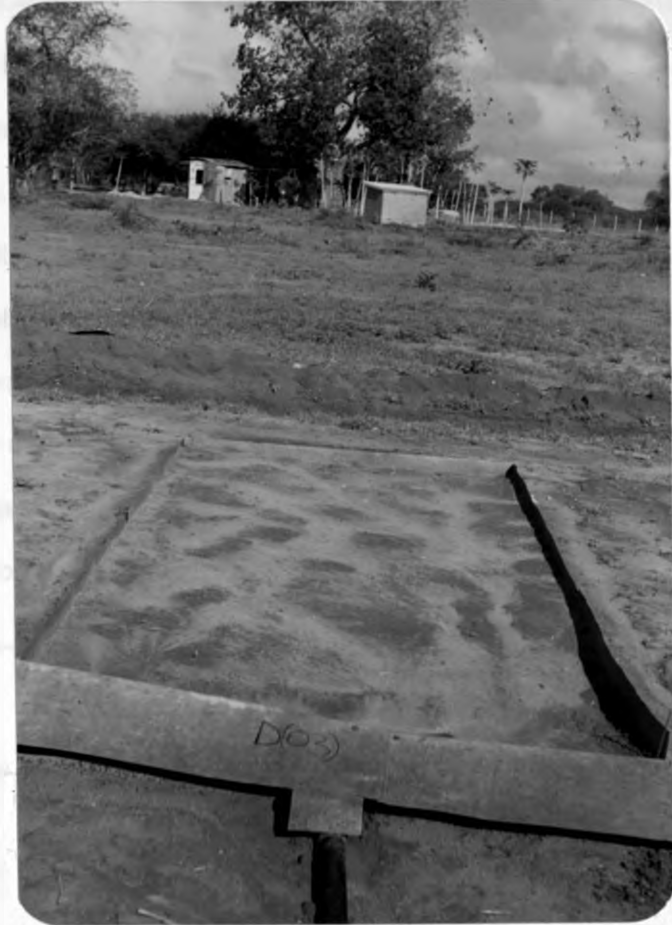
Plate 21: Sandy over wash evident in the control plots. Also noted in plate 4 (Photo taken in April 1989).

Soil sealing was seen to crack during the dry weather after a rainfall event. Many surface cracks were seen in all plots especially in the control plot which was directly exposed and bare. "A" and "O" horizons were absent and the soil surface had a sandy over wash. (see plate 21).

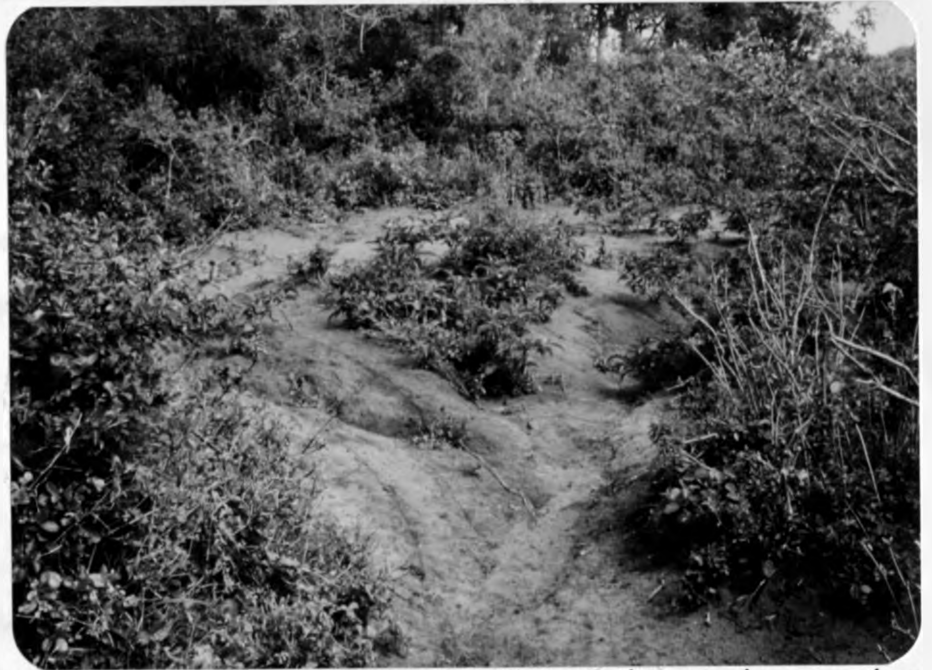
Plate 23: Some patches of bare denuded lands evident in grazing lands even after the rains, note rill erosion (Photo taken in May 1989).

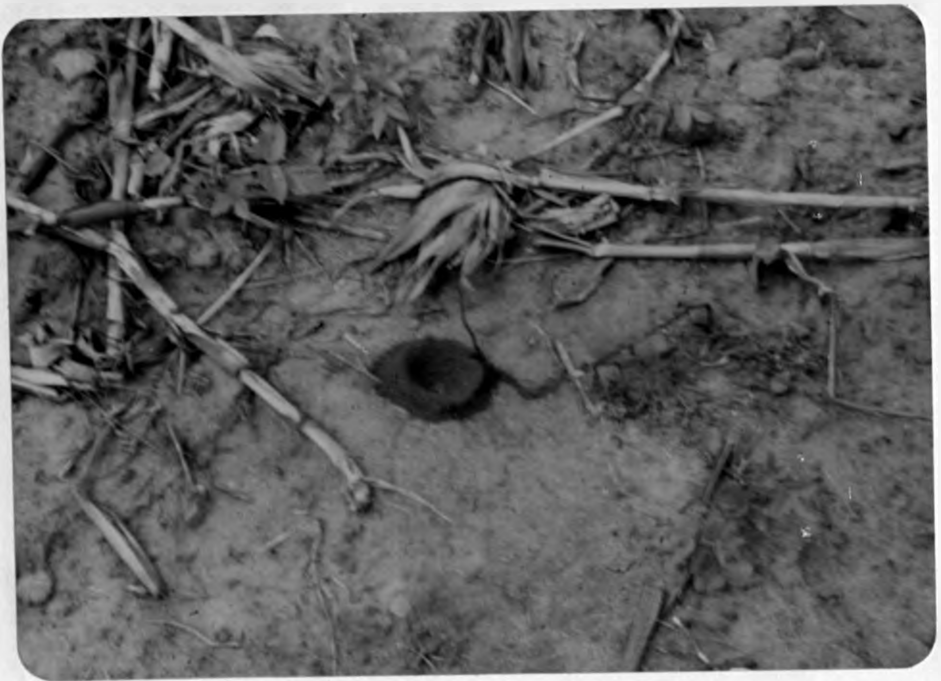
Plate 24. Moderate ground cover can prevent soil erosion.
(Photo taken in April 1989).

Plates 24 and 25 compares overall ground cover before the rains and the consequences of leaving some cover. Plate 24 does not show any evidence of soil erosion possibly due to cover left on the ground, but note also the presence of termites and their burrowing activity, Plate 25 in contrast shows prominent rill erosion due to poor ground cover before the rains. If the situation is not halted the rills may develop into gullies. The land of plate 25 is less steep than that of plate 24 but the reason for the difference in erosion is related to cover rather than steepness.

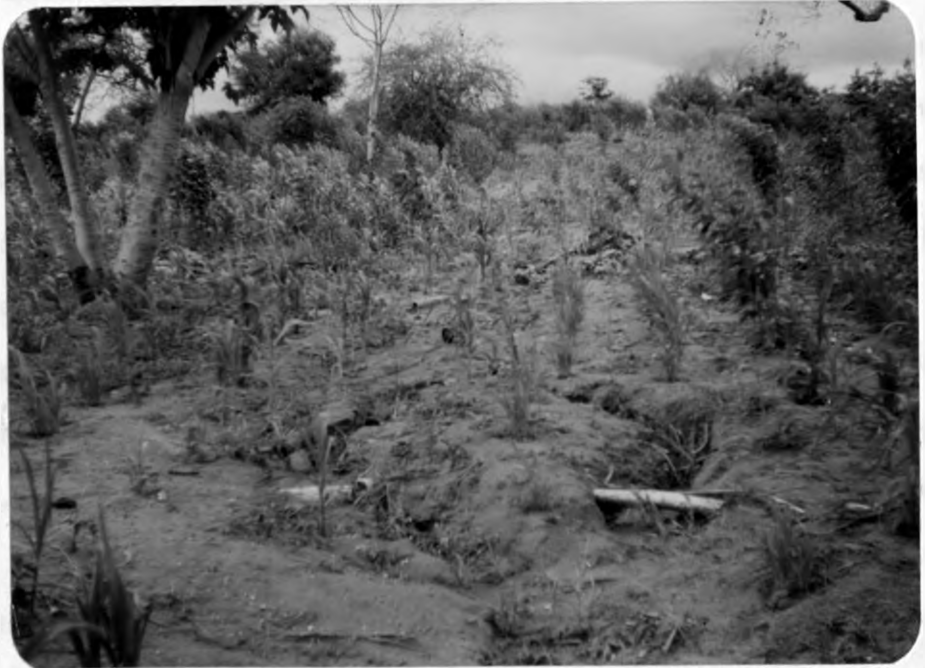
Plate 25. Rill erosion on a gentle slope. Lack of ground cover paved the way to rill erosion (Photo taken in April 1989).

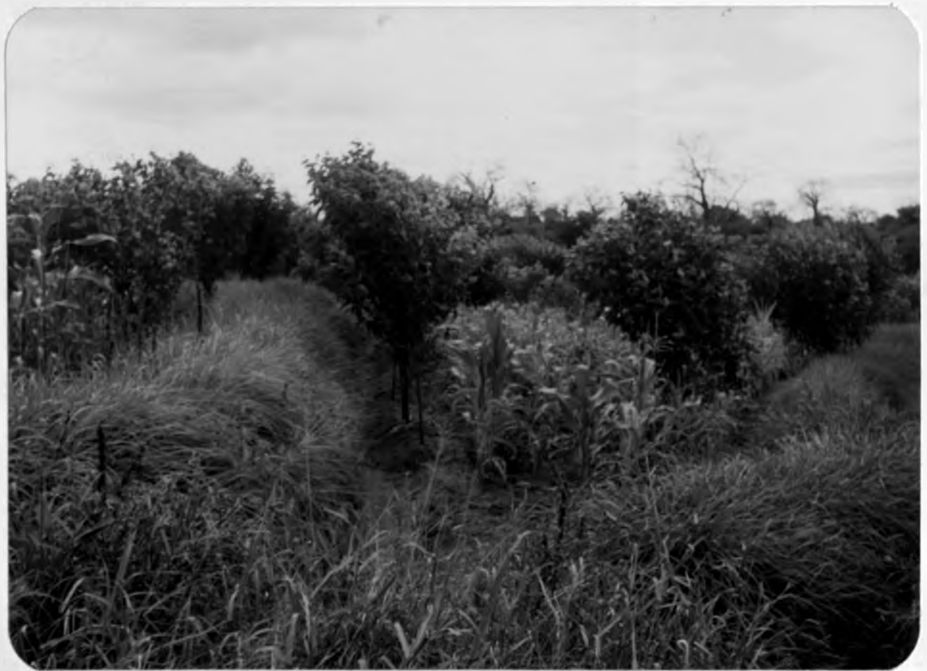
Plate 26. A well established fanya juu terrace. Note grassed bank and the resultant bench terraces (Photo taken in May 1989).

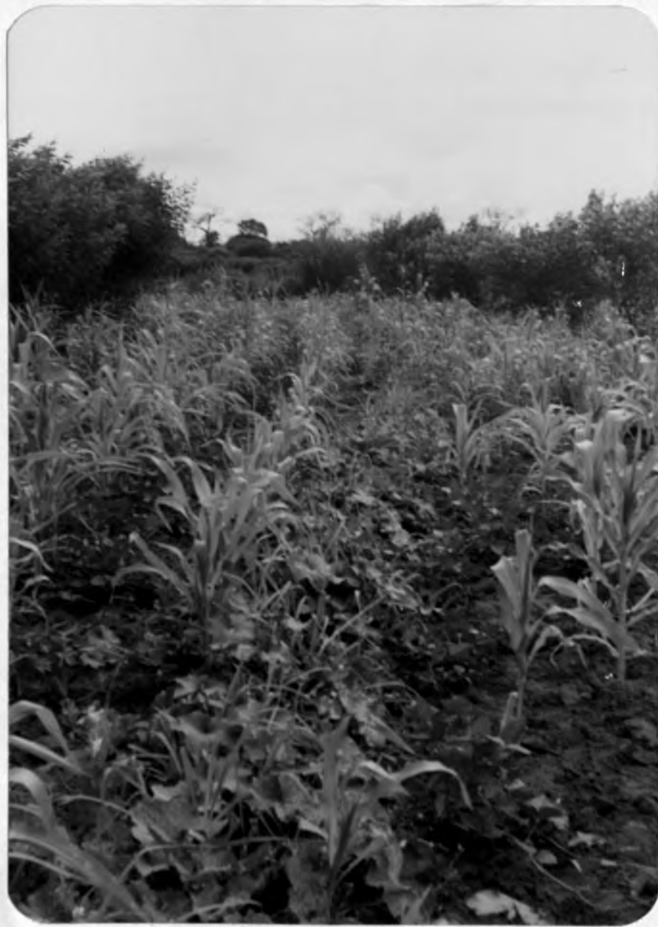
Plate 27: A grass strip planted in a row along the contour
(Photo taken in April 1989).

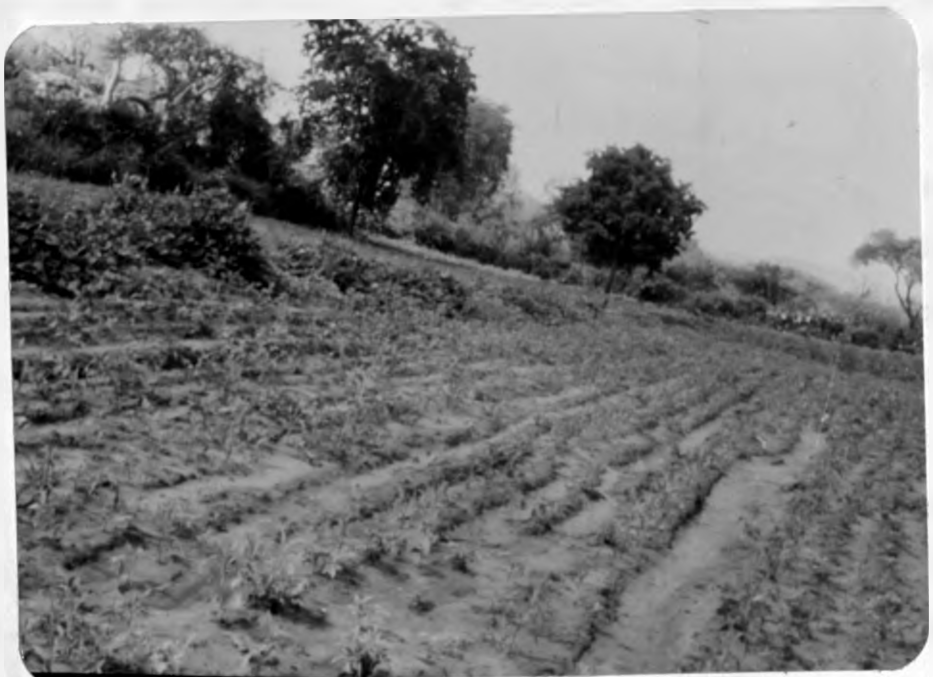
Plate 28: Bench terrace and a silted up fanya juu terrace. Note bank covered by a leguminous crop (Photo taken in April 1989).

However, as noted above, not all terraces had grassed banks. Plate 28 shows a bench terrace which has resulted from a fanya juu terrace. Its bank is covered by leguminous crop

while other terraces in other shambas were covered by self sown weeds or grasses and were silted up as in plate 28.

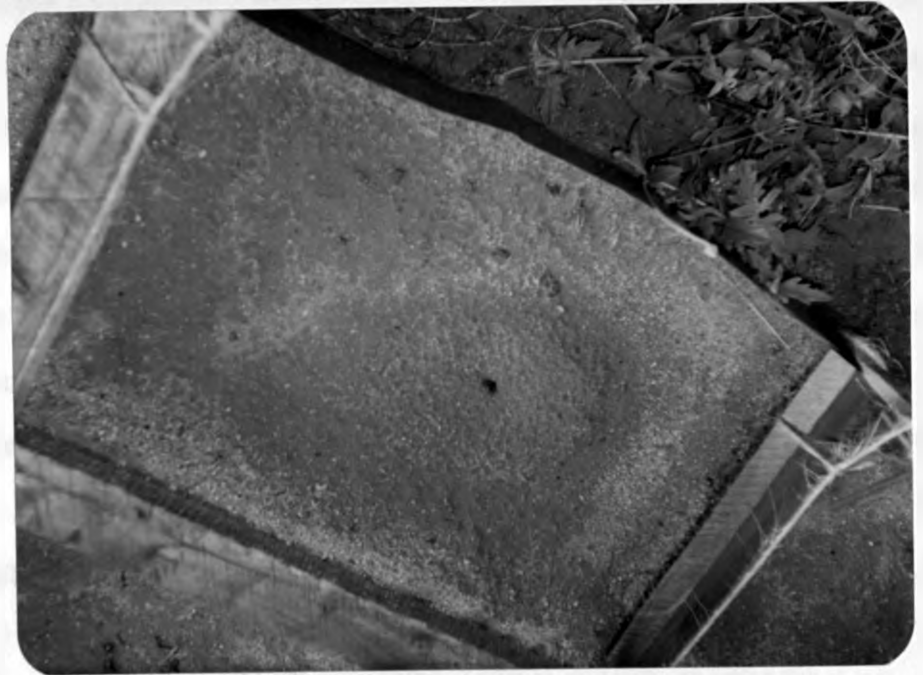
Plate 29. Loose soil surface as a result of termite activity in rainfall interception treatment plots (Photo taken in April 1989).

Though the implications of insect activity on soil sealing cannot be said with certainty as the activity was also found in other treatment plots where there was no brushwood, it was observed that in plots where termites were active, the soil surface configuration was generally uneven, loose and sometimes fragmented (plate 24 and 29) as a result of cast deposition and burrowing activity. This was also observed by Kladviko et al (1986) when dealing with earthworms. The soil was loose and thus could easily be eroded.
