**MINISTRY OF ENERGY AND PETROLEUM
RENEWABLE ENERGY DIRECTORATE**

Subject: Progress report for the biogas project at CAVS

Date: 23rd June 2015

A) Inception visit for the proposed biogas project at the College of Agriculture and Veterinary Sciences, Kabete

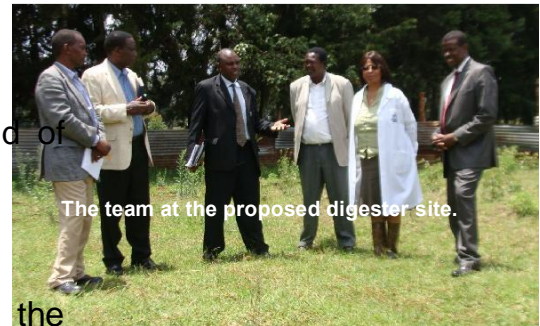
The team at the proposed digester site.

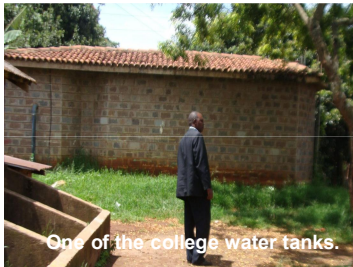
One of the college water tanks.

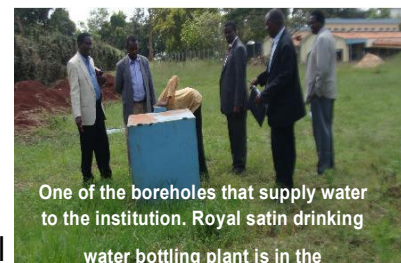
One of the boreholes that supply water to the institution. Royal satin drinking water bottling plant is in the

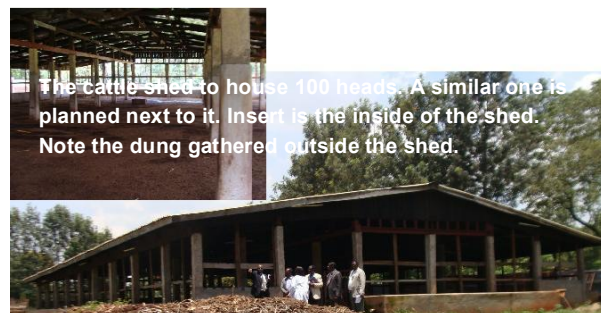
The cattle shed to house 100 heads. A similar one is planned next to it. Insert is the inside of the shed. Note the dung gathered outside the shed.

digester site is a cow shed estimated to hold a 100 heads of cattle. A similar shed

is proposed for construction at the same site and the two could serve the biogas plant. There was adequate space for the biogas plant. Water was readily available at the site and was said to be reliable. Within the college is the college owned Royal Satin drinking water bottling plant.

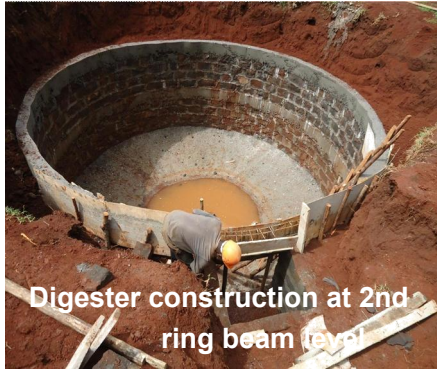
3.1 Digester construction

Excavation of the digester pit was done and construction of the digester had progressed to the second ring beam. The site had been fenced off to keep the area secured off to control human and livestock entry into the construction site.

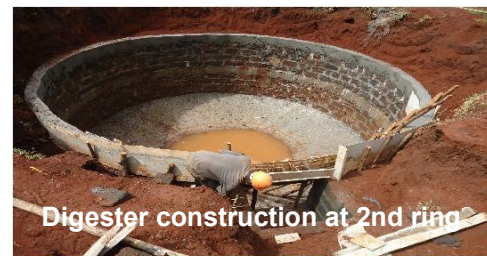
Digester construction at 2nd ring

The digester construction had progressed with main stone works complete and walls plastered. The inner of the dome is yet to be plastered. The digester dome has been reinforced and concrete layer applied. Backfilling was in progress. The mixing chamber has been done with the inlet pipe fitted but yet to be plastered.

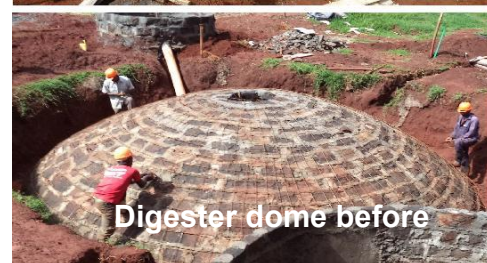
Digester dome before

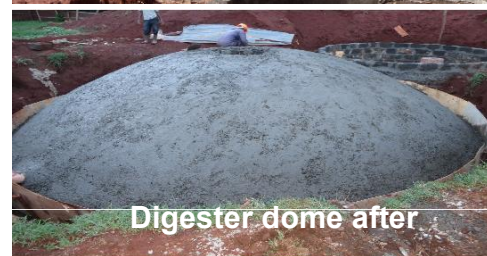
Digester dome after

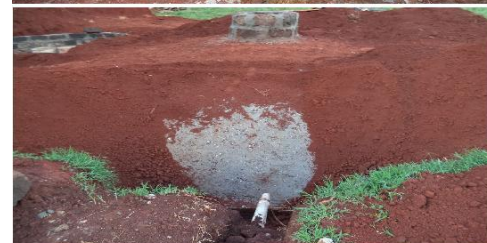
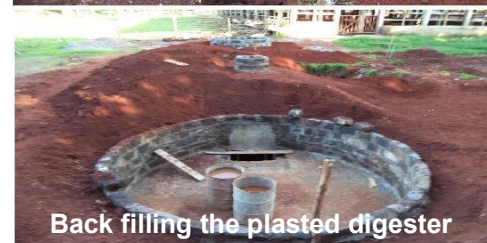
Back filling the plastered digester

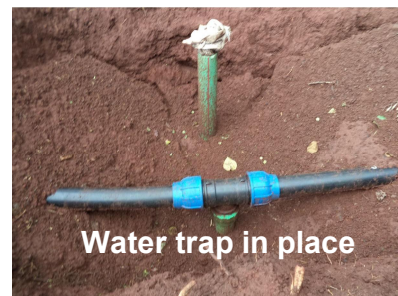
4.2 Gas pipeline

The laying of the gas pipeline had continued with 1.1km already laid and water traps fitted. The remaining 0.2km was yet to be done.

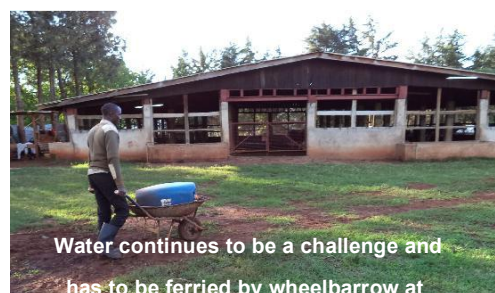
4.5 Digester feed stock

The college has started accumulation of cow dung near in the cattle shed to ensure enough dung will be available at the completion of the digester. The college has assured there will be enough dung to learn the biogas plant once completed.

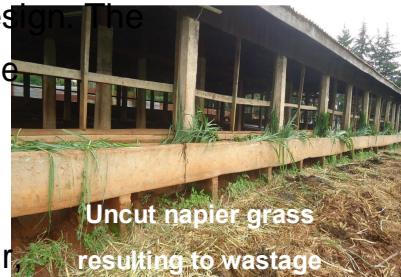
fewer than the expected 100 earlier promised. This compromises the expected amount of feed stock as per the project design. The feeding of the digester commenced on Monday 8th June 2015 and by the time of the visit, a depth of one (1) meter had been filled with available cow dung. The only hindrance was availability of approximately 40 tons of cow dung required as seed feedstock. Further the available chaff cutter is defective resulting to wastage of fodder and dung due to being trampled on with waste fodder.

Uncut napier grass resulting to wastage

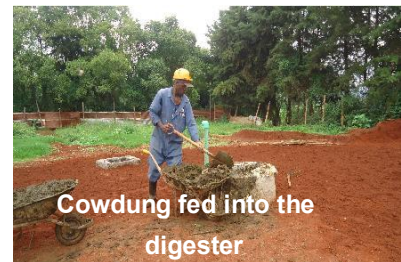
In addition water supply is inadequate, making mixing at the ratio of 1:1; water: cow dung quite difficult. About 60,000 litres of water is required to start up and subsequently 1,000 litres to mix approximately one (1) ton of cow dung daily.

The contractor has therefore resorted to direct feeding into the digester, instead of diluting at the mixing chamber for the substrate to flow freely into the digester. The College top management was informed of these challenges and promised to address them as a matter of urgency to fast track start up of the project.

Cowdung fed into the digester

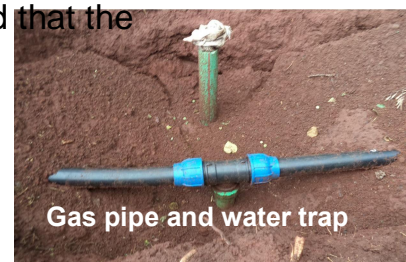
The gas line and all the seven (7) water traps had been done, ready for testing, once gas production commences. It is noted that the contractor has utilized own resources to add an extra 200m of the gas line that exceeded the quoted 1,100 m. The exceeded length will be considered as additional works.

Gas pipe and water trap

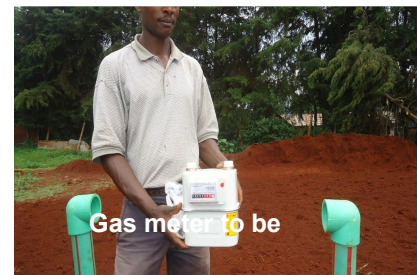
The gas meter has been procured ready for fitting. A decision by supervisory team was made to put up a gas meter housing to secure it from vandalism and poor weather conditions

Gas meter to be

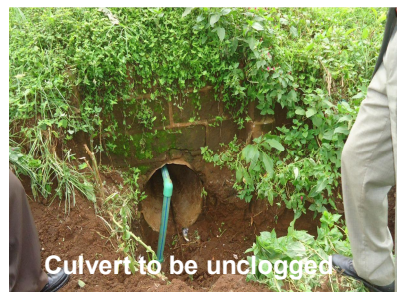
The visiting team appreciated the fact that the culvert had been blocked and may need remedial measures to safeguard the gas line passing therein. The contractor was urged to provide clips to anchor the gas pipe to the roof of the culvert and also to reinforce the exit and the entrance to the culvert to avoid damage by runoff water.

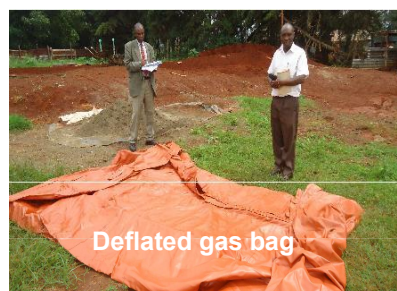
The 20 m³ gas bag has been procured and delivered ready for installation. This will be act as the storage for the biogas before usage in the kitchen.

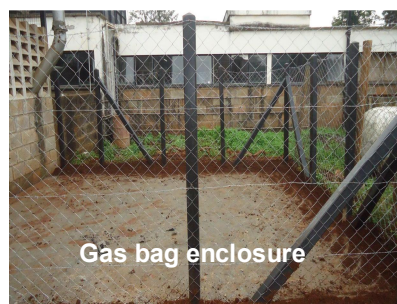
The 50mm thick 5.5 mx 4.5 m base slab has been put in place as well as fencing of the biogas storage area. The storage area is adjacent to the LPG tanks currently used in the kitchen. It is hoped that use of LPG will considerably reduce once biogas start flowing into the kitchen.

It has also been belatedly proposed that the biogas storage area also house the compressor and the desulphurizer due to insufficient space near the kitchen and also to ensure that the biogas is cleaned before entering the storage bag. In the circumstances, a 5.5 m x 4.5 m x 2.5m shelter has been proposed for the biogas storage area to secure the three components.

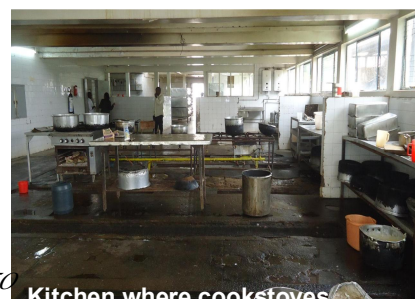
4.9 Kitchen

Although the installation of the cook stoves has not been effected, discussions were held with the Assistant Catering Officer, Ms Winnie Kinuthia with regard to the practicability of using 100 litres cook stoves. The catering officer observed that they

do not prepare large meals since students shun their catering services for other cheaper outlets. After lengthy discussion, it was proposed that 50-litre cook stoves would be more appropriate. In the circumstances, the team agreed with the catering department's request and asked the contractor to use the same quoted amount of money to procure the possible number of 50-litre cook stoves. The Assistant Catering Officer was made to understand that the mandate of the ministry is to enhance efficiency thus the need to embrace improved cook stoves as opposed to the open cook frame currently being used in the kitchen.
