**A STUDY OF EROSIONAL FEATURES AND ENVIRONMENTAL
RESTORATION OF RIVER KALIKUVU CATCHMENT IN
KITUI COUNTY, KENYA**

**A Project Submitted in Partial Fulfilment of the Requirements for Master of Arts Degree
in Geomorphology in the Department of Geography & Environmental Studies,
University of Nairobi**

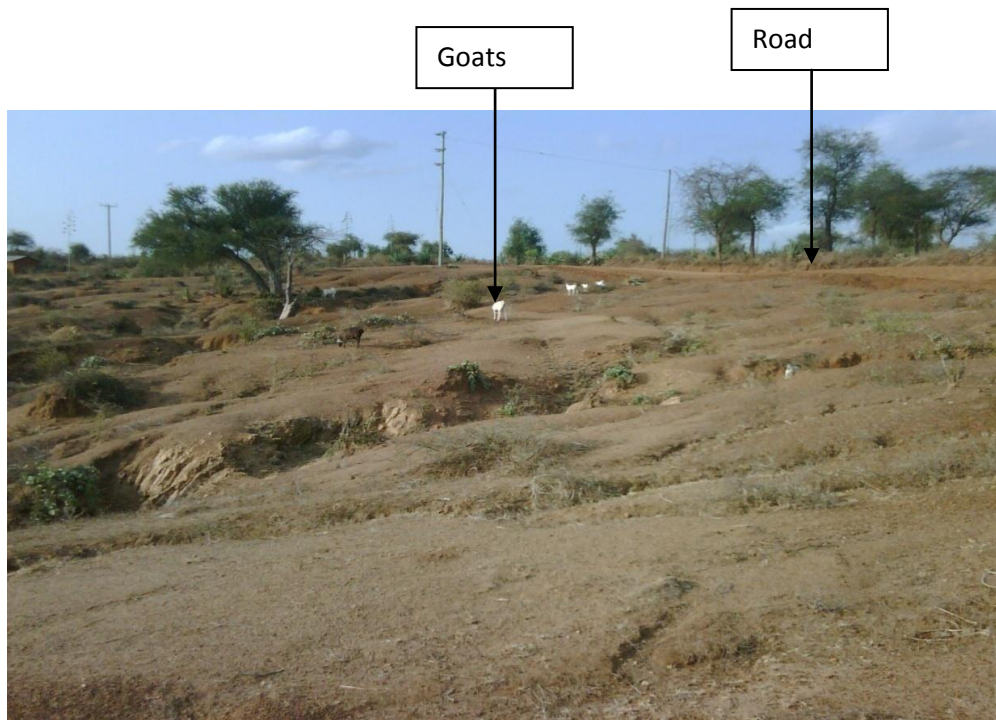
Plate 5.1: Goats browsing and cutting forming rills in the mature Kalikuvu Catchment

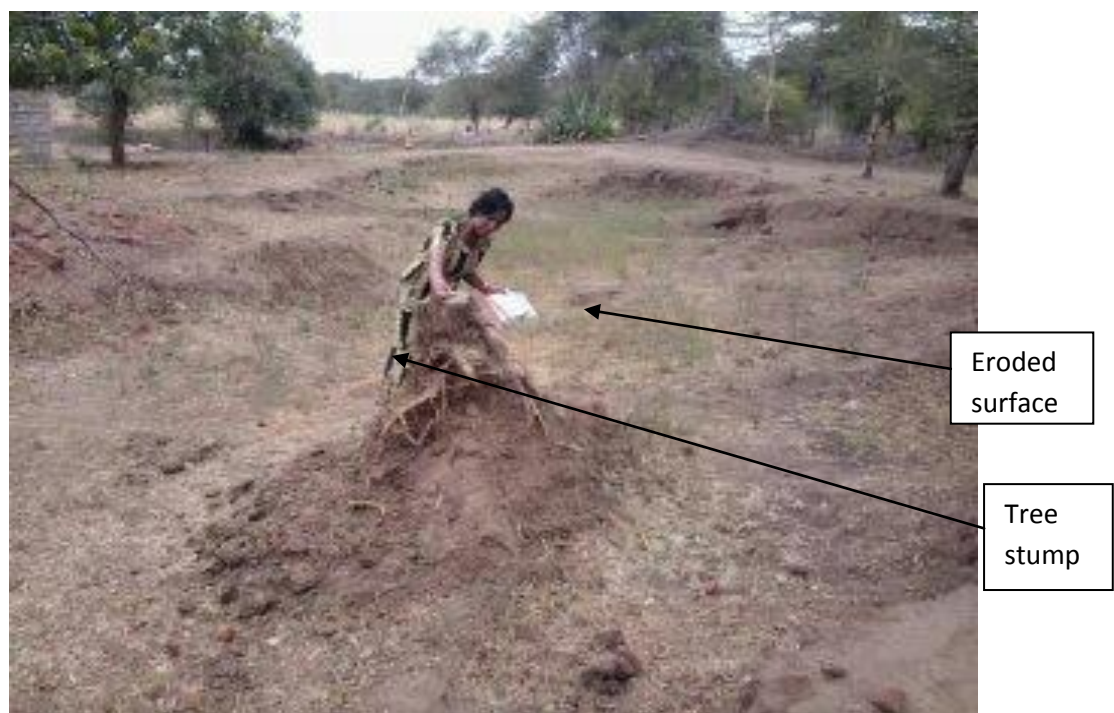
Plate 5.3: Deforestation in the mature Kalikuvu Catchment
(Source: Researcher, 2012)

Overexploitation of vegetation for domestic use: contrary to "deforestation and removal of natural vegetation", this causative factor does not necessarily involve the (near) complete removal of the "natural" vegetation, but rather a degeneration of the remaining vegetation, thus offering insufficient protection against erosion. It includes activities such as excessive gathering of fuel wood fodder, (local) timber. From plate 5.3, erosion has taken place to a depth of about 0.8metres around the tree stump in the mature catchment.

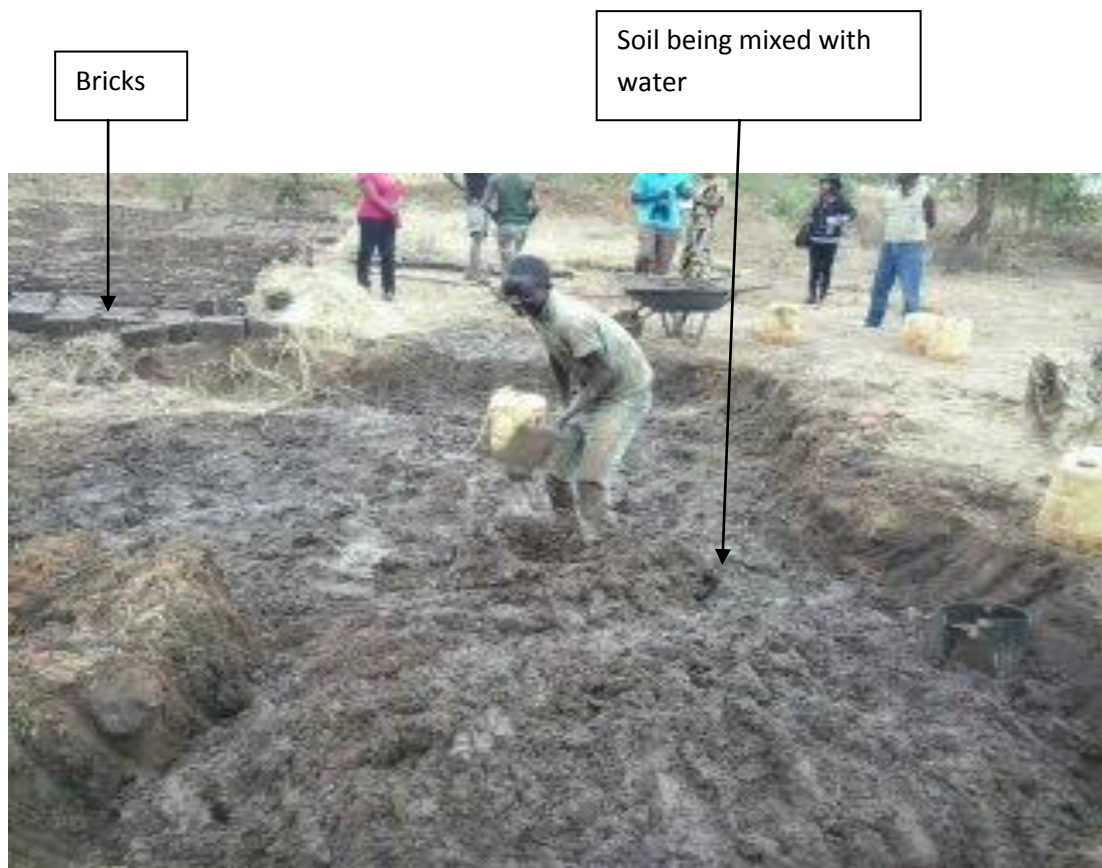
Plate 5.5: brick making in the mature Kalikuvu Catchment

There are other economic activities that take place in the catchment, such as, brick making, charcoal burning and selling of firewood. Brick making exercise was noted to take place at youthful stage of River Kalikuvu and along the river bank, this activity weakens the soil structure and with time gully and rill erosion take place as illustrated in plates 5.5 where the depression formed 40centimeteres deep. Soil excavation formed depression measuring 2.5 metres deep and 2 metres wide as noted in plate 5.6.

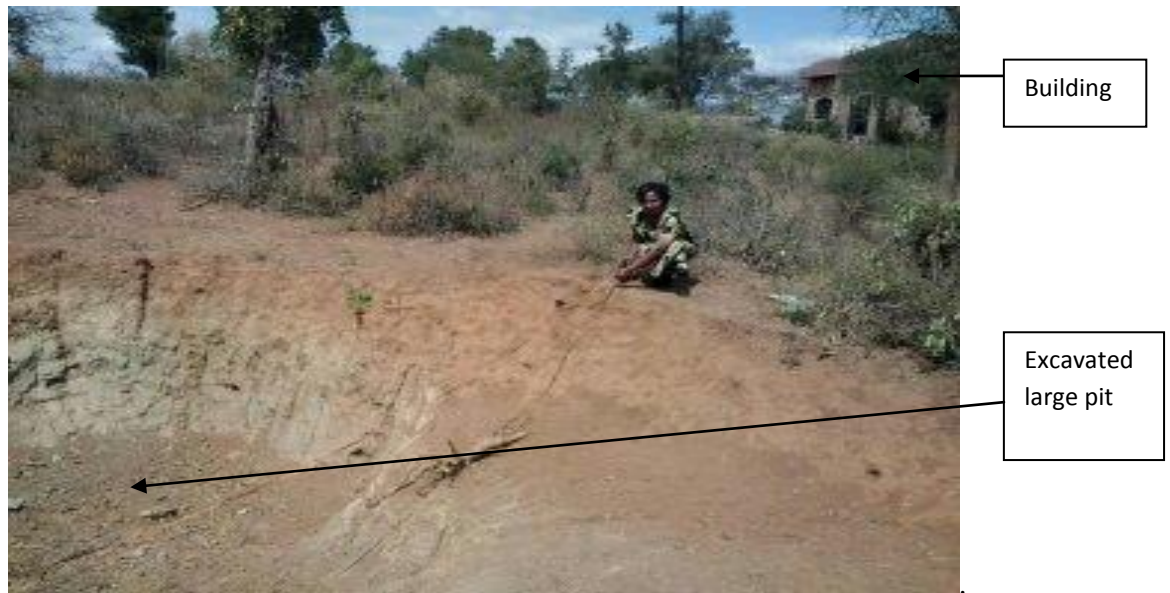
Plate 5.6: An excavated pit in the youthful Kalikuvu Catchment
(Source: Researcher, 2012)

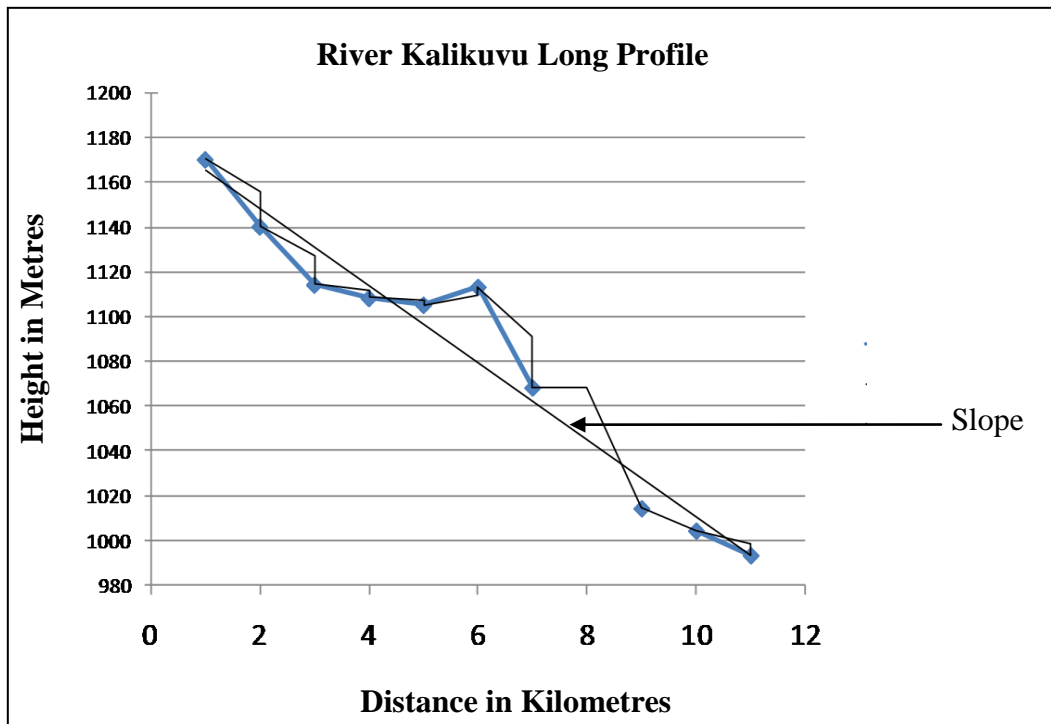
Figure 5.1: The Terrain of Kalikuvu Catchment

Figure 5.2: River Kalikuvu catchment

Figure 5.3: A GPS generated long profile of Kalikuvu River catchment

The altitudinal variations along the River Kalikuvu catchment was generated from the GPS readings during the field reconnaissance activity as shown in figure 5.1, 5.2 and 5.3. Multiple responses of 11.3% cited steep terrain to be a major physical factor causing soil erosion in the catchment. This factor conforms to observed data, where the areas with steep slopes were noted to have many gullies and rills. Geomorphologic researches have proved that, the steeper the slope, the greater the erosion, as a result of the increased velocity (swiftness) of water-flow. Soil erosion by water increases as the slope length increases due to the greater accumulation of runoff. Consolidation of small fields into larger ones often results in longer slope lengths with increased erosion potential, due to increased velocity of water, which permits a greater degree of scouring (carrying capacity for sediment). Steep slope has led to formation of a gully 3meters deep in the mature Kalikuvu catchment as shown in plate 5.7.

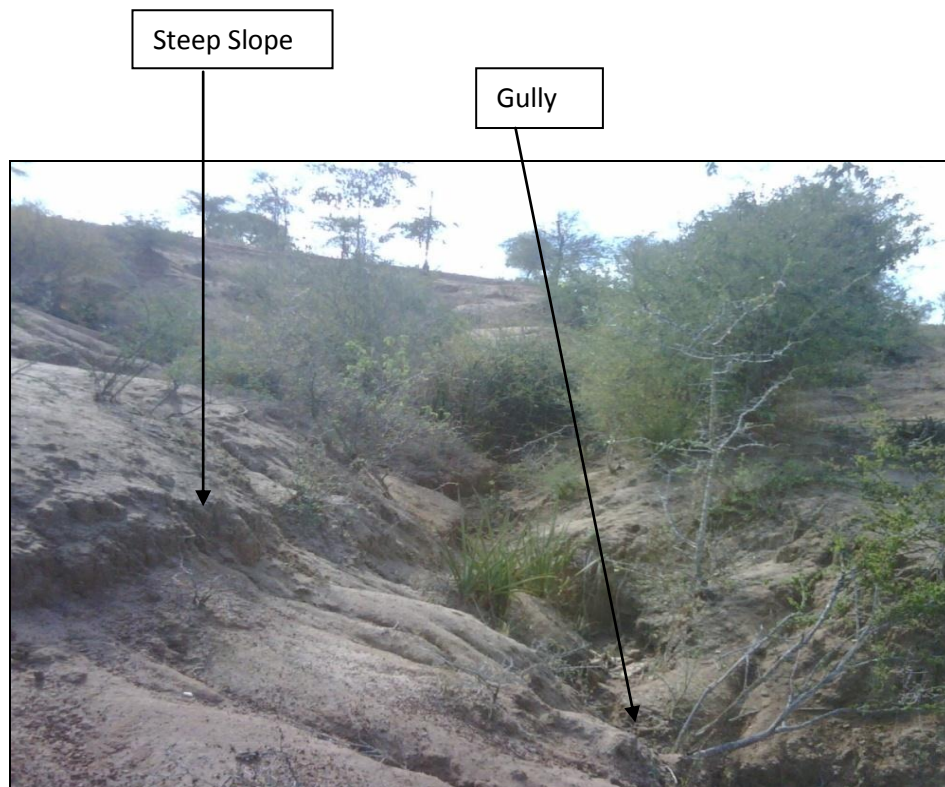
Plate 5.7: A Gully in the mature Kalikuvu Catchment

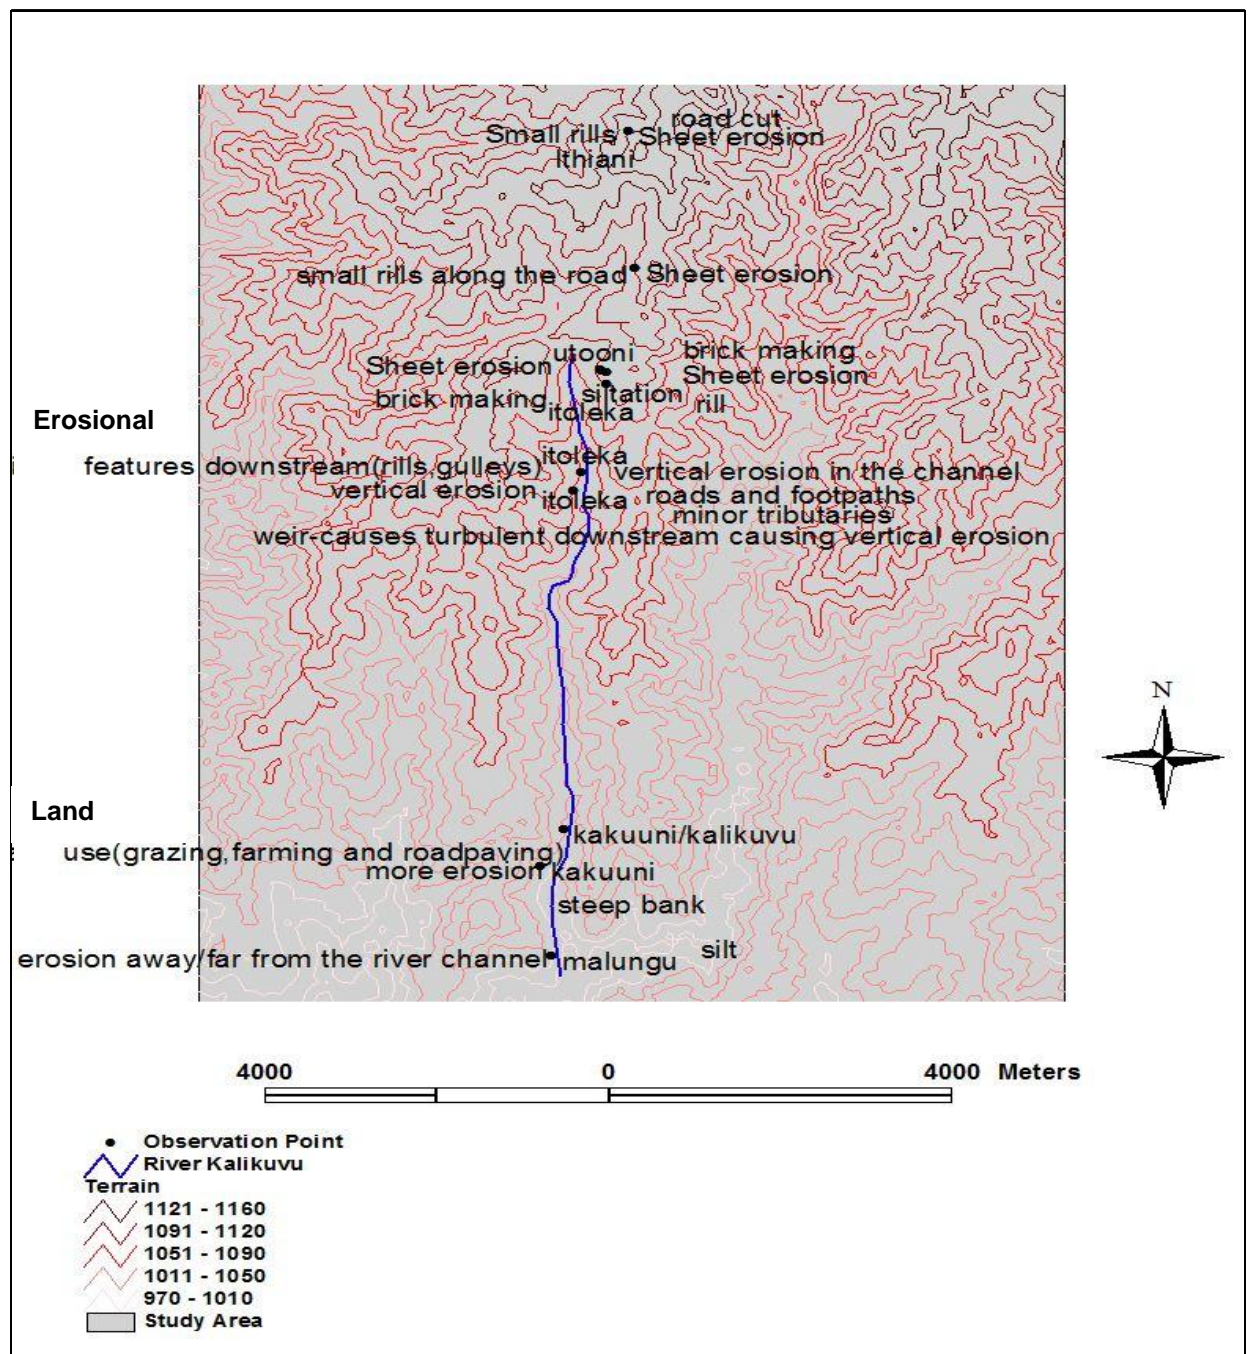
Figure 5.4: Types of Soil Erosion and Associated Landforms

There are three types of soil erosion in Kalikuvu catchment namely sheet, rill and gully erosion which has led to formation of erosional features as shown in figure 5.4.

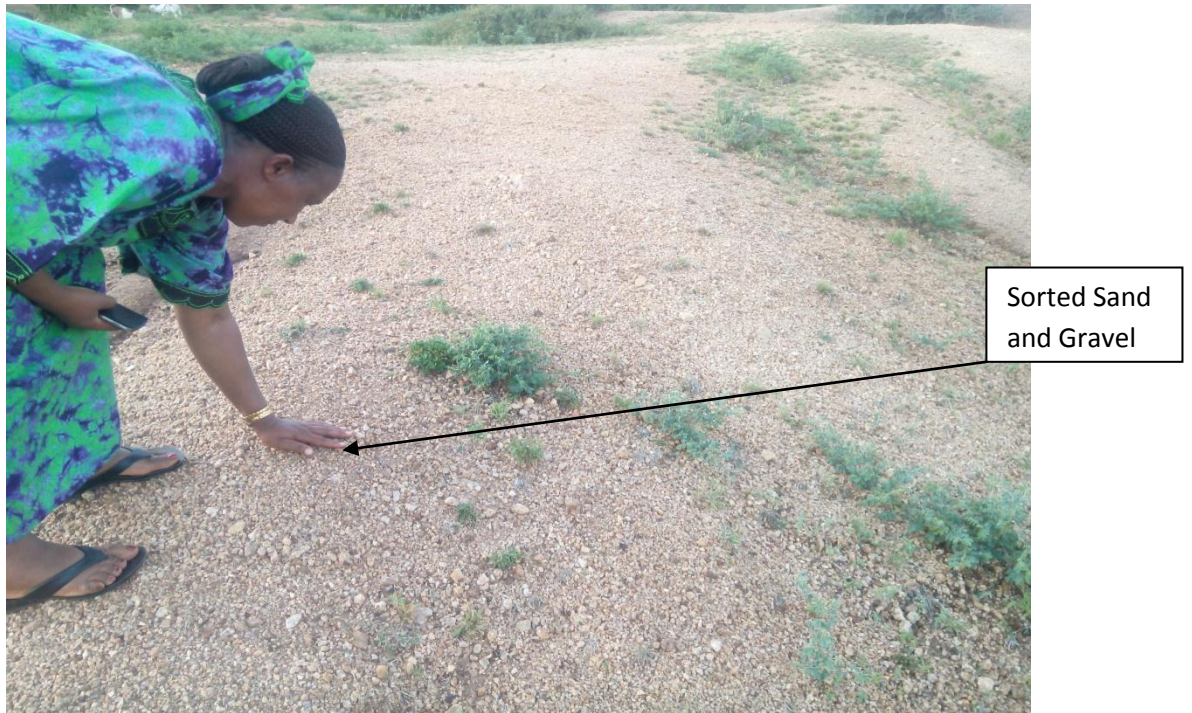
Plate 5.8: A plain with sorted sand and gravel in the mature Kalikuvu Catchment
(Source: Researcher, 2012)

Sheet erosion is caused by surface runoff, covering large area with uniform slope. Only the fine soil particles are carried away, leaving on the surface smooth and sorted sand and gravel particles as shown in plate 5.8. This is more evident on areas with scanty vegetation. Sheet erosion leads to formation of rills and mounds around plants.

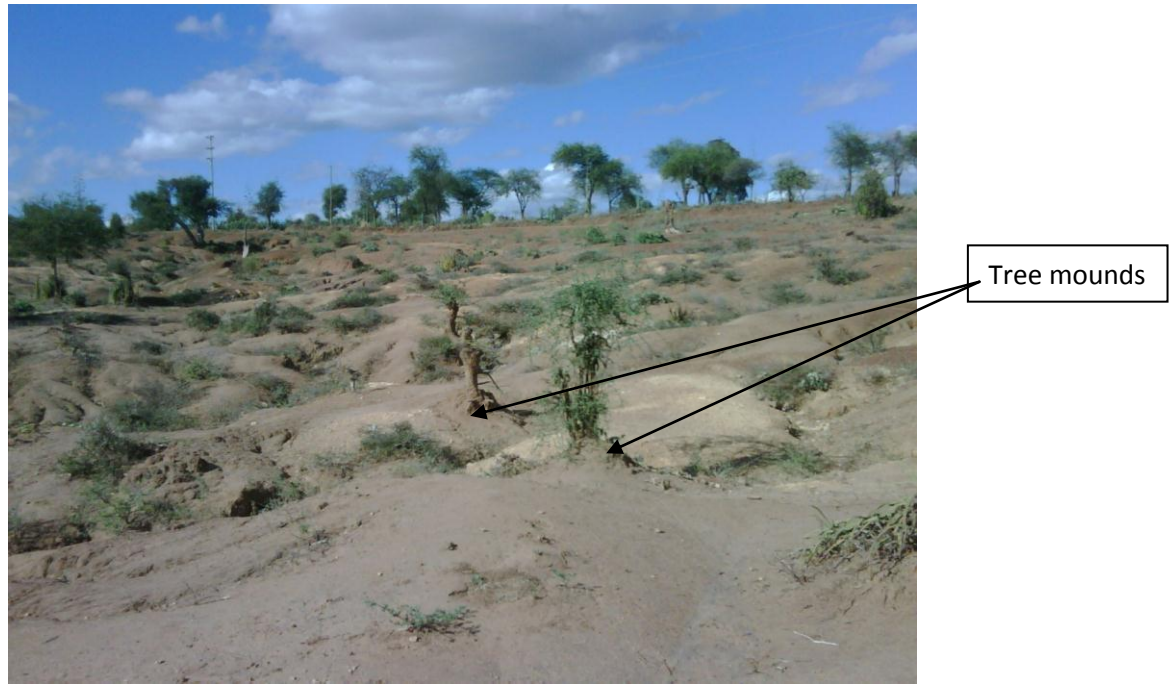
Plate 5.9: Tree mound in the mature Kalikuvu Catchment
(Source: Researcher, 2012)

Mounds were reported around *acacia* trees and scattered vegetation such as scrubs and shrubs in Malungu village these are typical vegetation types in arid and semi-arid environments. Mounds around trees are known sometimes to grow at about 10mm/year and can be used to measure the rate of sheet erosion as shown in plate 5.9. where they measured about 15centimetres high.

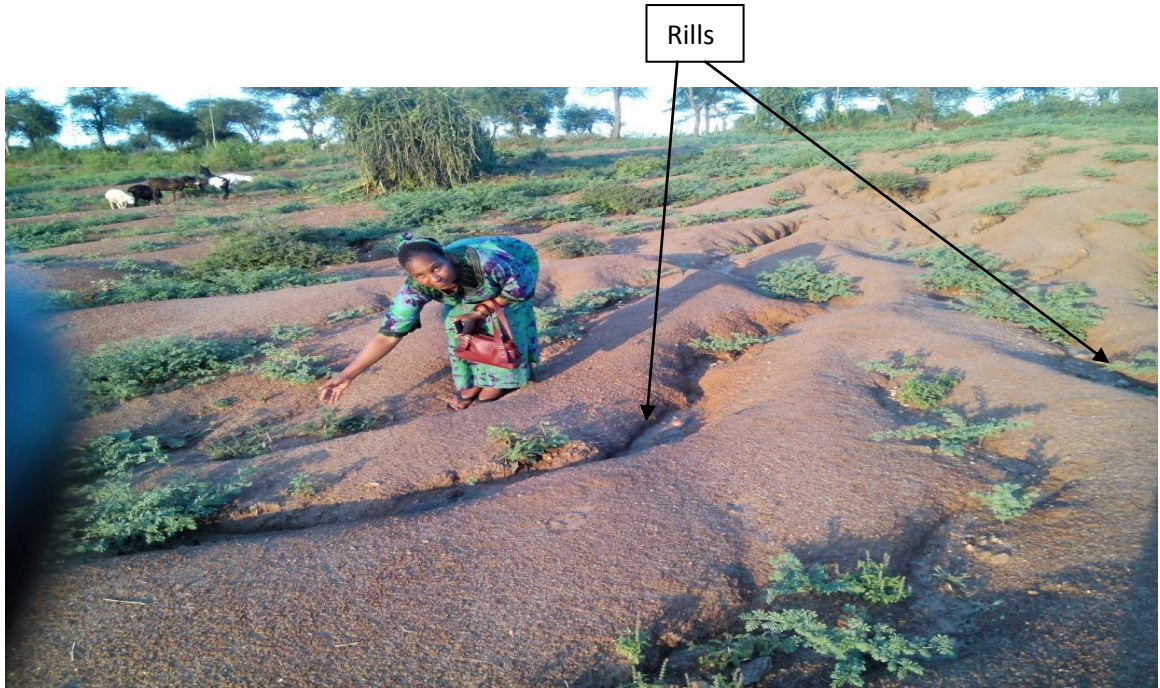
Plate 5.10: A rills in the mature Malungu Village

Rills are shallow channels eroded by threads of turbulent flow developed in the sheet flow where entrainment of soil is concentrated. On average rills had depth of about 0.5 metres and width of about 0.5 metres. During storms rills erode head ward on the steepest local gradient at cm/minute or faster. On open slopes, rills tend to form parallel to one another, converging in hillside hollows to form dendritic patterns that are ephemeral, that is, can be destroyed and recreated during major storms. Rills terminate at the base of slopes and thus are not part of the regional drainage network but they demonstrate dendritic drainage pattern. The runoff from the roads was poorly designed thus causing rill to erode the road abutment degenerating into gullies. This is illustrated in plate 5.10.

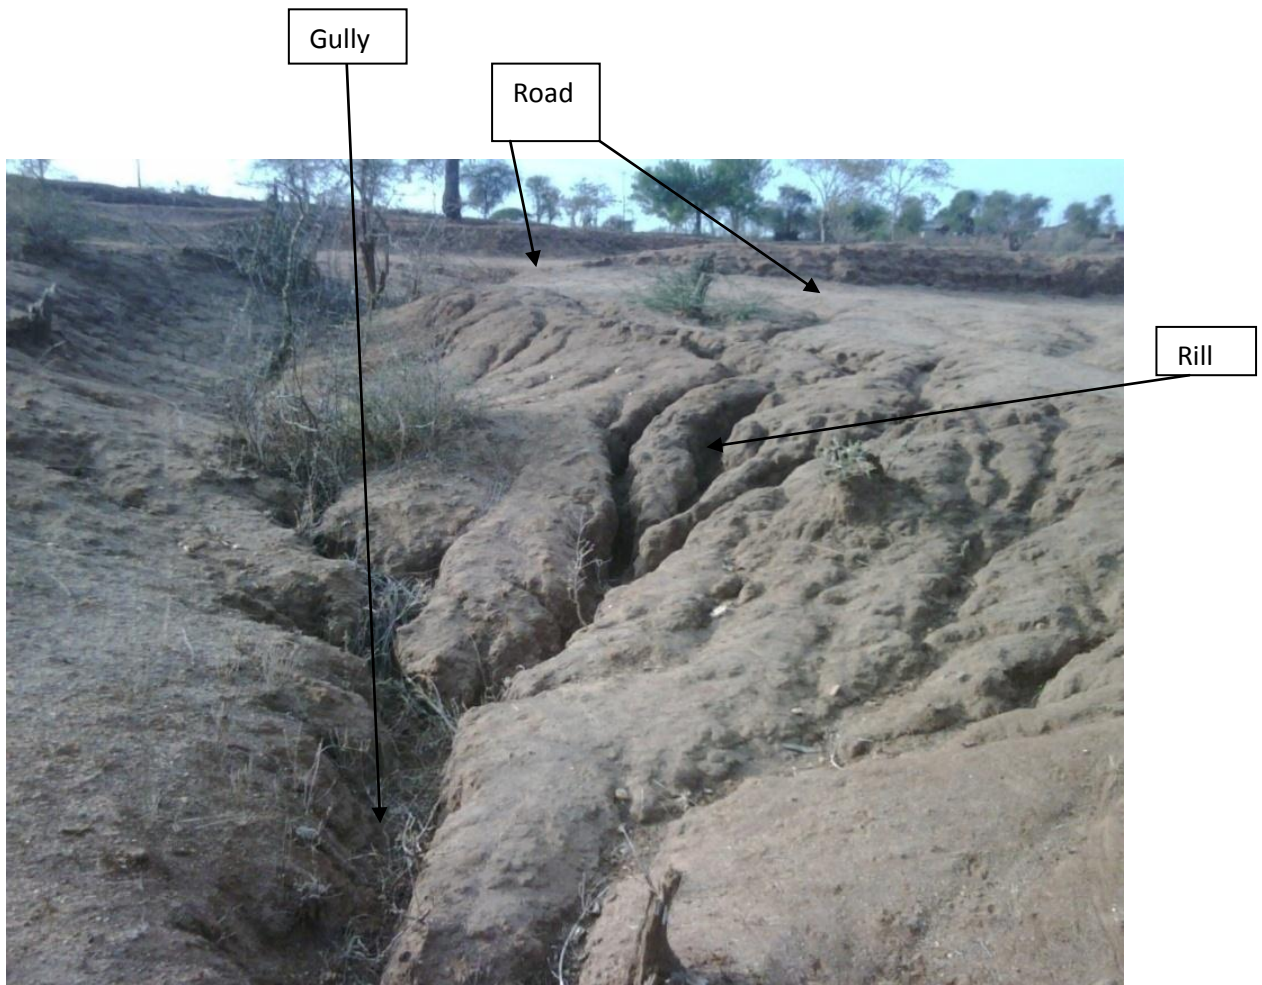
Plate 5.11: A gully in the mature Kalikuvu Catchment
 (Source: Researcher, 2012)

Gullies are the first-order stream channels that develop on slopes at the upper reaches of watersheds. They carry ephemeral stream flow. Narrow and deep sides, the depth and width persist for years or decades, so more persistent than rills but still not "permanent" landforms. Gullies had average measurements of depth about 2.5 metres and width about 2.0 metres. Farm machinery can pass through rills but not gullies. The backward eroding gully shows an abrupt initiation, generally appearing like a hole that quickly collapses. The head cut is discontinuous and the gully flow appears to be relatively flat. The rills soon coalesce to form a wider gully. The gully network is dendritic in character. Road cutting has led to formation of Rills which in turn have formed gullies in the mature catchment of Kalikuvu Village as shown in plate 5.11.

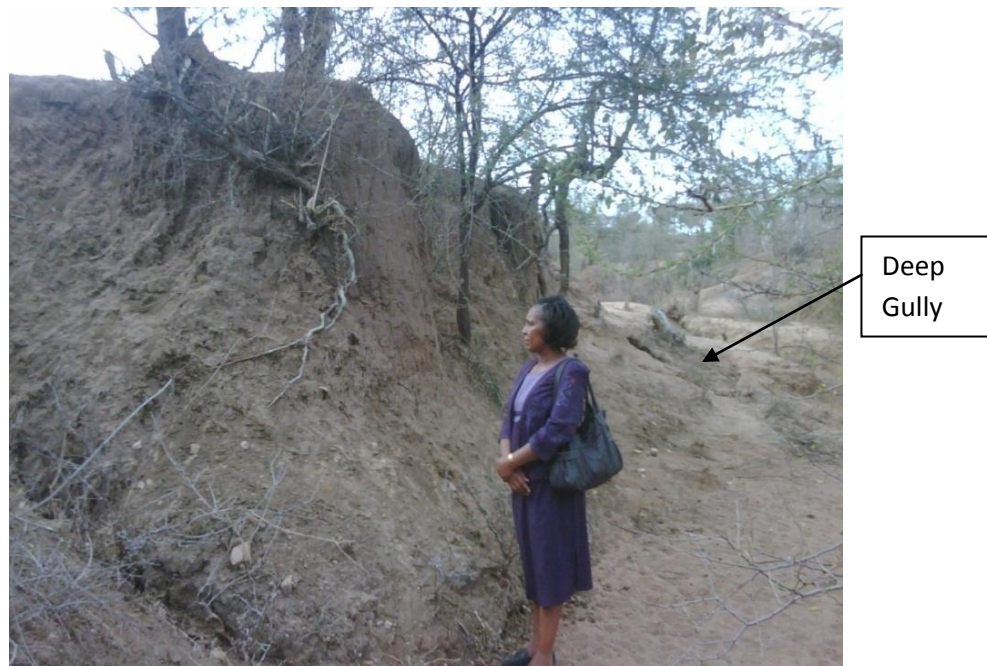
Plate 5.15: A wide and deep gully in the mature Kalikuvu Catchment
(Source: Researcher, 2012)

The depth of the weathered surface reflects how deep such a gully will be able to erode. Several gullies within the catchment, mainly the mature stage have been deepened by vertical to a depth of about 4 metres and widened to a width of about 9 to 10 metres as shown in plate 5.15.

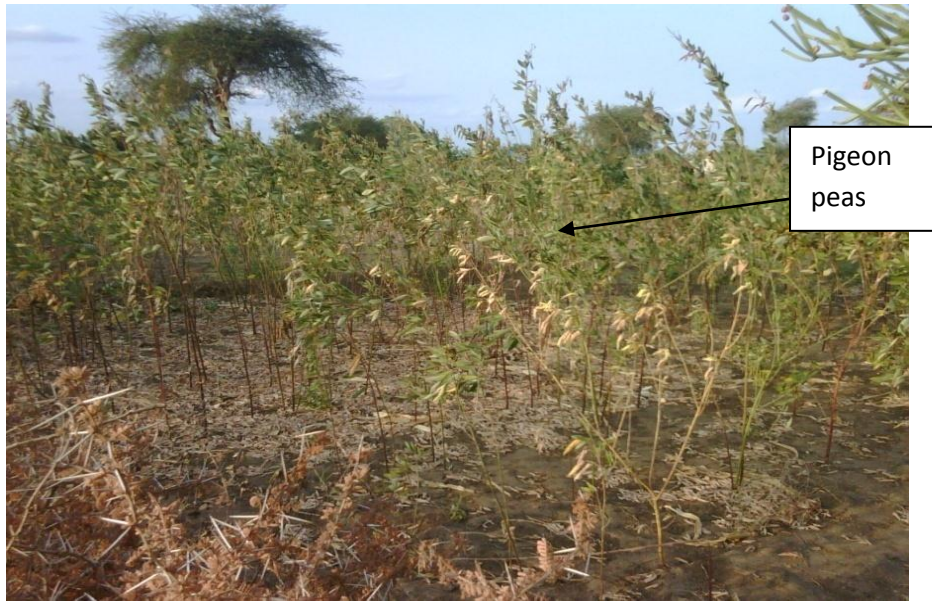
Plate 5.16: Pigeon peas in the mature Kalikuvu Catchment
(Source: Researcher, 2012).

The plate above demonstrates that sheet erosion is very rampant in spite of contour ploughing. The farmers adopted contour ploughing because they are aware of the ramification of the steep slopes and pigeon peas are planted as annual crops to control wind erosion during the June-August dry season, but they expose the soil to sheet erosion during the first rains of March.

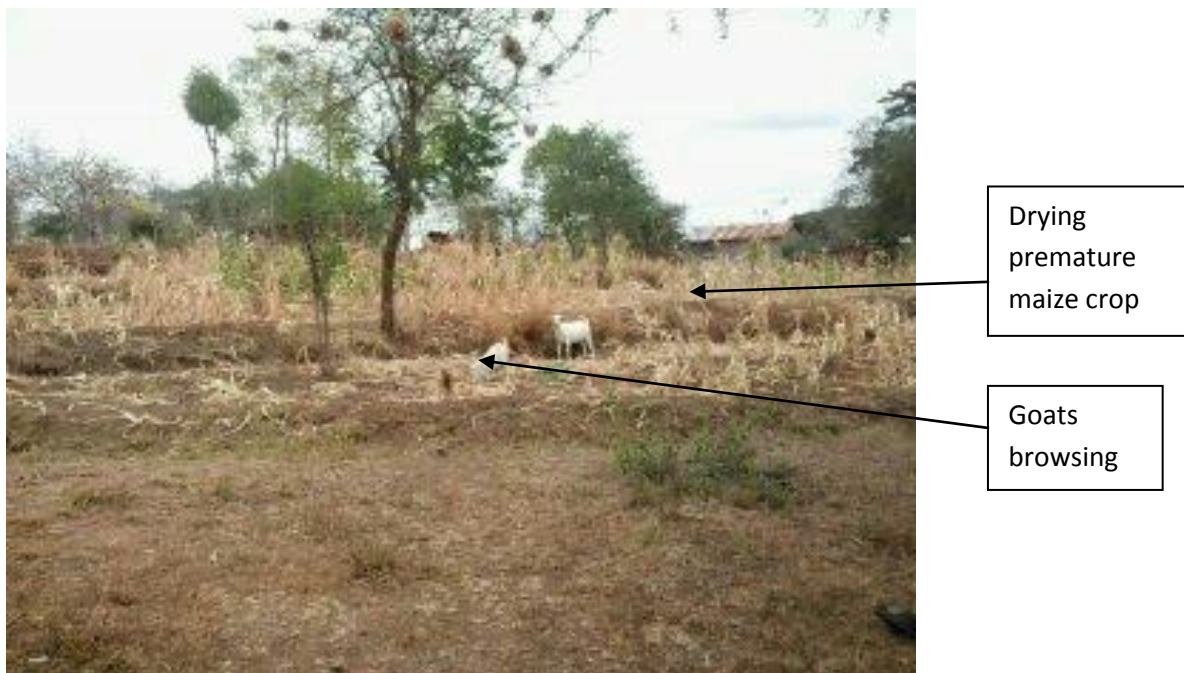
Plate 5.17: Maize crop, drying prematurely on the farm due to lack of enough rainfall
(Source: Researcher, 2012).

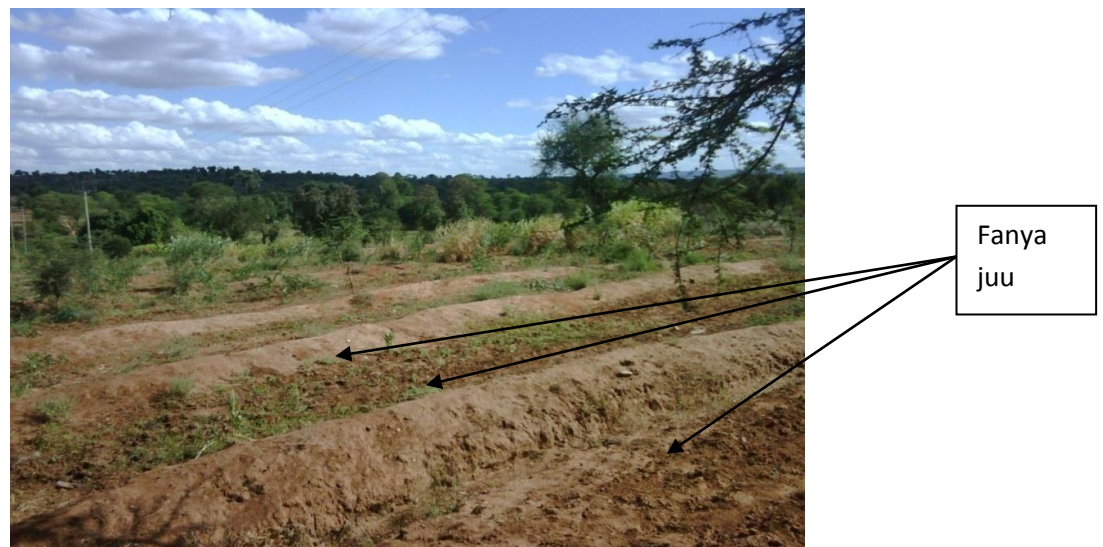
Plate 5.20: Terraces used to conserve soil in old Kalikuvu sub-location

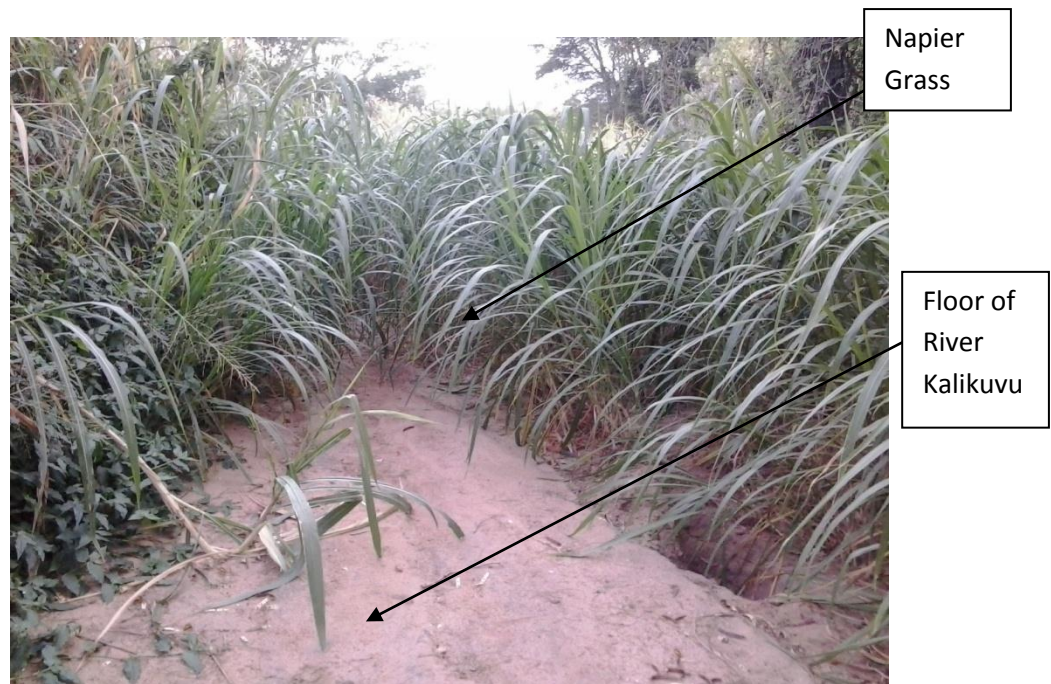
Plate 5.23: *Napier grass along the old River Kalikuvu.*

The respondents indicated that, planting of vegetation along the river channel controls water velocity which in turn reduces the rate of soil erosion within the catchment. This conforms to work done by Mati (2000) and Muhia (2000). Napier grass was cited along the Kalikuvu channel at the old stage. Preserving river banks is able to reduce bank erosion as shown in plate 5.23.

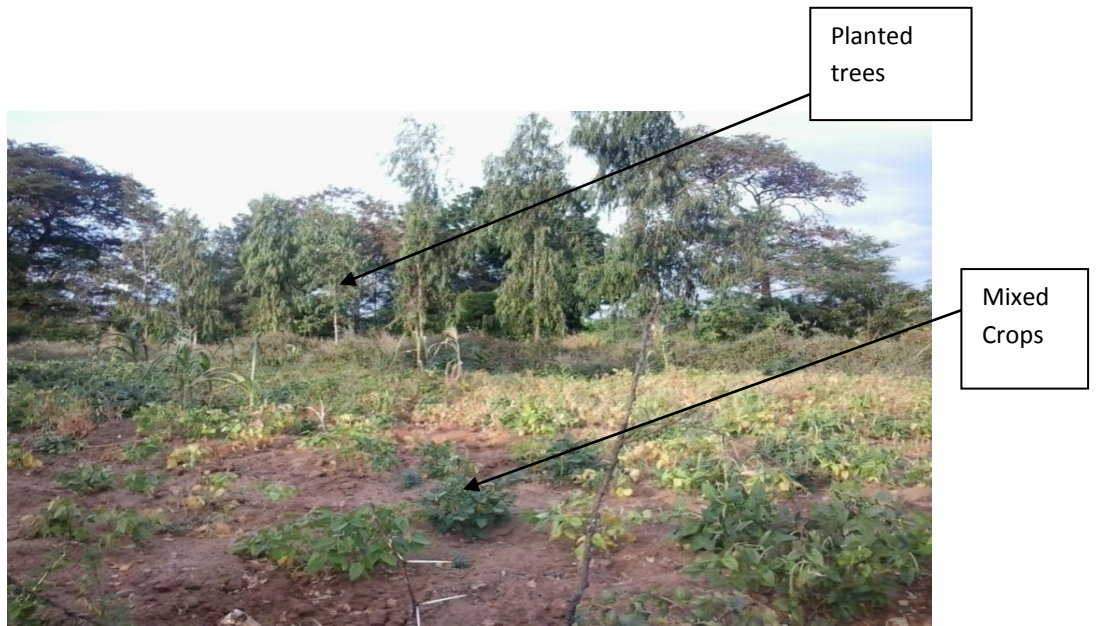
Plate 5.24: *Trees planted at the edge of the farm and mixed farming at the old Kalikuvu*
(Source: Researcher, 2012)

This is the process of planting many trees on an area of land. A total of 15% of the respondents indicated that afforestation is practised in the catchment; this conformed to field observation and researches by ICRAF (2004). Trees were evident at the edge of the farm to control sheet erosion in the farm. Mixed farming is practised and maize and cowpeas were planted in the same farm as shown in plate 5.24. This was observed to be common in all areas sampled.
