**PERFORMANCE OF LOW VOLUME SEALED ROAD PAVEMENTS: A  
CASE STUDY OF ROADS 2000 STRATEGY IN CENTRAL KENYA**

*A Thesis Submitted in Partial Fulfilment for the Award of the Doctor of Philosophy in Civil  
Engineering, Department of Civil and Construction Engineering, University of Nairobi.*

**July 2024**

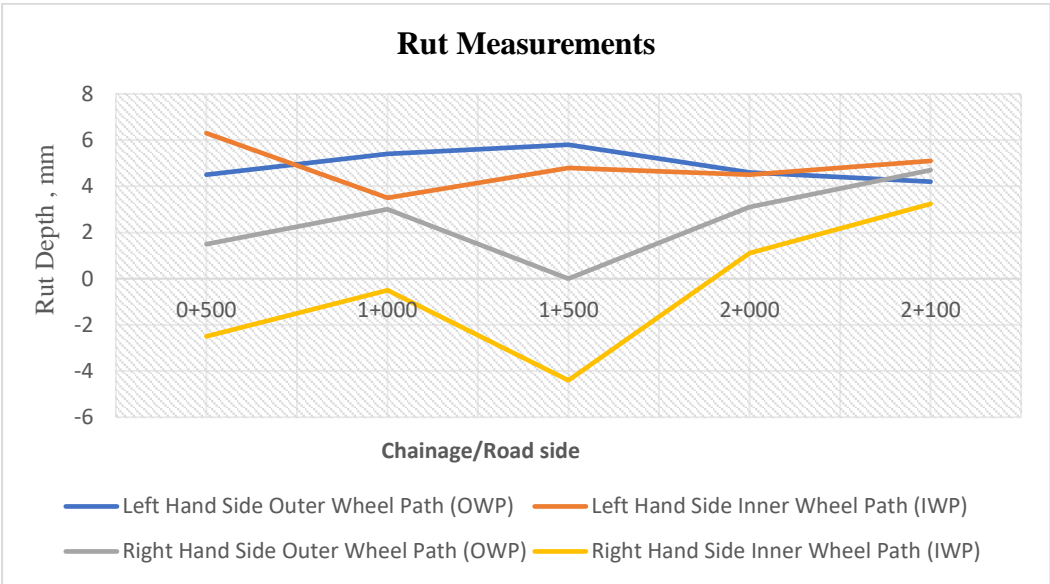
**Figure 4.4:** Representation of rut measurements along the road

Table 4.3 shows the average rut depths for both road sides measured on the road. The average rut depths for the left-hand side and right-hand side were rated at Very Good. Figure 4.4 gives a graphical representation of the rut measurements.

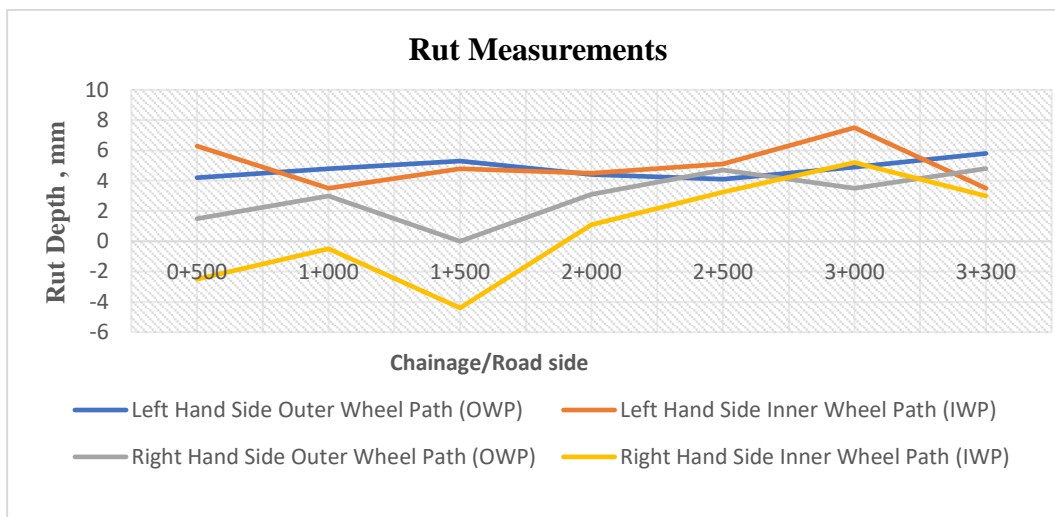
**Figure 4.5:** Representation of rut measurements along the road

Table 4.9 shows the average rut depths for both road sides measured on the road. The average rutting depth for the left-hand side and the right-hand side are generally rated at Very Good. Figure 4.5 gives a graphical representation of the rut measurements.

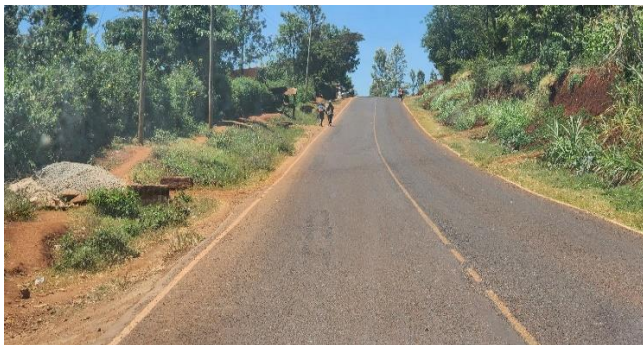
(a) Section showing the finished smooth surface. The drainage system was however not well defined (Author, 2023).

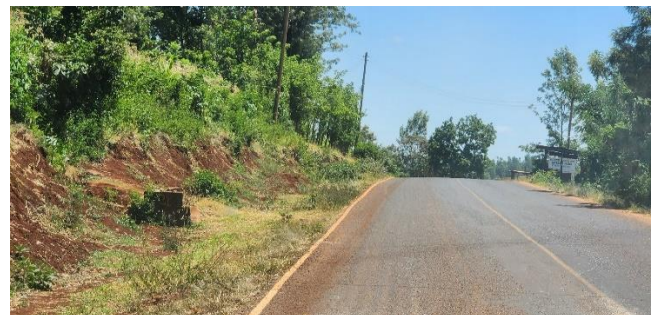
(d) Section showing unprotected slopes prone to erosion, leading to siltation of the drains and culverts (Author, 2023).

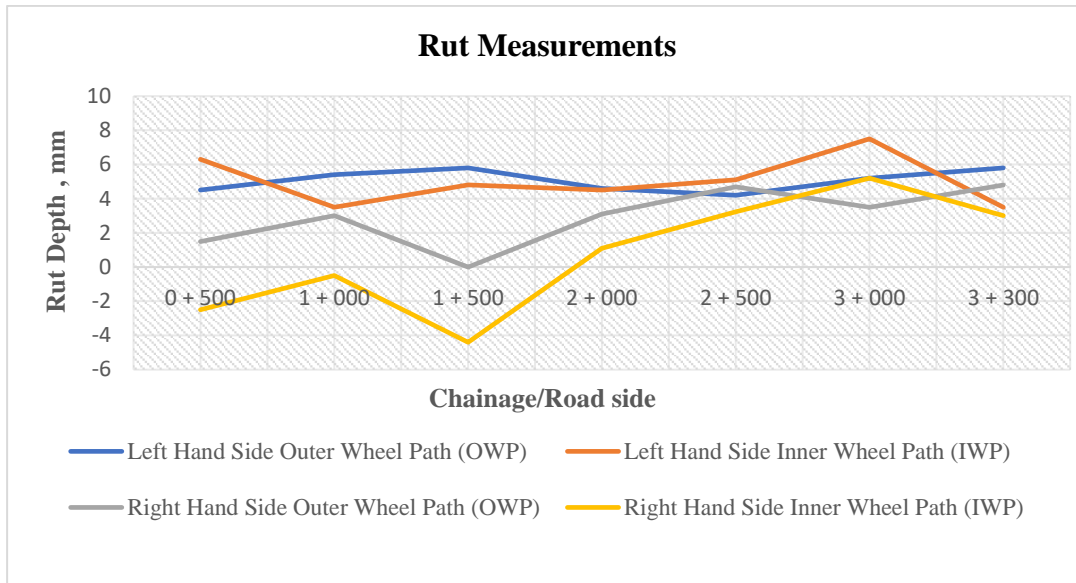
**Figure 4.10:** Representation of rut measurements along the road

Table 4.13 shows the average rut depths for both road sides measured on the road. The average rut depths for the left-hand side and right-hand side are generally rated at Good and Very Good respectively. Figure 4.10 gives a graphical representation of the rut measurements.

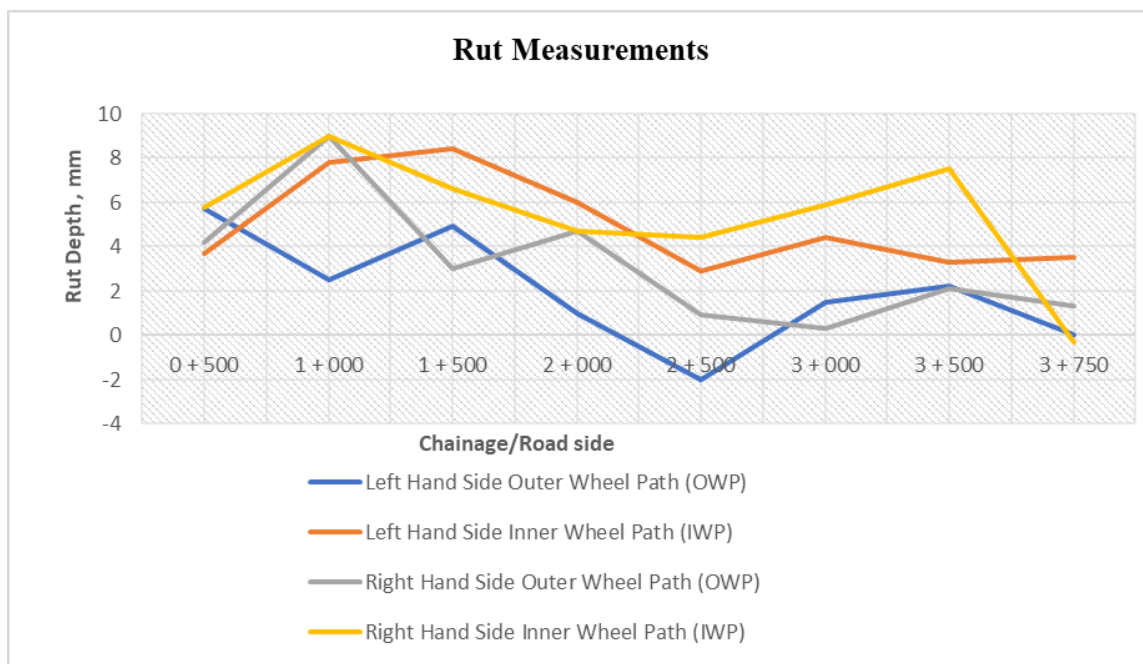
**Figure 4.14: Representation of rut measurements along the road**

Table 4.19 shows the average rut depths for both road sides measured on the road. The mean rutting depths for the left-hand side and the right-hand side are generally rated at Good to Very Good. Figure 4.14 gives a graphical representation of the rut measurements.

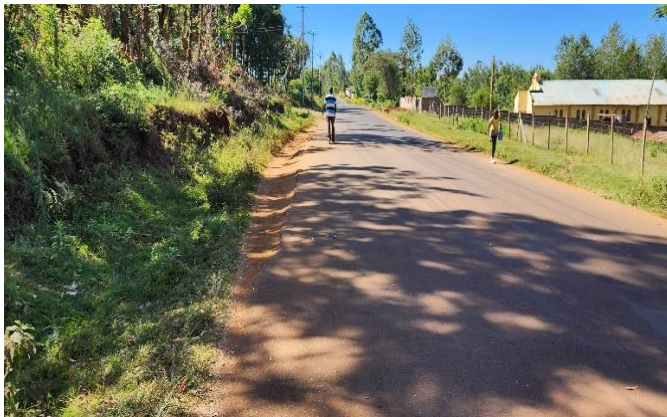
(a) Road start showing signs of edge subsidence, but the surfacing still intact (Author, 2023).

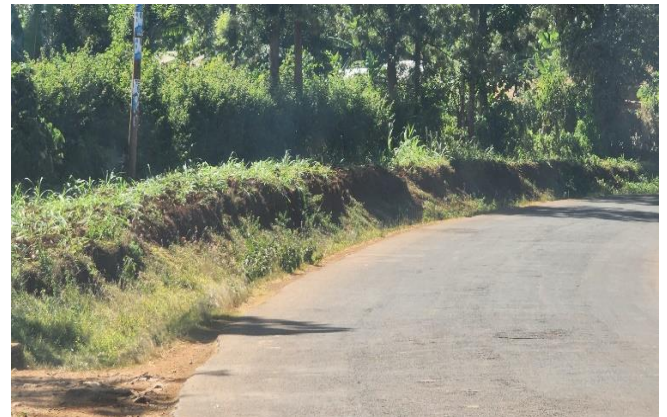
(b) Section showing the erodibility potential of the embankment slopes (Author, 2023)

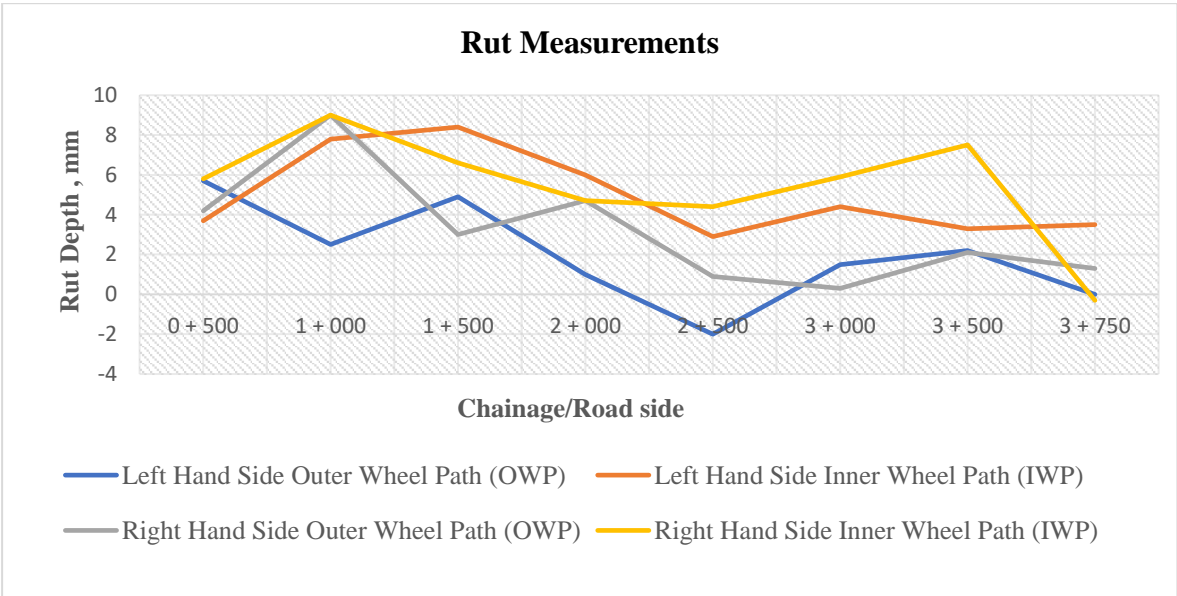
**Figure 4.15:** Representation of rut measurements along the road

Table 4.25 shows the average rut depths for both road sides measured on the road. The average rut depths for the left-hand side and right-hand side are generally rated at Very Good to Good. Figure 4.15 gives a graphical representation of the rut measurements.

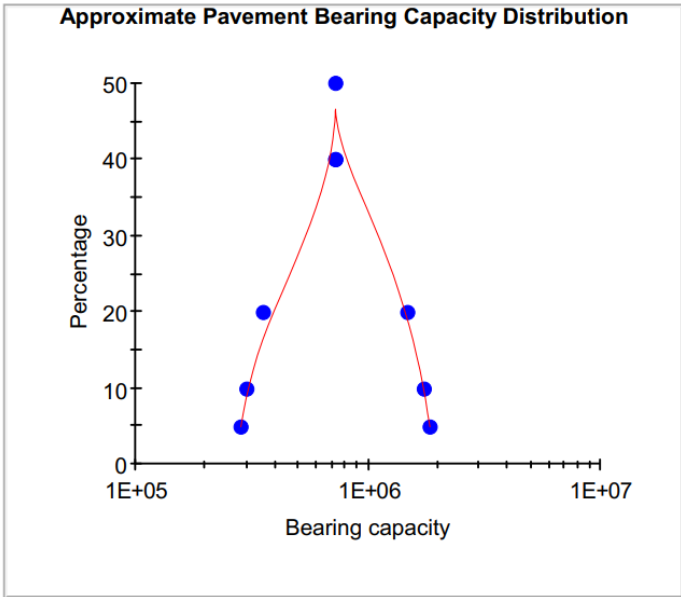
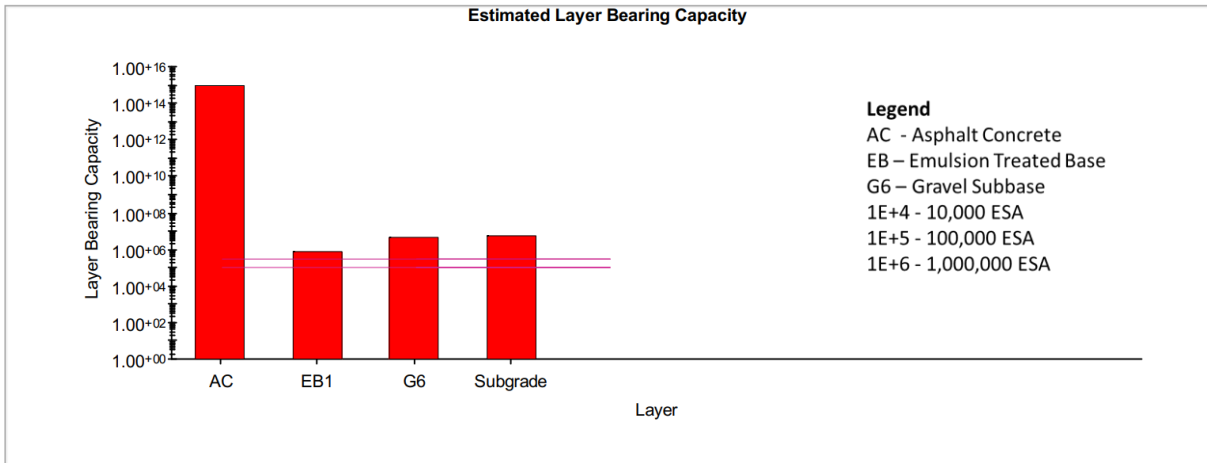
**Figure 4.17:** Approximate Pavement Bearing Capacity Distribution

A mechanistic-empirical modelling of the pavement, as shown in Appendix H and summarised in Figures 4.17 and 4.18, showed that the layer bearing capacity distributions were within the capacities required for low volume roads, that is one million standard equivalent axles, based on the estimated traffic for the 15-year period, and that the pavement was able to support the existing traffic adequately. The estimated layer bearing capacities were also found to be adequate to support the current loading.

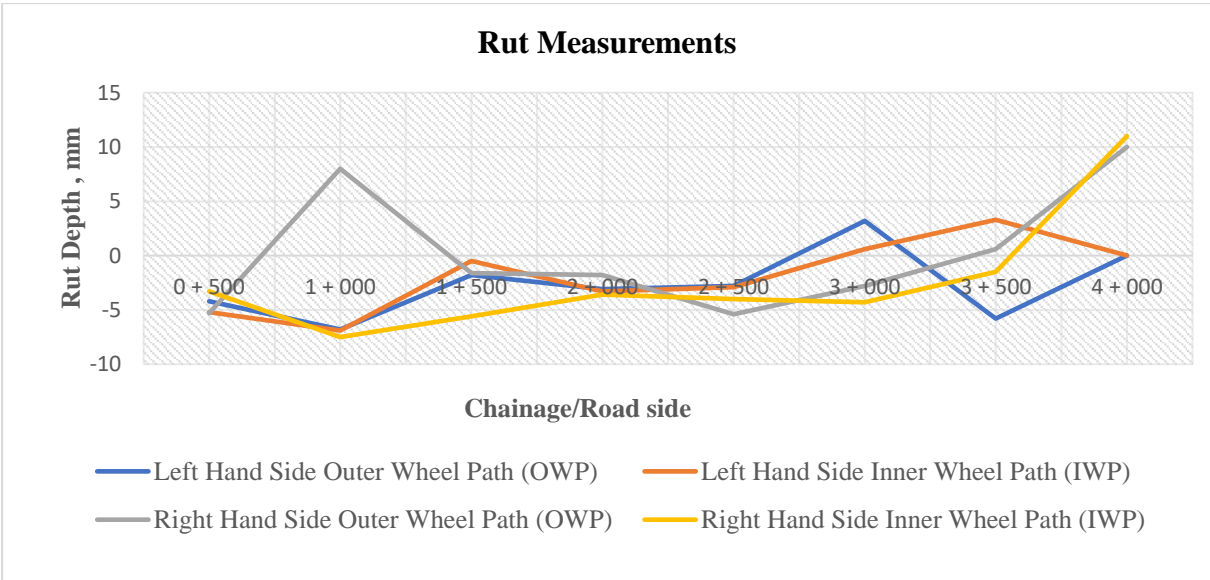
**Figure 4.19:** Representation of rut measurements along the road

Table 4.36 shows the average rut depths for both road sides measured on the road. The average rut depth for both directions is rated very good for both wheel paths in both directions. Figure 4.19 gives a graphical representation of the rut measurements.

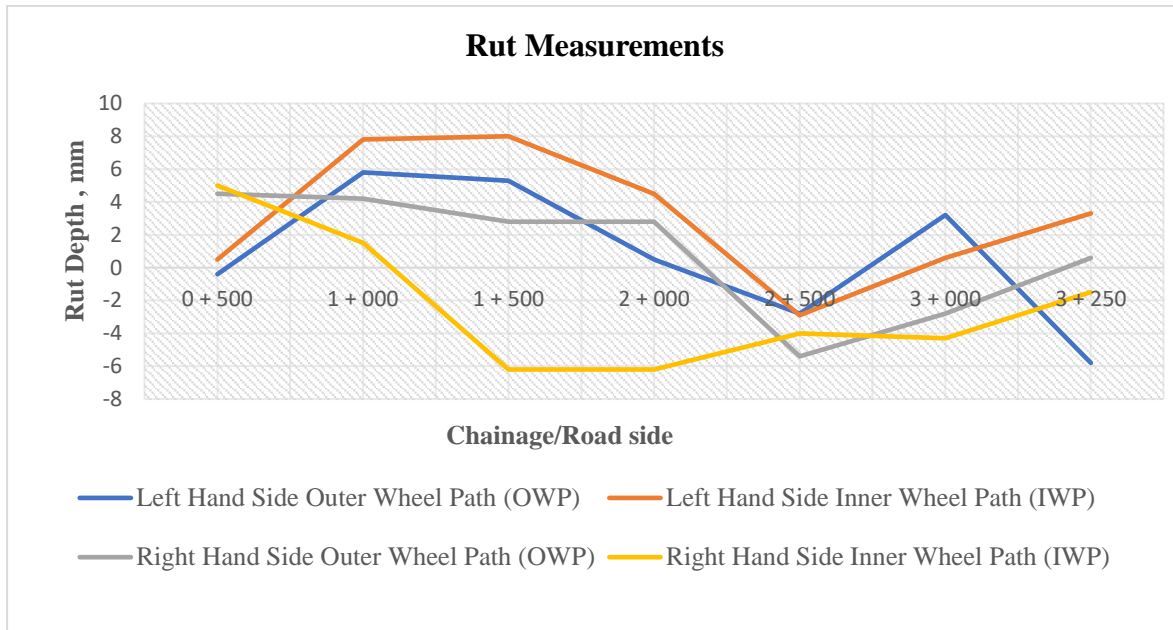
**Figure 4.20:** Representation of rut measurements along the road

Table 4.42 shows the average rut depths for both road sides measured on the road. The average rut depth for both directions is rated very good for both wheel paths in both directions. Figure 4.20 gives a graphical representation of the rut measurements.

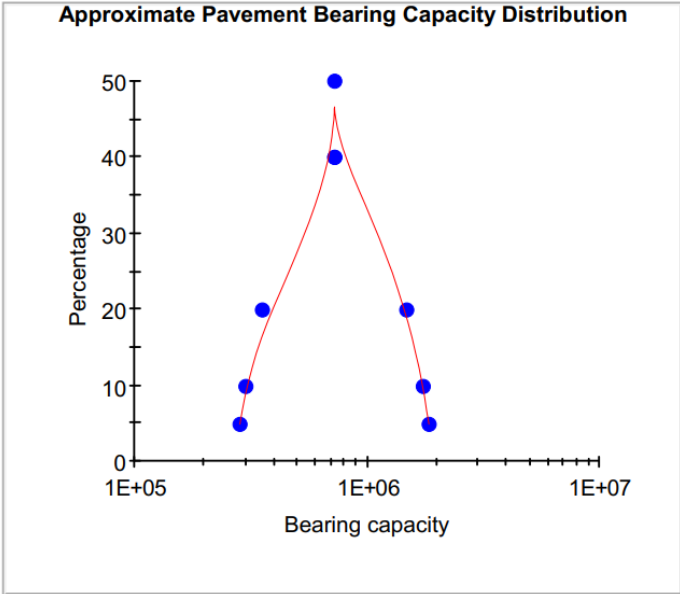
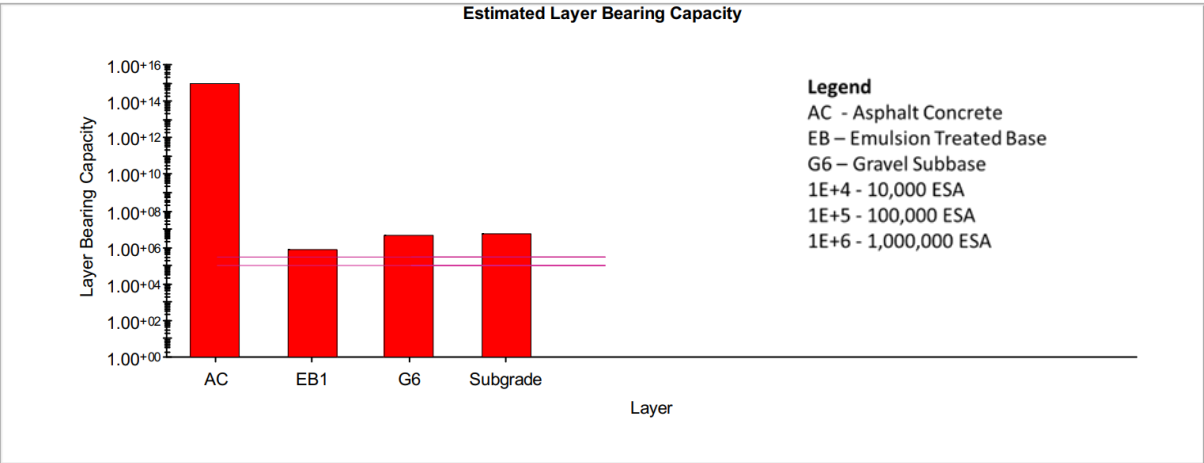
Figure 4.22: Approximate Pavement Bearing Capacity Distribution

A mechanistic-empirical modelling of the pavement, as shown in Appendix H and summarised in Figures 4.22 and 4.23, showed that the layer bearing capacity distributions were within the capacities required for low volume roads, that is one million standard equivalent axles, based on the estimated traffic for the 15-year period, and that the pavement was able to support the existing traffic adequately. The estimated layer bearing capacities were also found to be adequate to support the current loading.

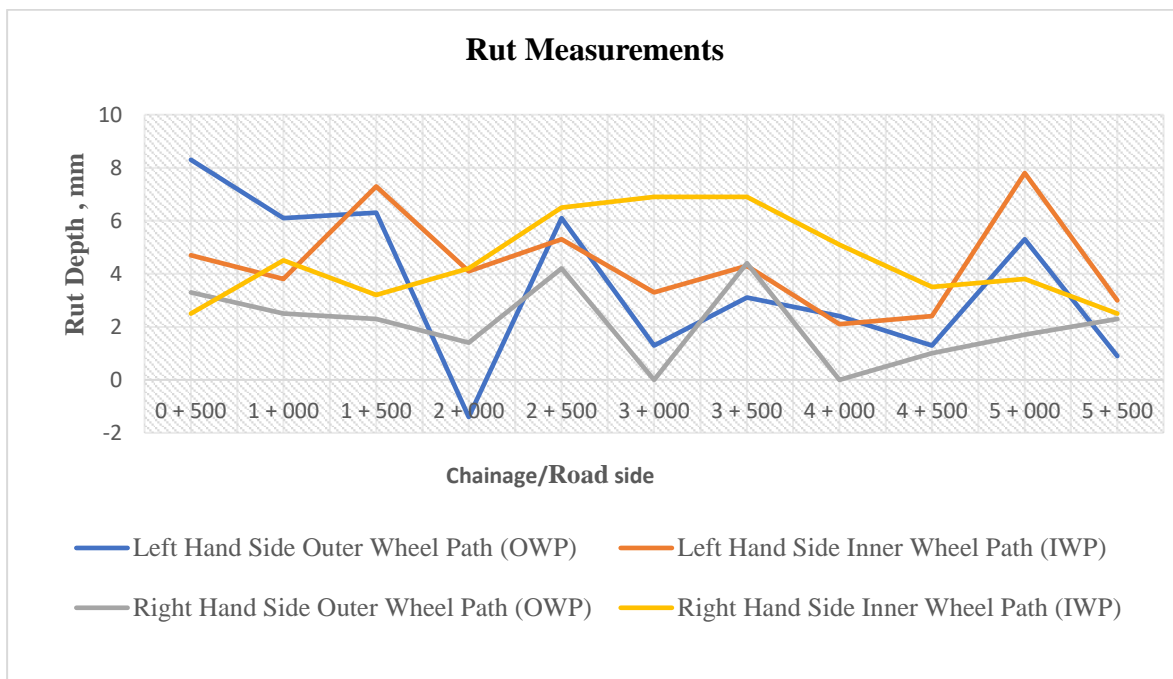
**Figure 4.24: Representation of rut measurements along the road**

Table 4.55 shows the average rut depths for both road sides measured on the road. The average rut depth for both directions is rated as very good. Figure 4.24 gives a graphical representation of the rut measurements.

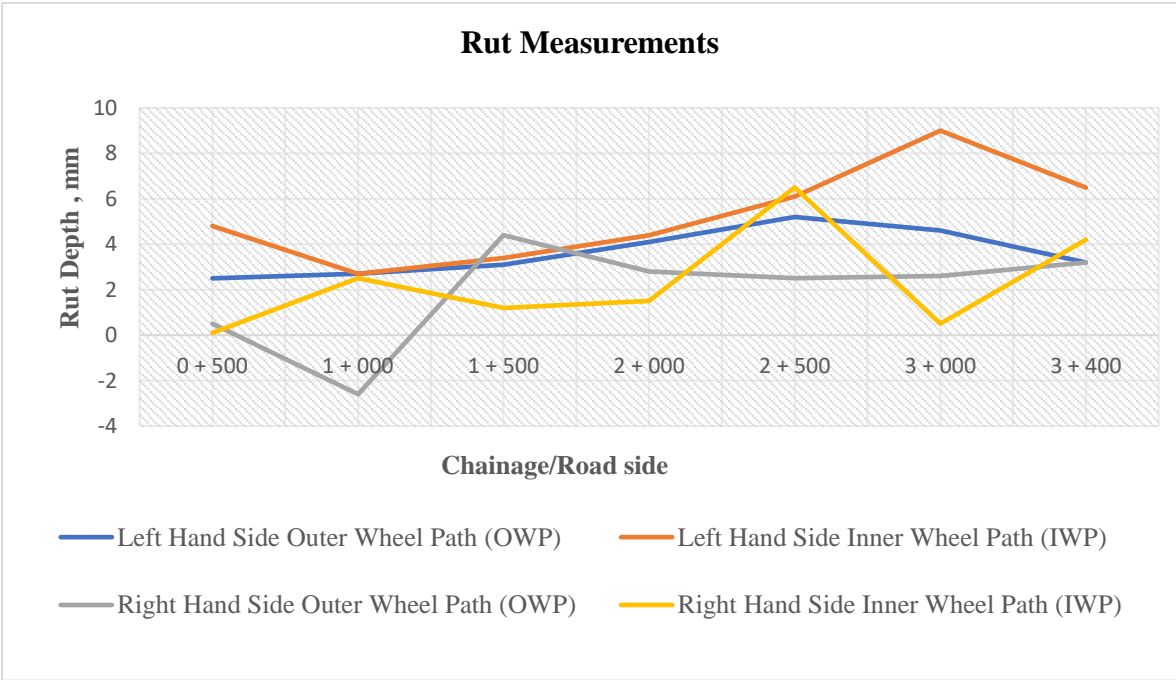
**Figure 4.25:** Representation of rut measurements along the road

Table 4.61 shows the average rut depths for both road sides measured on the road. The average rut depth for both directions is rated as very good. Figure 4.25 gives a graphical representation of the rut measurements.

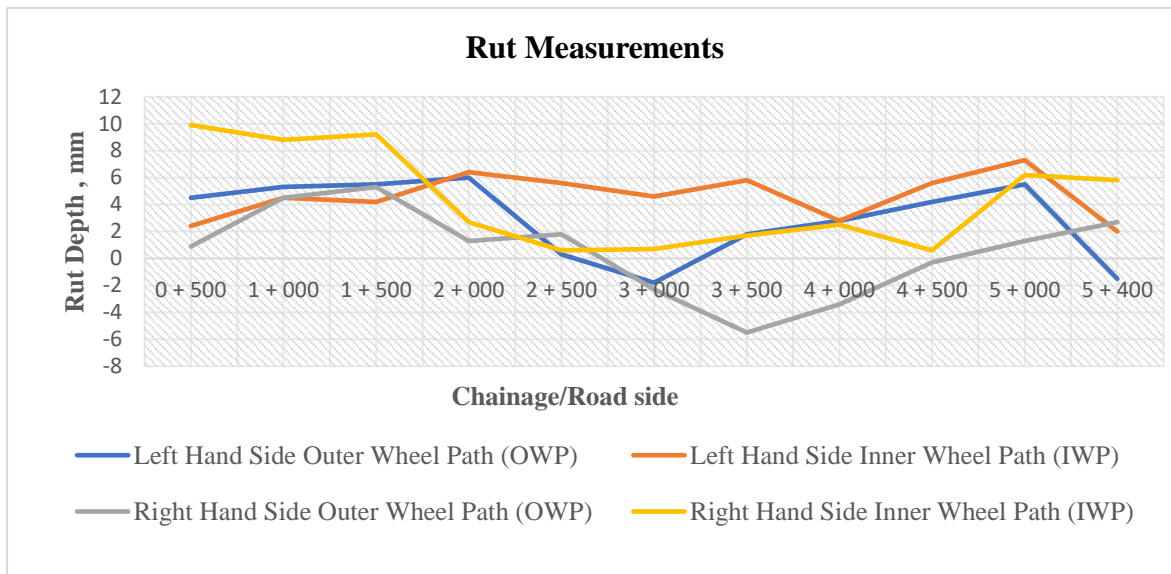
**Figure 4.26:** Representation of rut measurements along the road

Table 4.66 shows the average rut depths for both road sides measured on the road. The average rut depth for both directions is rated as very good. Figure 4.26 gives a graphical representation of the rut measurements.

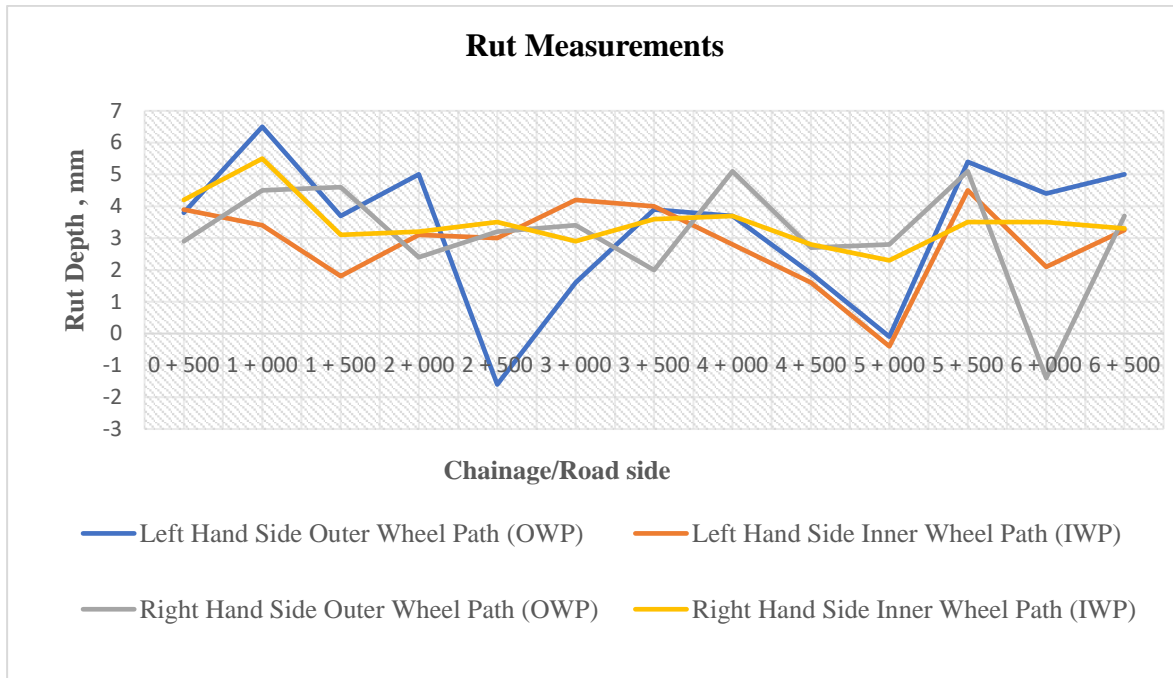
**Figure 4.27:** Representation of rut measurements along the road

Table 4.71 shows the average rut depths for both road sides measured on the road. The average rut depth for both directions is rated as very good. Figure 4.27 gives a graphical representation of the rut measurements.

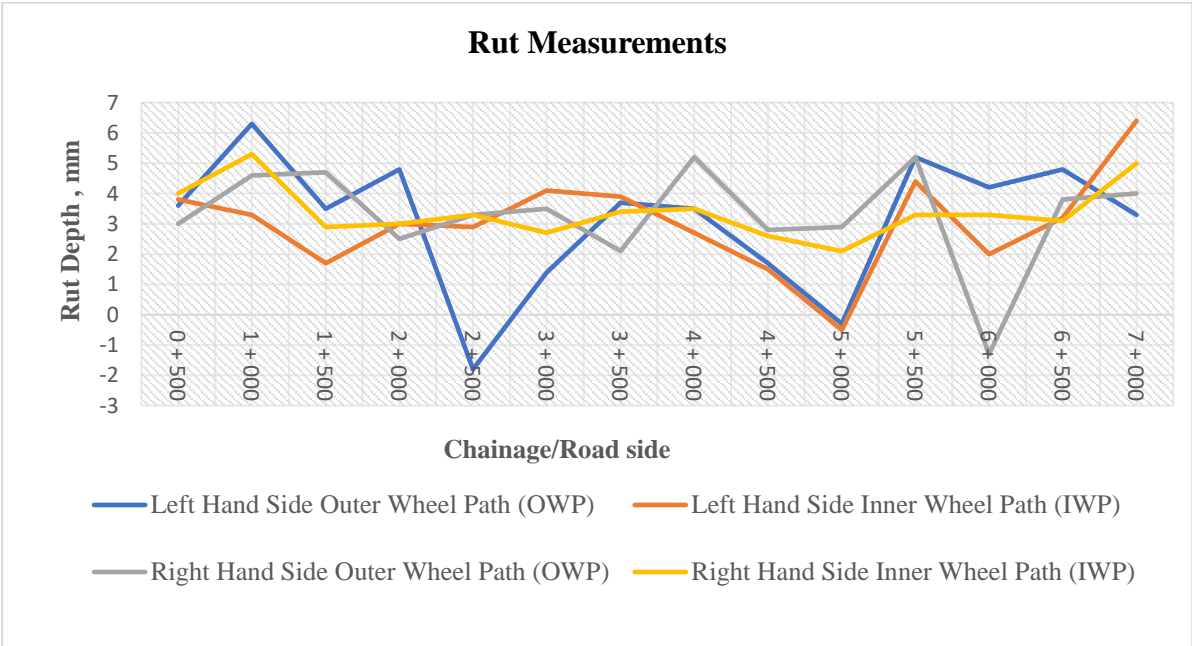
**Figure 4.28: Representation of rut measurements along the road**

Table 4.76 shows the average rut depths for both road sides measured on the road. The average rut depth for both directions is rated as very good. Figure 4.28 gives a graphical representation of the rut measurements.

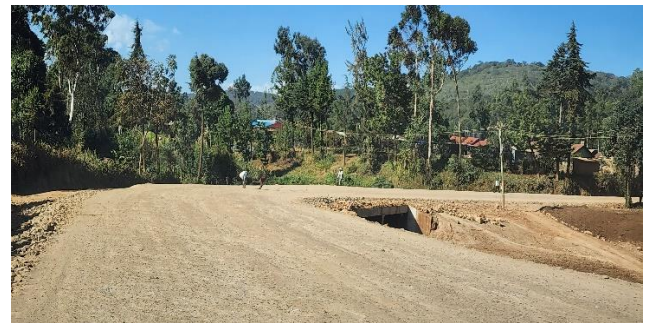
(d) Ongoing box culvert works at the road upgrading project (Author, 2023)

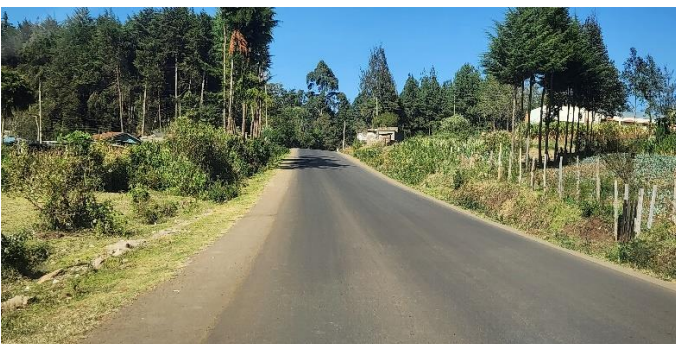
(e) Completed asphalt surfacing where upgrading works were on-going (Author, 2023)

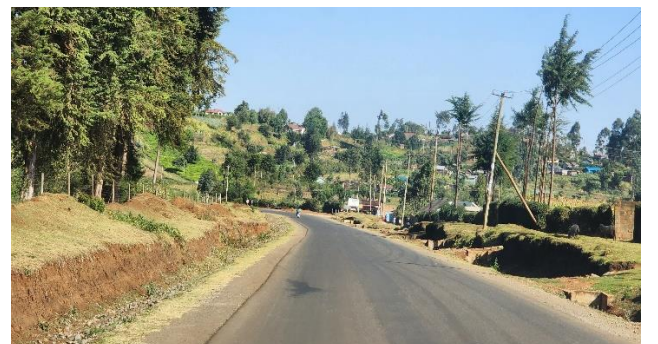
(f) Completed section of the upgrade showing erodible and unprotected embankment slopes (Author, 2023)

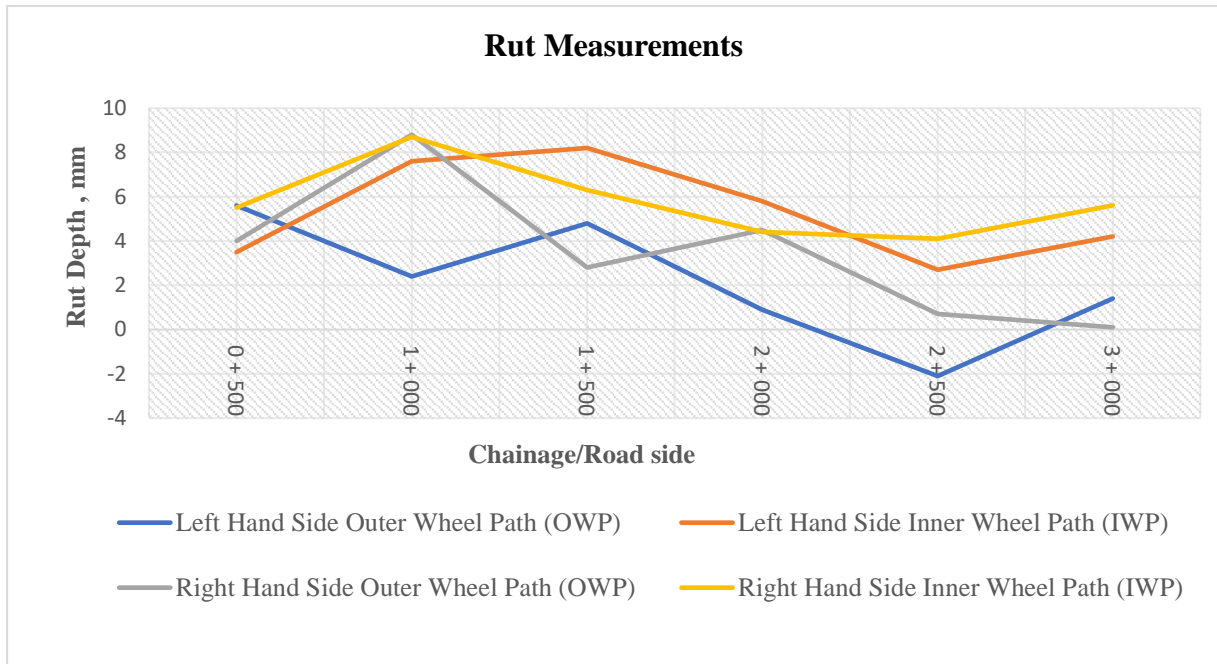
**Figure 4.29:** Representation of rut measurements along the road

Table 4.82 shows the average rut depths for both road sides measured on the road. The mean rutting depths for the left-hand side and the right-hand side are generally rated at Good to Very Good. Figure 4.29 gives a graphical representation of the rut measurements.

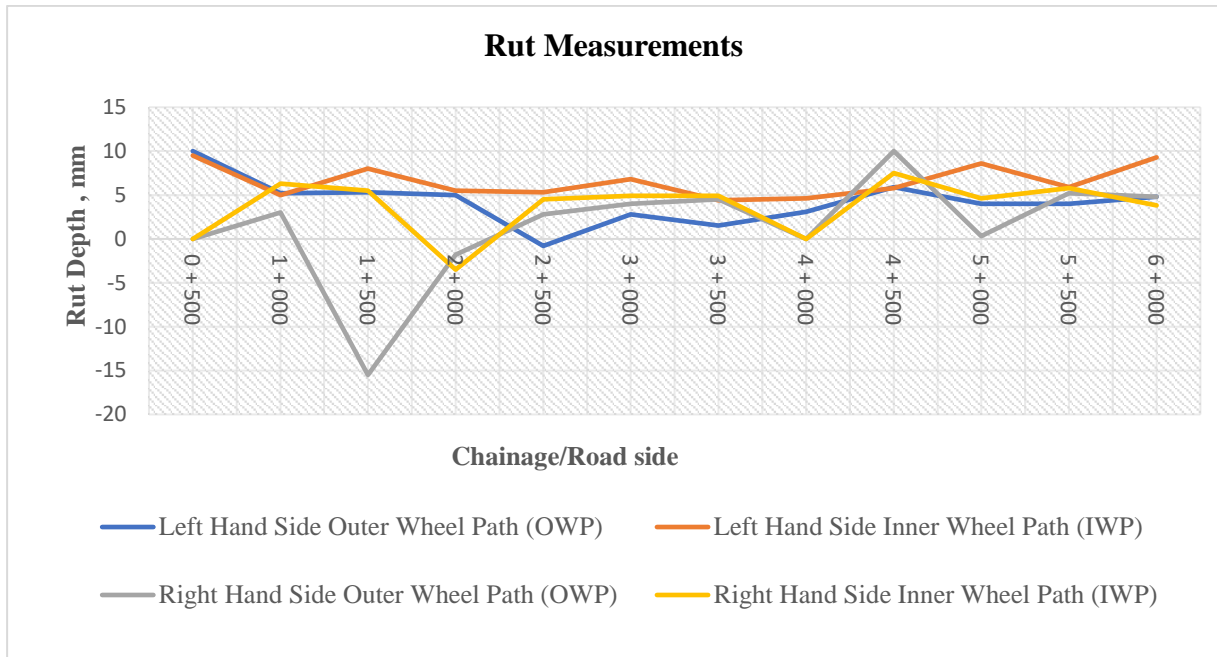
**Figure 4.30:** Representation of rut measurements along the road

Table 4.88 shows the average rut depths for both road sides measured on the road. The average rut depth for both directions is rated as very good. Figure 4.30 gives a graphical representation of the rut measurements.

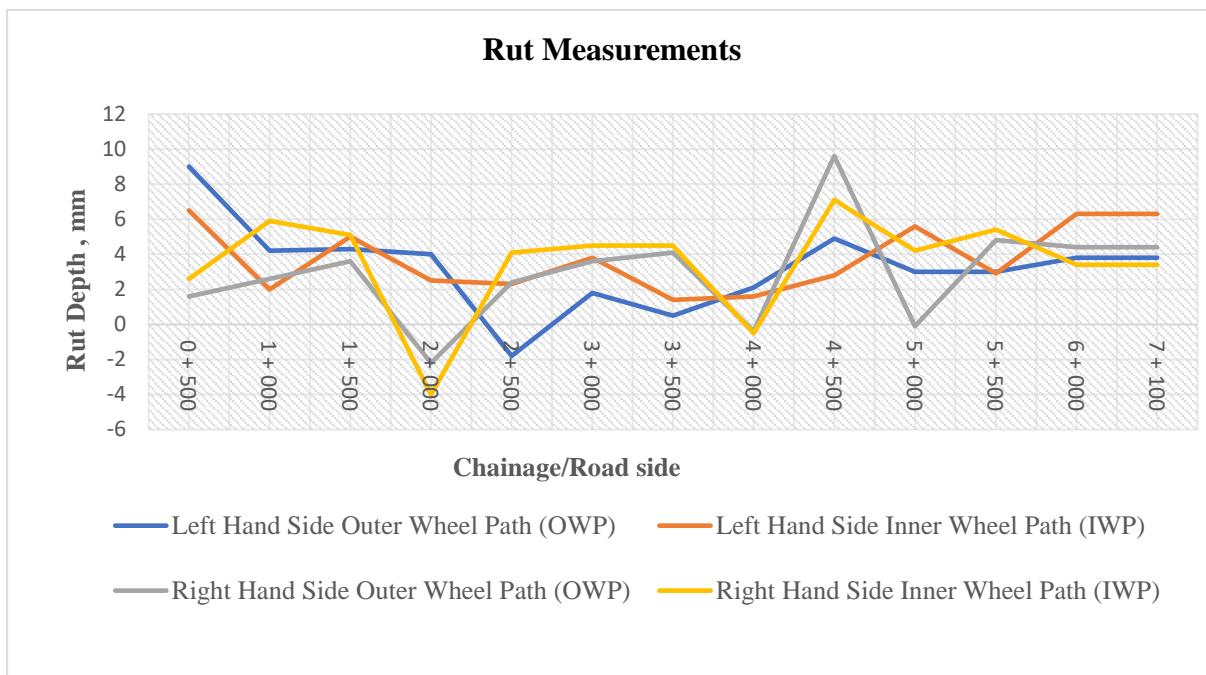
**Figure 4.31:** Representation of rut measurements along the road

Table 4.93 shows the average rut depths for both road sides measured on the road. The mean rutting depth for both directions is rated as very good. Figure 4.31 gives a graphical representation of the rut measurements.

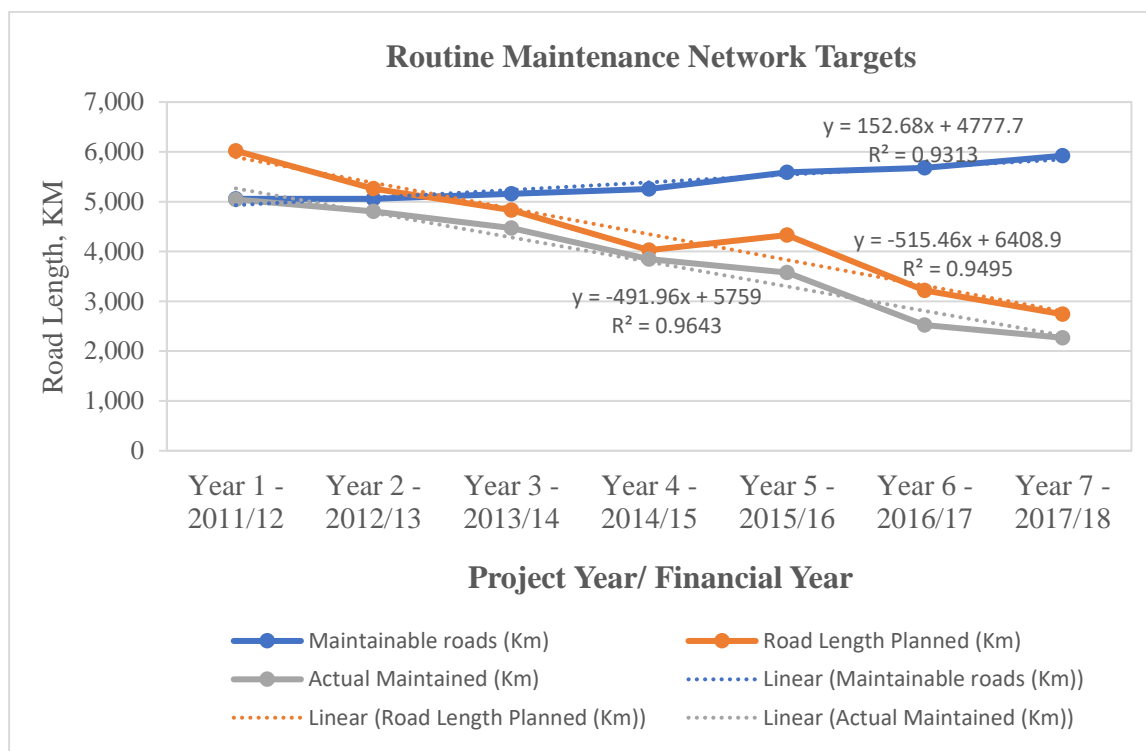
**Figure 4.32:** Comparison Between Project Maintainable Roads Target Versus Actual Maintained

It was observed that the planned and actual lengths maintained had reduced from FY 2011/12 to FY 2017/18, as also shown in Table 4.97 and Figure 4.32. It was to be noted that shortage of funds and utilisation of the available funds to undertake spot improvement works and/or open new roads were among the reasons for the decrease in road lengths maintained annually.
