TITLE: INVESTIGATION INTO CAUSES OF GULLYING AND
GULLY CONTROL IN KANDARA DIVISION OF
MURANGA DISTRICT.

AUTHOR: JOHN DAMBA, (B. SC. AGRIC., DIP. AGRIC., EDUC.)
(MAKERERE UNIVERSITY)

PROJECT REPORT SUBMITTED TO THE UNIVERSITY OF NAIROBI
IN PARTIAL FULFILLMENT OF THE REQUIREMENT FOR POST-
GRADUATE DIPLOMA IN IRRIGATION AND SOIL CONSERVATION

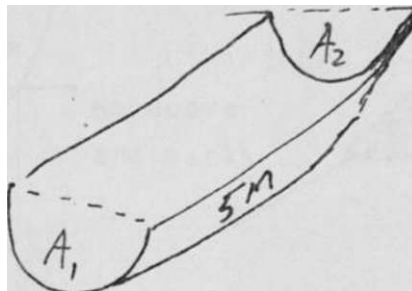
Fig. 3

Areas of two cross-sections 5M apart were calculated and their average taken.

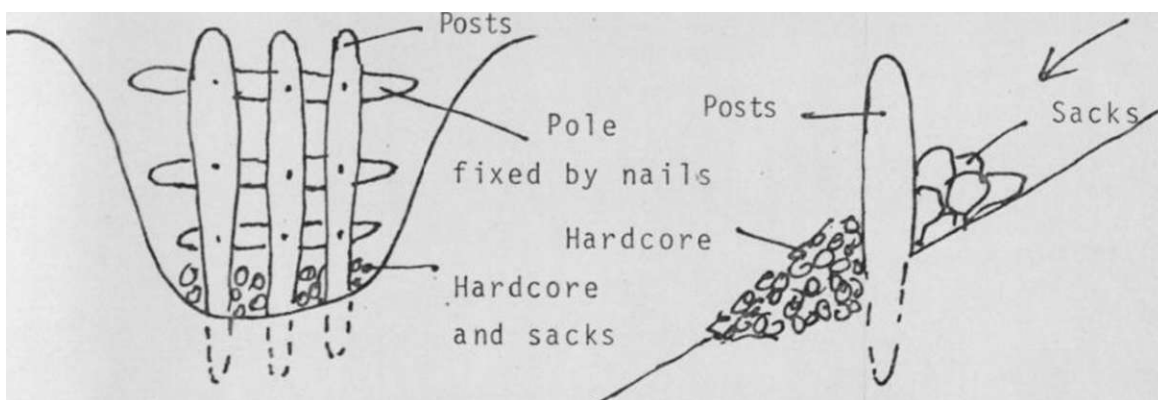
Fig. 4

Check dams have been constructed in the gully to cause siltation. A total of 21 check dams have been constructed along the whole length of the gully and their spacing is between 6-10 metres depending on slope. Check dams are constructed from posts and rafters, hardcore and sacks filled with soil. Posts were lined up across the gully at right angles and were joined together by rafters. Sacks full of soil were deposited behind the posts on the

upstream side and hardcore deposited on the downward stream side of the poles.

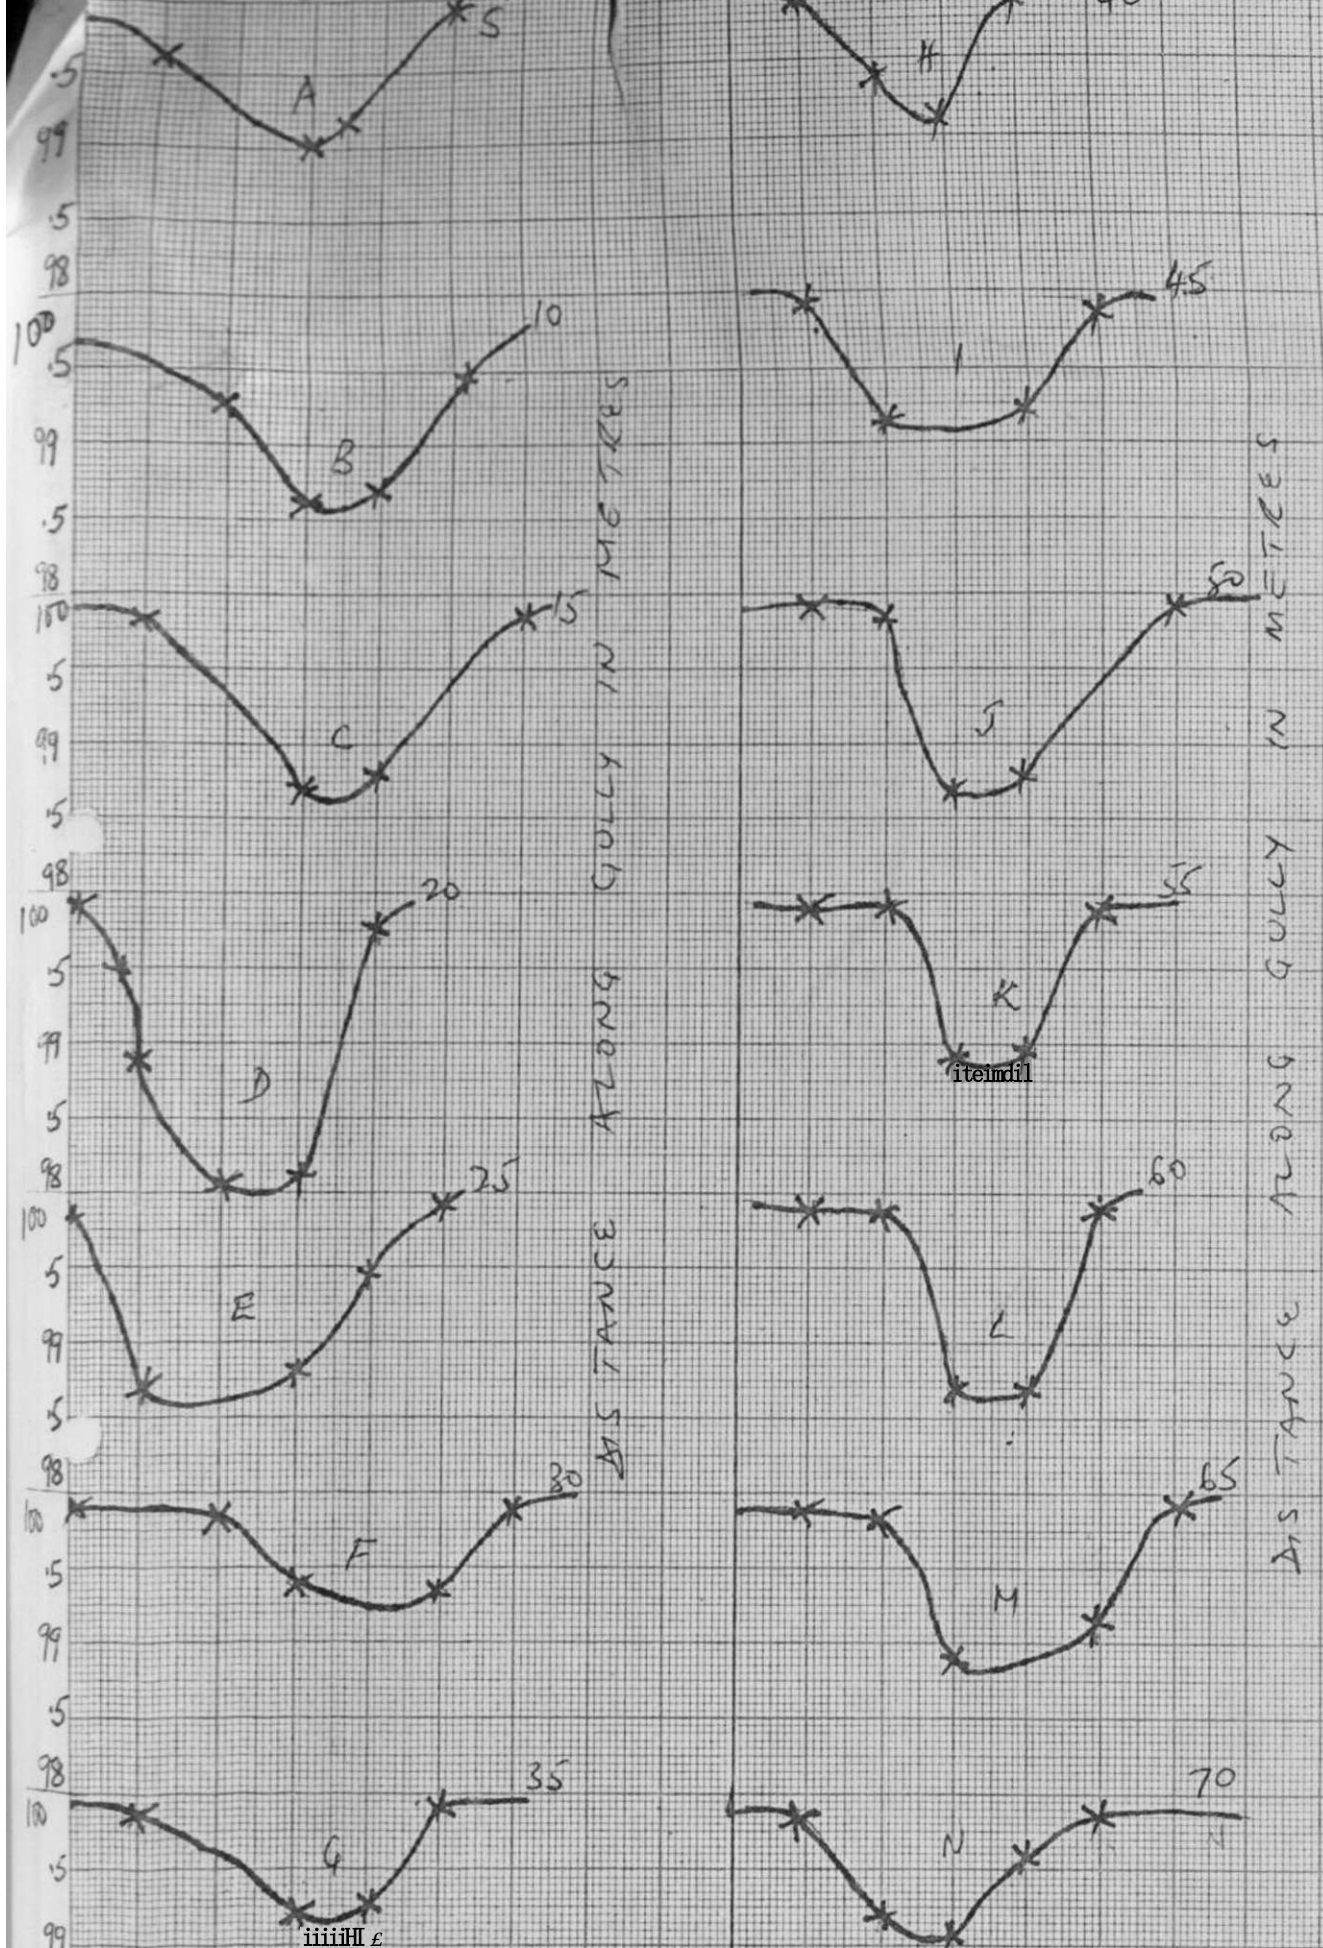
CROSS SECTIONS OF KIKIRO GULLY.

. The same procedure was used to calculate the volume of soil lost in Kiriko gully as was used in the Kabati one. Total volume is about 194.9 M³. Long profile and cross-profiles of Kiriko gully are shown in figures 13 and 14. The long profile of the land surface is shown in fig.13. It should be noted that gully is being reclaimed.

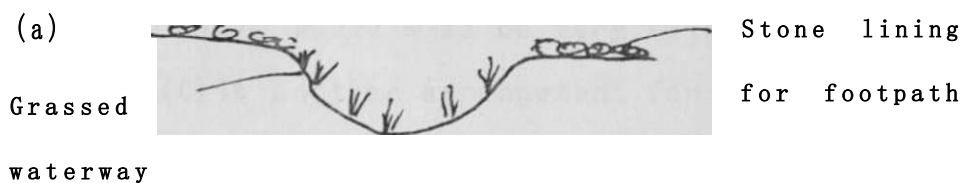
- (°) Plot boundaries run up and downslope and footpaths and tracks run on boundaries where waterways may be needed.

Footpath alongside waterway.

Below are cross-sections of suggested structures of footpath and waterway complex:-

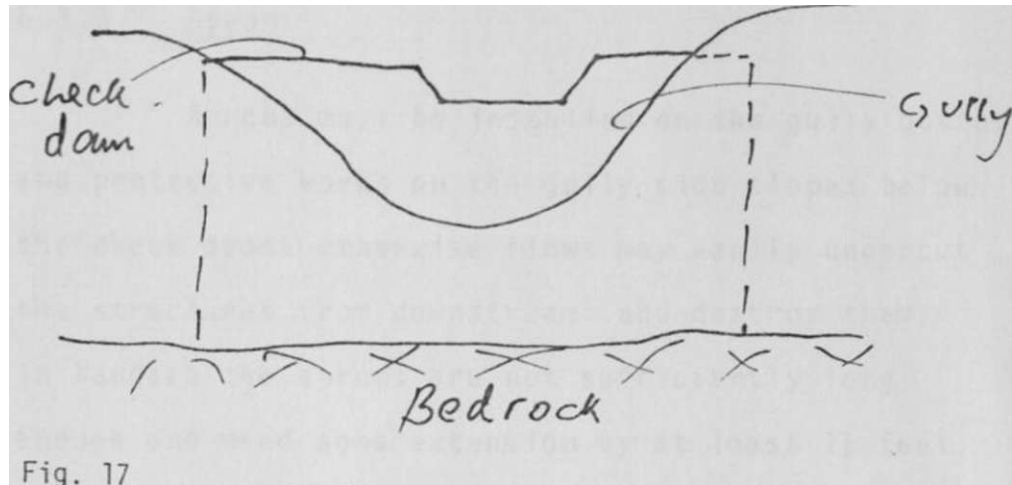
One important point in design of check dams is to concentrate flow in the centre of the structure and to build walls into bank with high shoulders to avoid cutting around. This was not evidenced anywhere in the control structures of gullies in Kandara, It should be carried out and foundations should be strong. This can be achieved by using rock as foundation.
